Indian Pacing and Electrophysiology Journal

A new method for localizing the landmark of axillary vein and its application

Xiaxia Wang, Yongtao Zhang, Yingying Zhang*

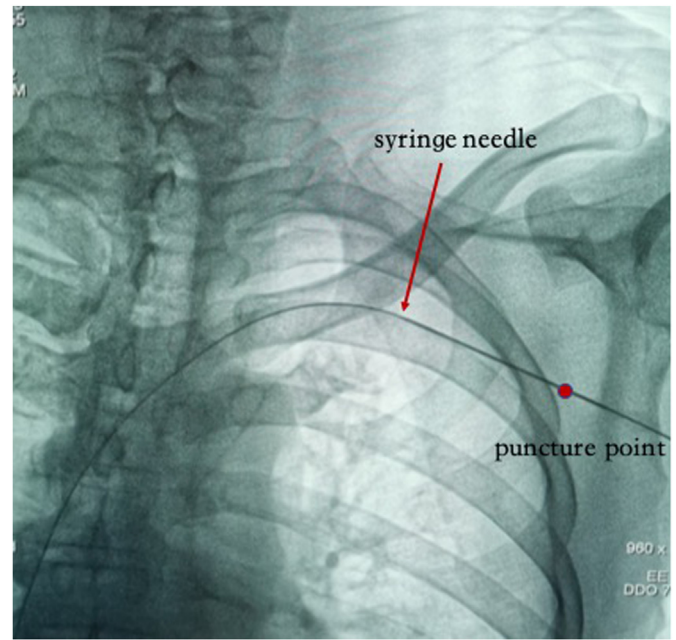
Fig. 2. The blind puncture point of axillary vein.

cusps of thoracic triangle and the coracoid process were directly touched with fingers. The puncture point was about 1 cm below the coracoid, and the needle tip pointed to the medial cusp of thoracic triangle with the angle of 30–60°. The third segment of the axillary vein was punctured with this method (Fig. 2.). All patients were blind punctured successfully.

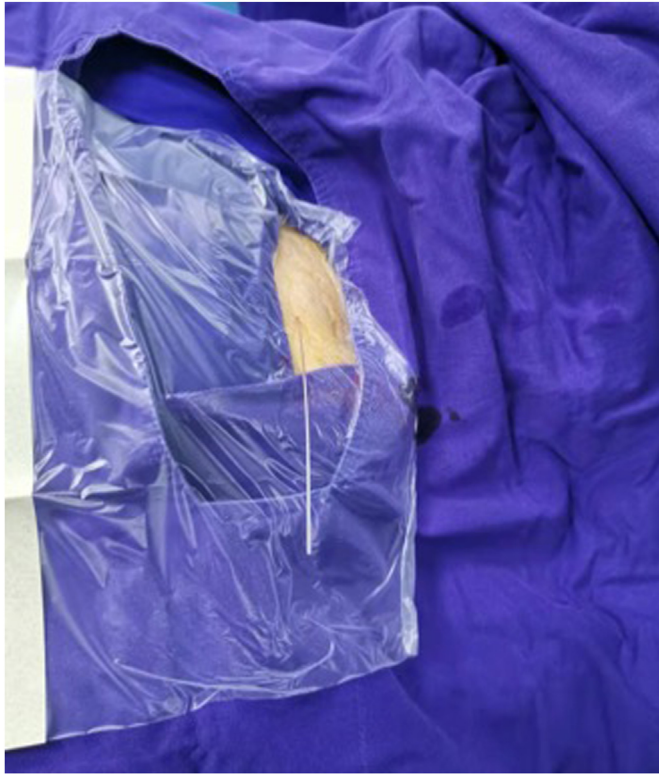
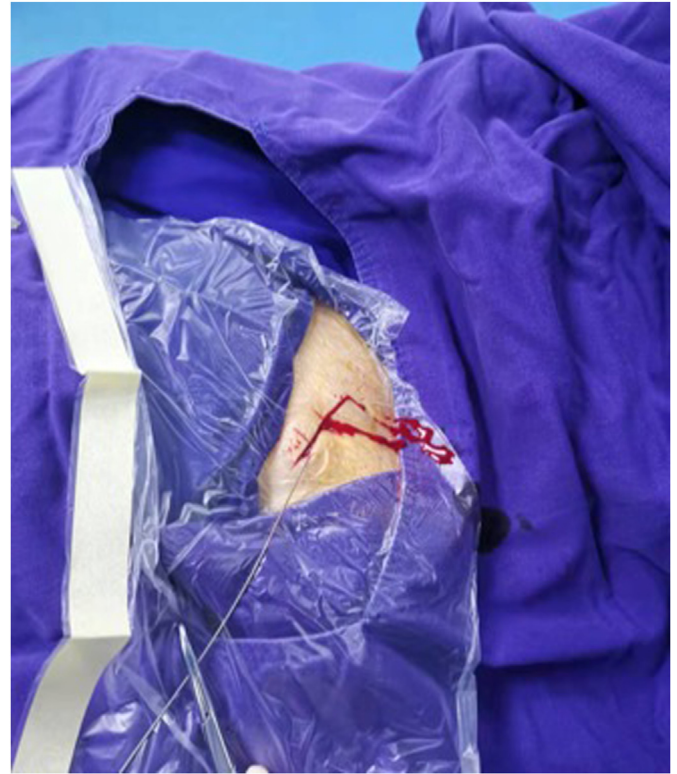
Besides, we cut the pacemaker pocket along the puncture point, which can avoid to draw or replace the guidewire (Fig. 3.). In addition, it is an ideal place for the pacemaker pocket, as it does not cause the friction with the arm and the dislodgement of pacemaker resulted from the overly relaxed pocket (Fig. 4.).

Fig. 3. A pacemaker pocket was created by an incision through the puncture point.
