## CASE REPORT

# Magnet dislocation during 3 T magnetic resonance imaging in a pediatric case with cochlear implant<sup>☆</sup>

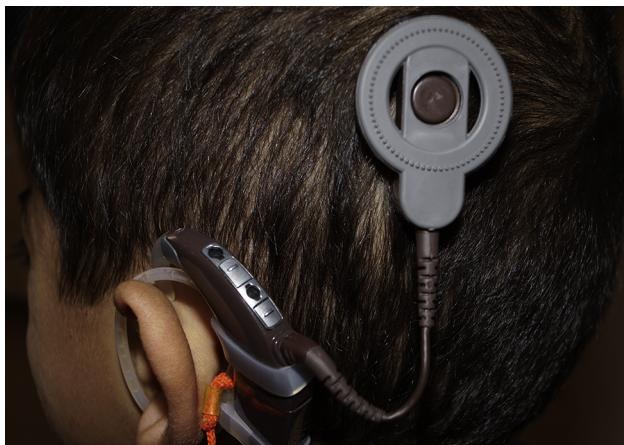
**Figure 1** After the reversal of the external magnet, the external part appears to hold on to the internal part.

The physical examination showed a swelling in the area where the magnet was estimated to be located. The magnet had turned upside down, the external part was reversed (inside facing out) and still attracting to the internal part (Fig. 1). After reversing the external magnet, it was attached to the internal part. In this case, it was found that the stimulation had been restored. The patient was examined radiographically and a minimal shift was observed in the position of the magnet (Fig. 2). Considering the status of patient's disease, a new MRI was planned after removing the magnet.

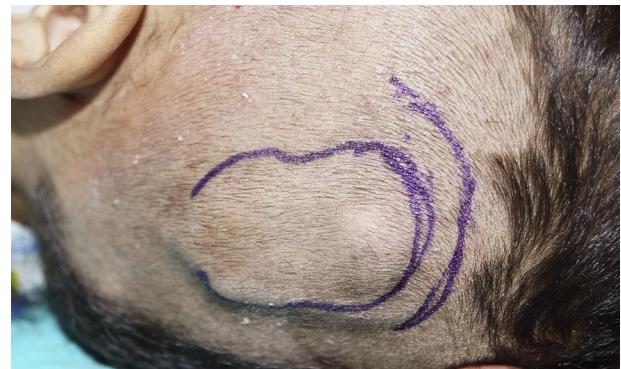
**Figure 3** Marking the boundaries of the inner part for planning the skin incision.

A skin incision was performed under sedoanalgesia as it would not pass through the skin contact area of the device's external and internal part (Fig. 3). After incising the skin, subcutaneous tissue and periosteal layer, the internal part of magnet was reached (Fig. 4). The magnet was turned upside down and was found set apart from its bed superiorly. The magnet was removed and the incision was closed. To avoid

The problem faced with the change of a magnet's polarization was solved by changing the direction of external magnet in a case presented by Jeon et al.<sup>1</sup> Titanium plates were inserted after removing the magnet in another two cases.<sup>8,9</sup> In our case, for the detection of spread of tumor and to reduce artifact, the MRI was performed after the magnet had been removed. Skin problems are the most important problems encountered in magnet revision surgery. The incision should not pass over the internal part in order to reduce skin problems.<sup>10</sup> In the present case, the skin incision was performed so that it would not pass through the skin contact area of the device's external and internal parts

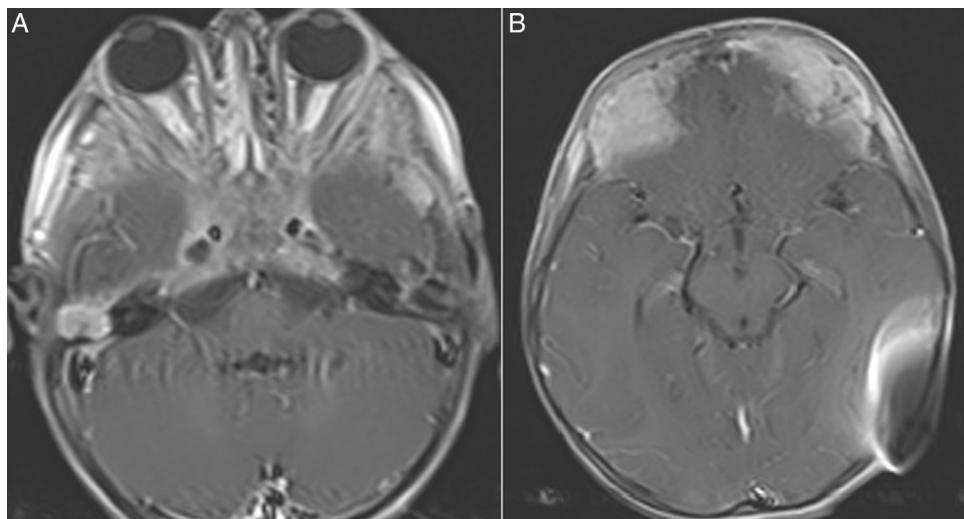
**Figure 5** Lesions showing contrast enhancement in the right mastoid bone, skull base and anterior fossa with artifacts created by remainder of the internal part after intravenous contrast medium administration.

hematoma, a compression bandage was applied and then an MRI was performed at 1.5 T. The MRI showed that the tumor had infiltrated the bilateral petrous apex, clivus, cavernous sinus, and the anterior fossa. Additionally, it had obliterated the frontal sinuses and had extended to fronto-parietal calvarial region. The tumor showed diffuse heterogeneous contrast enhancement after intravenous contrast medium administration. Isointense areas in T1 imaging and heterogeneous hypointense areas in T2 imaging were observed (Fig. 5). The MRI procedure was completed without any problems. The patient was recommended a new magnet placement in order to use the implant again, but the parents refused a surgical intervention since the patient was in a bad general condition. They stated that they would decide the intervention after the completion of treatment. The patient currently remains under chemotherapy for treatment of the tumor.
