Article

First Large Scale Application with Self-Healing Concrete in Belgium: Analysis of the Laboratory Control Tests

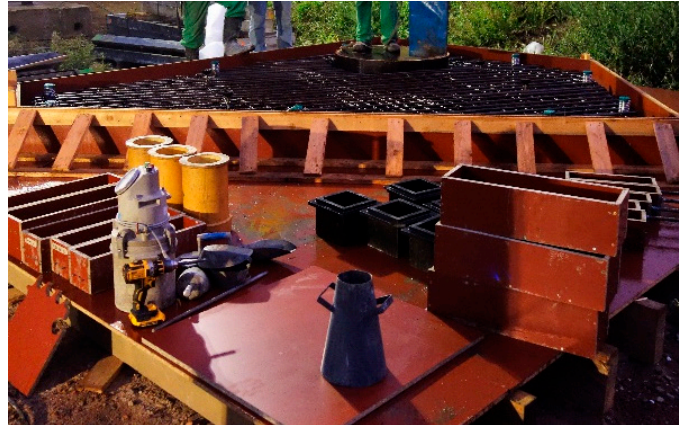
Figure 1. Formwork of the roof slab with the molds of the accompanying lab specimens in front.

To allow for a smooth execution of the substantial project, preparatory works have been undertaken. Part of these preparatory works were the relocation of drainage pipes from the company Aquafin, which is responsible for water treatment in Belgium. The construction project on which the trial site was chosen was executed by a consortium of different contractors, called THV Schijnpoort. Different trials sites to test the efficiency of self-healing bacterial concrete in a real life application were considered. In the end, a roof slab of an inspection chamber of one of the drainage pipes was chosen as the most preferred trial site. It was expected that there would be liquid water, or at least a very high humidity, in the inspection chamber, which is a prerequisite for healing [6]. Furthermore, the roof slab would be located 3.9 m below ground level but would remain accessible through a manhole. This way the bottom of the roof slab, where cracks are expected to appear, will remain accessible over time for inspection of crack formation and subsequent crack healing. It is noted that self-healing concrete can have many applications, but not all elements are easily and safely accessible throughout their lifetime without thorough preparation (e.g., bridge girders which need an aerial work platform to be accessible or tunnels for which traffic has to be diverted for safety reasons). The roof slab was cast on site next to the building pit. Figure 1 shows the formwork of the roof slab, as well as the molds of the accompanying

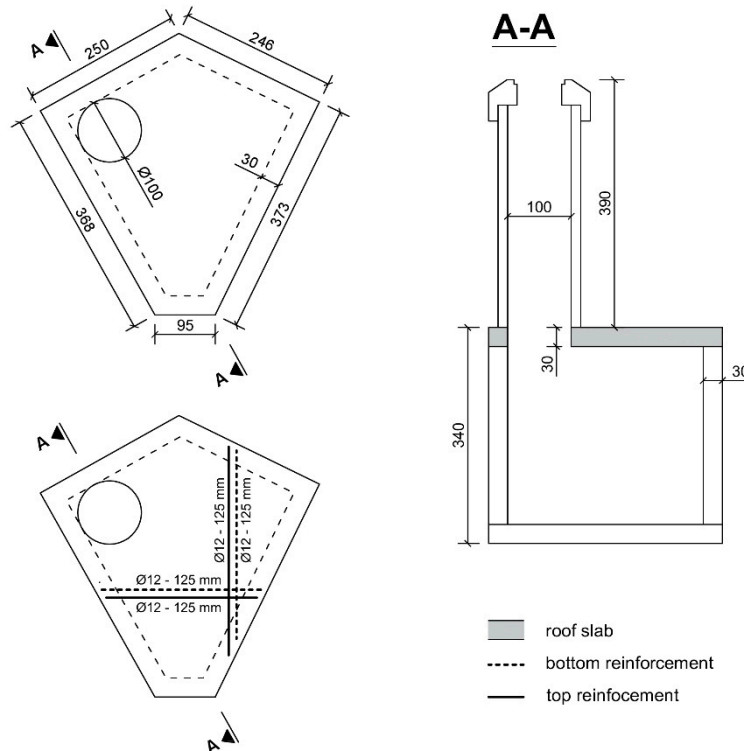
Figure 2. Top view with dimensions of the roof slab (top left). Top view with principle top and bottom reinforcement of the roof slab (bottom left). Side view of the inspection chamber with the roof slab highlighted (dimensions are in mm).

lab specimens (see also Section 3.3). Figure 2 shows two schematic top views of the roof slab, one with the dimensions of the slab and one with the principle reinforcement. Additionally, Figure 2 also shows a side view of the inspection chamber in which the roof slab has been highlighted. To allow for access through the manhole via a precast shaft, there was a circular opening with a diameter of 100 cm in the roof slab. The principle top and bottom reinforcement consisted of nets with bars with a diameter of 12 mm and a spacing of 125 mm. The concrete cover was 50 mm. After curing, the slab was positioned on top of the inspection chamber using a crane (see also Section 5). The thickness of the walls on which the roof slab rests are equal to 30 cm, see Figure 2.

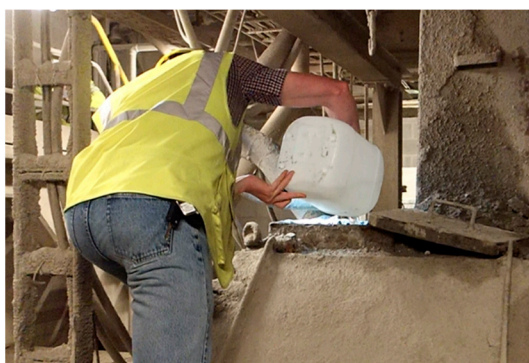
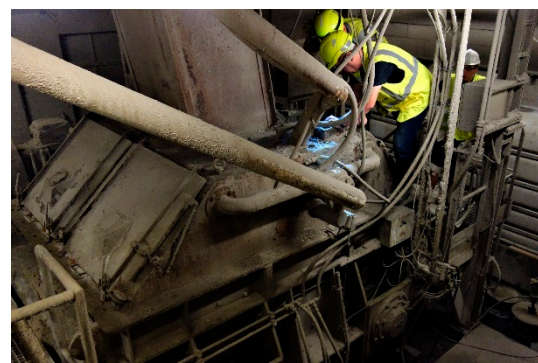
Figure 3. (a,b) Addition of bacterial agent, urea and calcium nitrate tetrahydrate through inspection hatch above industrial concrete mixer.

A batch of 3.5 m³ of concrete for casting of the roof slab and the accompanying lab specimens (see also Section 3.3) was mixed in a concrete plant near the trial site. The mix proportions are given in Table 1. As a slump keeper (superplasticizer A containing a polycarboxylic ether), respectively a water reducer (superplasticizer B, containing a lignosulfonate), two superplasticizers were added to the mix. The dosage of the bacterial healing agent, the urea and calcium nitrate tetrahydrate was for each component separately 1 mass % relative to the cement weight, see Table 1. The urea and calcium nitrate tetrahydrate were dissolved in part of the mixing water in order to promote a uniform distribution of these agents throughout the concrete. The bacterial agent was not dissolved in water, because it was produced in a dry powder form. Several options on what would be the best method to add the self-healing additives to the mixing process were explored. In the end the bacterial agent, the urea and the calcium nitrate tetrahydrate were added separately to the mix by means of an inspection opening at the top of the mixer, see Figure 3.

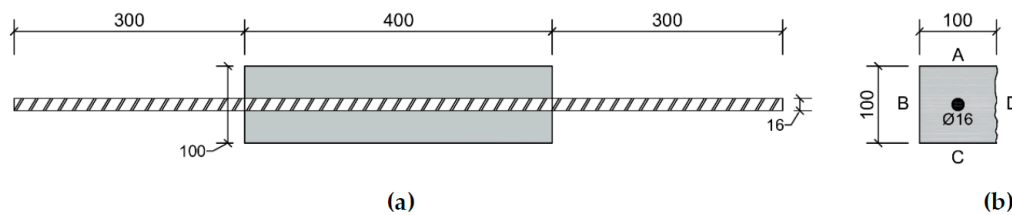
Figure 4. (a) Side view of reinforcement in prismatic specimen used to evaluate visual crack healing; (b) Cross-section of prismatic specimen used to evaluate visual crack healing (A: top surface, B: side surface, C: bottom surface, and D trowelled surface) (dimensions in mm).

Prismatic specimens (100 mm × 100 mm × 400 mm) were cast with one reinforcement bar (Ø 16 mm) with a length of 1000 mm, see Figure 4. The reinforcement bar was centrally positioned, so that 300 mm was sticking out of each side of the specimens. In total 4 specimens were cast. At an age of 5 weeks the specimens were cracked in a uniaxial tensile test similar to the cracking of prismatic mortar specimens by Wang et al. [16]. The reinforcement bar was clamped at both ends in a tensile setup (Amsler 100, SZDU 230). At a displacement of 0.01 mm/s a tensile load was applied on the bar allowing it to deform in a plastic way. After cracking of the specimens, the parts of the reinforcement bars sticking out of the specimens near the end surfaces were sawn off and these end faces were coated. Due to the tensile load on the reinforcement bar two cracks were formed, one of which was in the center of the specimen and one was a combination of a perpendicular and a longitudinal crack near the end of the specimens, see Figure 5. One specimen had an additional crack near the end.

After characterization of the crack widths, the specimens were healed: two specimens were stored in wet/dry cycles (4 h wet/2 h dry) using tap water (20 °C, 60% RH during the dry period), one specimen was submerged in tap water (20 °C), and one specimen was stored in a moist environment (20 °C, 95% RH). After 3 and 6 weeks, the specimens were temporarily removed from their healing condition to evaluate the crack closure by re-measuring the crack width in exactly the same locations. Care was taken that the orientation of the specimens stayed the same, i.e., the same side was always positioned at the bottom during the healing condition, see Figure 4b.

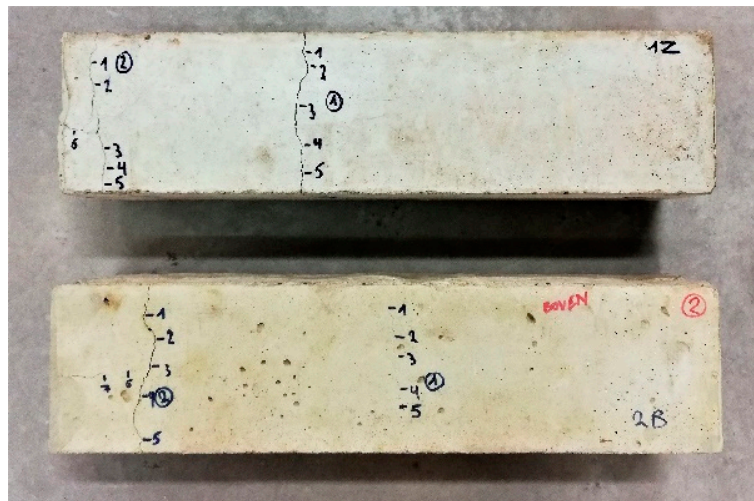
Figure 5. Specimens for visual crack healing with an indication of measurement locations. The reinforcement bar running along the length of the specimens has already been sawn off.

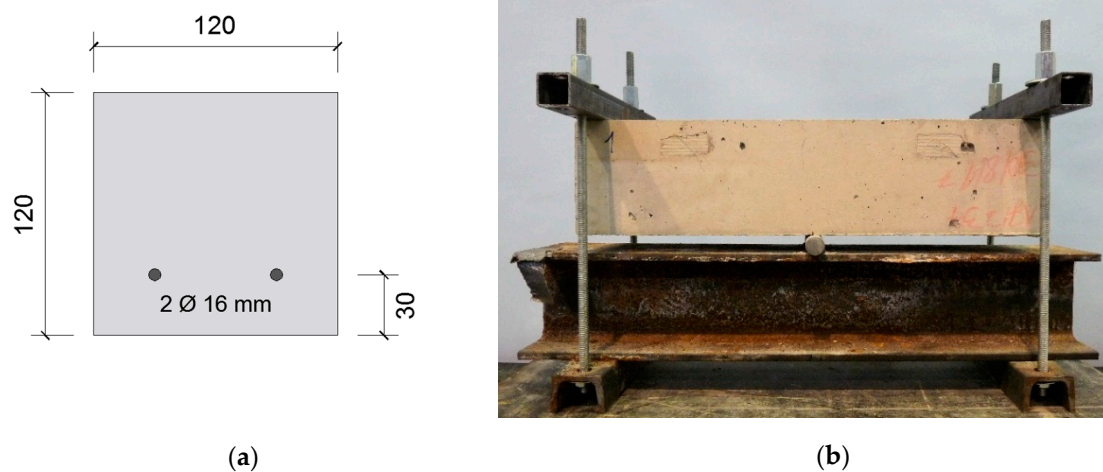
Figure 6. (a) Cross-section of specimen used for capillary water absorption (dimensions in mm). (b) Manual three-point bending setup to crack the capillary water absorption specimens.

To test the capillary water absorption, 4 prismatic specimens (120 mm × 120 mm × 500 mm) were cast with 2 reinforcement bars (Ø 6 mm) located at 30 mm from the bottom side of the specimens, see Figure 6a. The prisms were cracked at an age of 6 weeks in a manual three-point bending setup, see Figure 6b. The bottom side of the specimens was facing up. The two upper supports had a width of 3 cm. The distance between the two upper supports was 44 cm. The bar which forms the third support had a diameter of 2 cm. The specimens were loaded until the crack width after unloading was

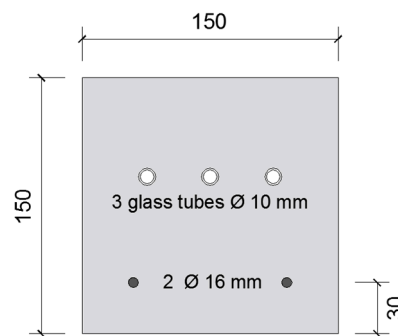
Figure 7. Cross-section of water permeability specimen (dimensions in mm).

Five prismatic specimens (150 mm \times 150 mm \times 550 mm) were cast with 2 reinforcement bars (\varnothing 6 mm) located at 30 mm from the bottom side of the specimens, see Figure 7. The specimens also had 3 glass tubes ($\varnothing_{out} = 10$ mm, $\varnothing_{in} = 8$ mm) running over their entire length which were located 92 ± 2 mm from the bottom side of the specimens, similar as in the work of Feiteira [33]. At an age of 6 weeks the specimens were cracked in a similar way as the capillary water absorption specimens (see Section 3.3.2). The distance between the upper supports was equal to 43 cm. During cracking of the beams it was possible to hear the racking of the glass tubes.

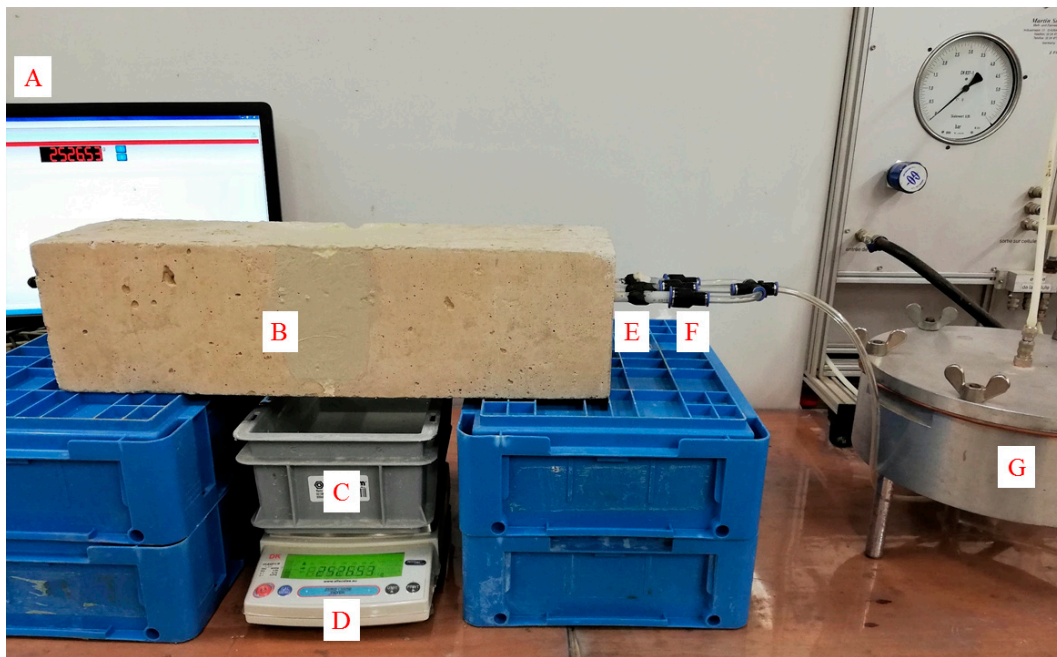
Figure 8. Water permeability setup (A: computer recording the weight measured by the scale, B: epoxy to seal the lateral side of the specimen, C: container to capture the water leaking out of the crack from the bottom side of the specimen, D: scale, E: glass tubes which run along the entire length of the specimen, F: connection of the glass tubes to a pressurized water reservoir via flexible tubing, and G: pressurized reservoir).

Prior to executing an initial permeability test, the specimens were submersed in tap water for 5 days. This was done to prevent water uptake of the matrix during the test. After this saturation period, the glass tubes on one side of the specimens were connected to a water reservoir pressurized at 1 bar, see Figure 8. The other side of the glass tubes was sealed. Due to the applied pressure, water from the reservoir flowed into the glass tubes and from there into the cracks. The mass of water leaking out of the bottom of the specimens was continuously recorded for 15 min. To prevent leaking from the lateral sides of the specimens, the cracks at the lateral sides of the specimens were sealed with an epoxy after cracking. If leakage from the lateral sides would be allowed, this could give too conservative a value [34]. After all, these prismatic specimens are used to analyze the healing behavior of a roof slab, in which there can be no lateral water leakages.

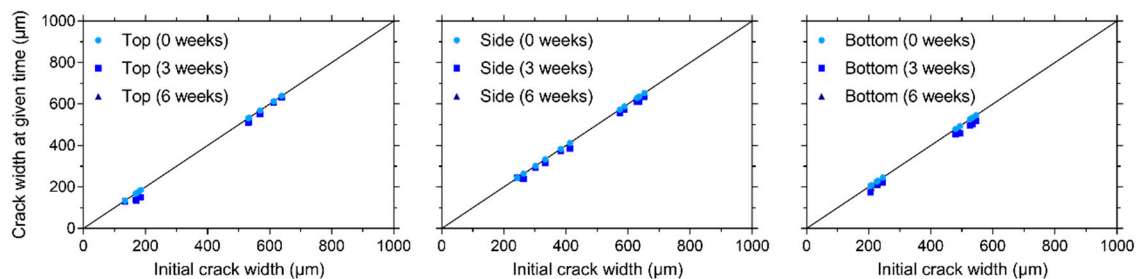
Figure 9. Evolution of the crack width under > 90% RH on the top, side, and bottom surfaces.

Regardless of the face of the specimen, the crack closure is very limited for the specimen stored at 95% RH, see Figure 9. The maximum relative crack closure is: 17.0%, 8.4%, and 13.9% for the top, side, and bottom face, respectively. It should be noted that the five locations with the lowest crack width were located at the top (134–185 μm). In contrast, the minimum crack width at the side and bottom was, respectively, 243 μm and 206 μm . This could explain why the highest relative crack closure could be found for a location at the top face of the specimen.

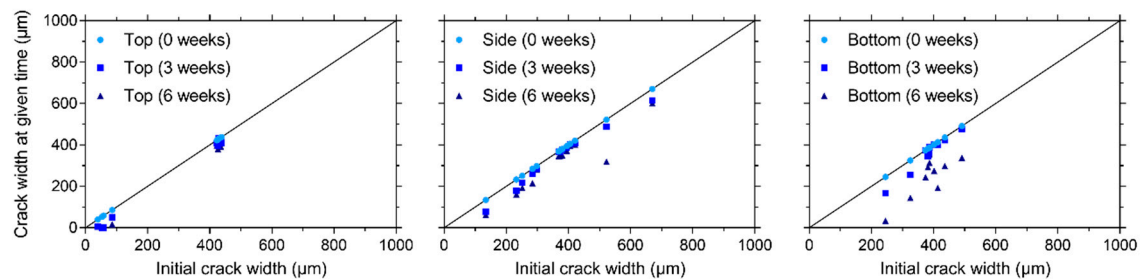
Figure 10. Evolution of the crack width under saturation on the top, side, and bottom surfaces.

The healing of the cracks is clearly better for the specimen subjected to water submersion, see Figure 10. Three locations at the top of the specimen with a mean crack width varying between 52 and 58 μm obtain a perfect crack closure. The maximum crack closure for the cracks on the side of this specimen is 53.9% for a location with a mean crack width equal to 134 μm . The maximum crack closure for the bottom of the specimen is significantly higher—86.3% for a location with a mean crack width of 245 μm . From these results, it is difficult to conclude which face of the specimen gives the best crack closure for a submersed healing condition. The top face obtains a higher maximum crack closure, yet it should be noted that this is obtained for cracks with a mean width smaller than 100 μm , while the location with the smallest mean crack width for the bottom face is 245 μm . In any case, it appears that the cracks at the bottom have a more consistent crack closure even at higher mean crack widths.

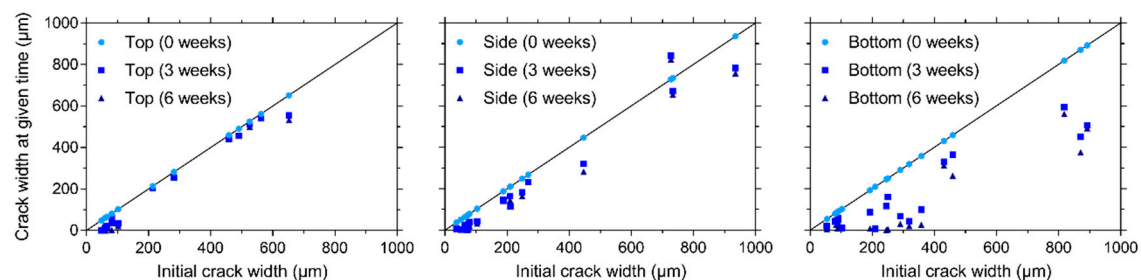
Figure 11. Evolution of the crack width under wet-dry (W/D) cycles on the top, side, and bottom surfaces.

On all faces of the specimens subjected to W/D cycles, a maximum relative crack closure of 100% was recorded, see Figure 11. The maximum mean crack widths for which a closure of 100% was measured were: 61 μm (top), 72 μm (side), and 245 μm (bottom). Additionally, several locations obtained a nearly perfect crack closure (>90%): five locations at the top (with a crack width varying between 48 μm and 81 μm), two locations at the side (with a crack width varying between 72 μm and 76 μm), and nine locations at the bottom (with a crack width varying between 54 μm and 358 μm). From these results, along with the global visual impression of Figure 11, it is clear that the bottom side obtains the best crack closure. There are two possible causes for this. The first being the effect of gravity, where calcium carbonate which is produced by the bacteria and which is not well bonded to the crack walls falls down and is deposited in a lower part of the crack. The second cause is related to the movement of the water. From Figure 9, it can be concluded that the bacteria need water to form calcium carbonate. When calcium carbonate is formed and the wet cycle is at an end, the water can take the calcium carbonate down in the crack where it is again deposited. Since the bottom face of the specimen also gave the most consistent crack closure for permanent saturation (Figure 10), in which there is no water flow, the first cause related to the influence of gravity is more plausible.

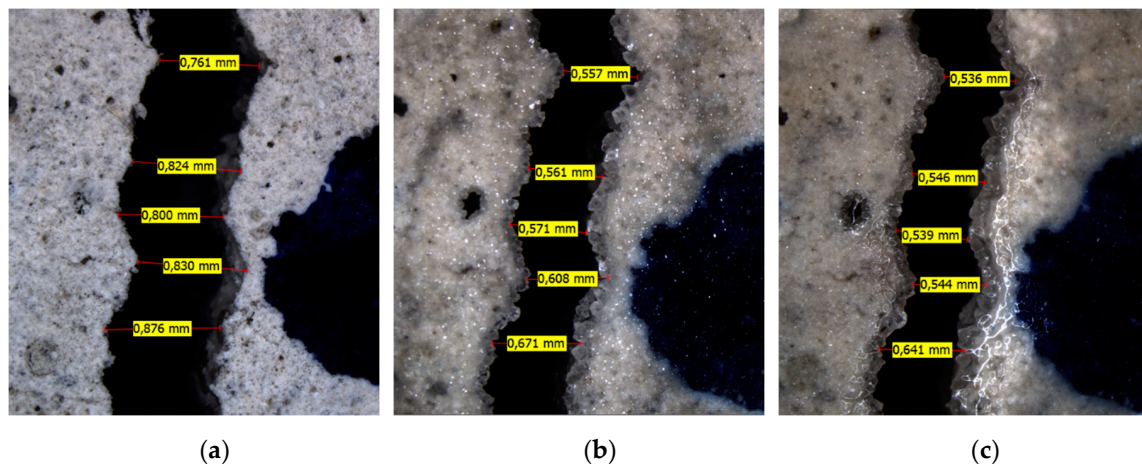
Figure 12. Crack location on the bottom faces of a specimen subjected to W/D cycles (a: initial, b: 3 weeks of healing, and c: 6 weeks of healing).

Figure 12 gives an overview of the healing of a relatively wide crack location located on the bottom of a specimen subjected to W/D cycles. The formation of crystals in the crack is evident. Though it also appears that part of the crack closure is not the result of healing products, but rather an elastic closure. This is possibly the result of a relaxation in the steel.

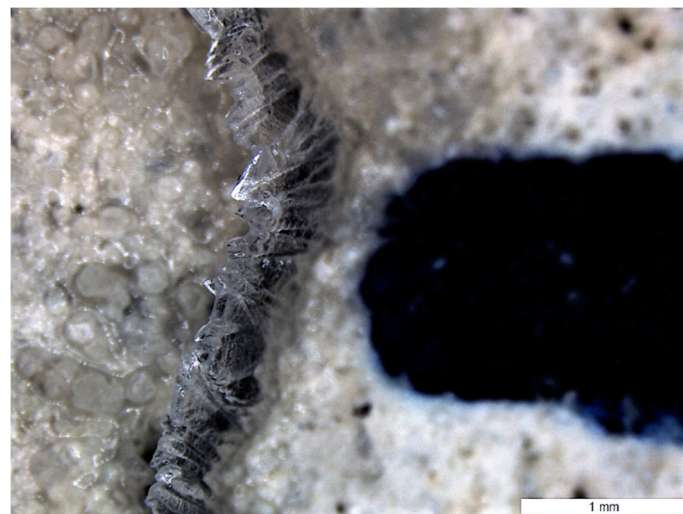
Figure 13. Formation of stalactites on a crack location on the bottom face of a specimen subjected to W/D cycles.

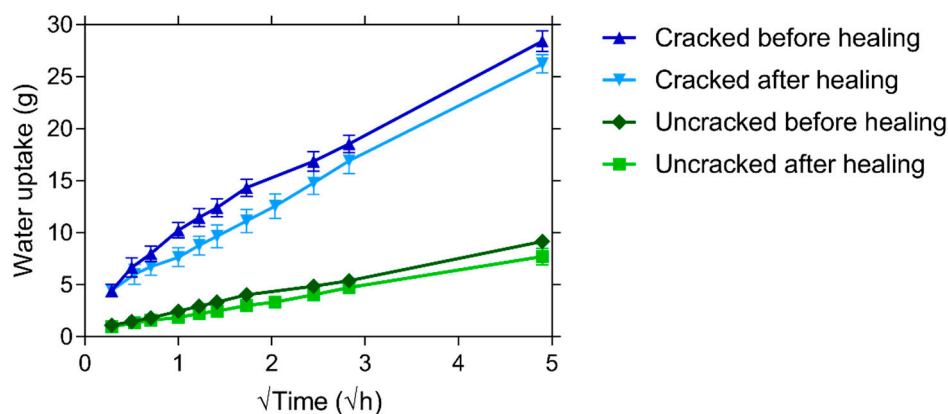
Figure 14. Mean cumulative water uptake in function of the square root of time of both cracked and uncracked specimens before and after healing. The length of the error bars represent two times the standard deviation.

The mean cumulative mass increase due to capillary water uptake in function of the square root of time for both the cracked and uncracked specimens before and after healing is given in Figure 14. The healing period causes only a slight decrease in the mean water uptake of the uncracked specimens. This indicates that there is only a small densification of the concrete matrix. Similarly, there is also only a limited decrease in the capillary water uptake of the cracked specimens after healing. The mean water uptake in the first 5 min is even equal before and after healing, which could potentially be explained by small differences in the water height during the two tests. Table 3 gives the sorption coefficients before and after healing, out of which it is possible to calculate a sealing efficiency using Equation (1). The sealing efficiency varies between 0.9% and 15.3%. This limited improvement in capillary water uptake

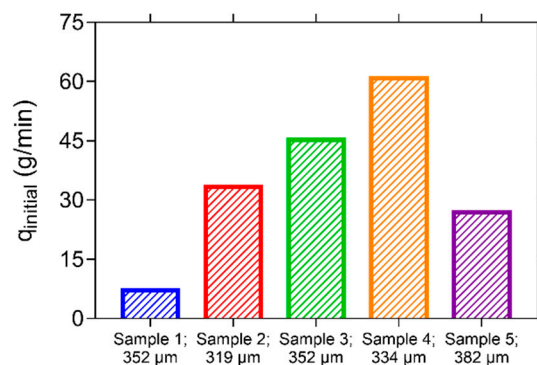
Figure 15. Initial flow rate measured in the water permeability setup for the five different specimens with an indication of the mean crack width.

Figure 15 shows the initial flow rate of the five water permeability specimens, prior to healing. The flow rates vary from 7.1 g/min to a maximum flow rate of 60.9 g/min. The average of these five flow rates is equal to 34.7 g/min with a coefficient of variation (*COV*) equal to 58.0%. This is quite a

large variation compared to the crack width which has an average value of $348 \mu\text{m}$ with a coefficient of variation (COV) equal to 6.8% for the five specimens. It has already been noted in previous research that the variation on the flow rate can be an order of magnitude higher than the variation on the crack width [34]. In this previous study the COV of the flow rate varied from 9.5% (mean crack width of $307 \mu\text{m}$) to 20.5% (mean crack width of $161 \mu\text{m}$) for different series. The COV of the flow rate in the current study is much higher, which can be explained by the difference in specimen layout and mix composition. In the previous research, prismatic mortar specimens ($40 \text{ mm} \times 40 \text{ mm} \times 160 \text{ mm}$) were tested in a permeability setup in which water was induced through one cast-in hole located at 15 mm from the bottom of the specimens. In the current study, the specimens are made from concrete, instead of mortar. The larger aggregate size will make the matrix less homogenous and thus the influence of the internal crack geometry can be very different between specimens. Additionally, in the current study the specimens are much larger ($150 \text{ mm} \times 150 \text{ mm} \times 550 \text{ mm}$) and also the water is induced much higher in the specimens (at $92 \pm 2 \text{ mm}$ from the bottom of the specimens). Therefore, the water has to travel a much larger distance along the crack before it can leak out of the specimens. As a consequence, the influence of the internal crack geometry on the flow rate becomes more pronounced. Furthermore, the reported crack width is measured at surface, whereas the crack width at the location of the glass tubes where the water is introduced into the crack will be different. The influence of these aspects is evident when comparing samples 1 and 3: both have the same crack width at the surface ($352 \mu\text{m}$), yet the flow rate of sample 3 is six-times larger than the flow rate of sample 1.

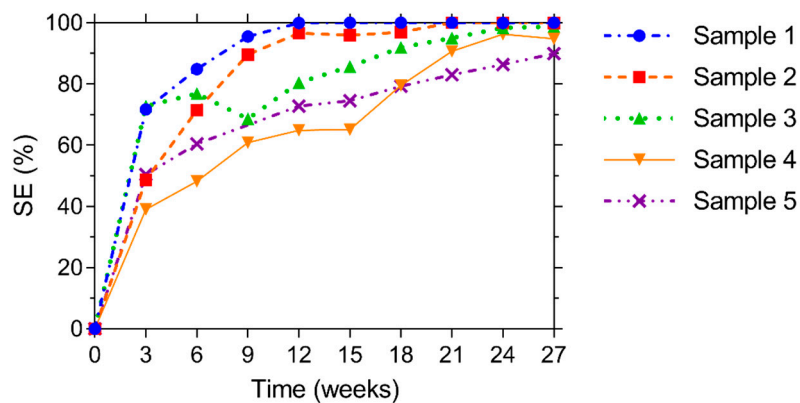
Figure 16. Evolution of the sealing efficiency SE of five samples up to 27 weeks of water saturation.

After the initial water permeability test, the specimens were immersed and their flow rate was determined again every 3 weeks, up to a saturation period of 27 weeks. By comparing the flow rate of a sample after a certain healing duration to the initial flow rate of the same sample, the sealing efficiency (SE) could be determined according to Equation (2). Figure 16 shows the evolution of SE over time for the five different samples. Already after 3 weeks of water saturation, SE is at least equal to 39.1%, up to a maximum of 72.8%. After 12 weeks of submersion, the rate of water leakage of sample 1 is almost identical to the evaporation rate. This is also the case for sample 2 after 21 weeks of submersion. After 27 weeks of submersion, SE is at least equal to 90% and for three specimens SE is even higher than 98.5%, resulting in an average SE of 96.7% after 27 weeks of healing in saturation. It can be noticed that there is a slight dip in the curve of sample 3 at a time of 9 weeks. The reason for this is not entirely clear, but could be the result of break age and subsequent washing out of some of the healing product.

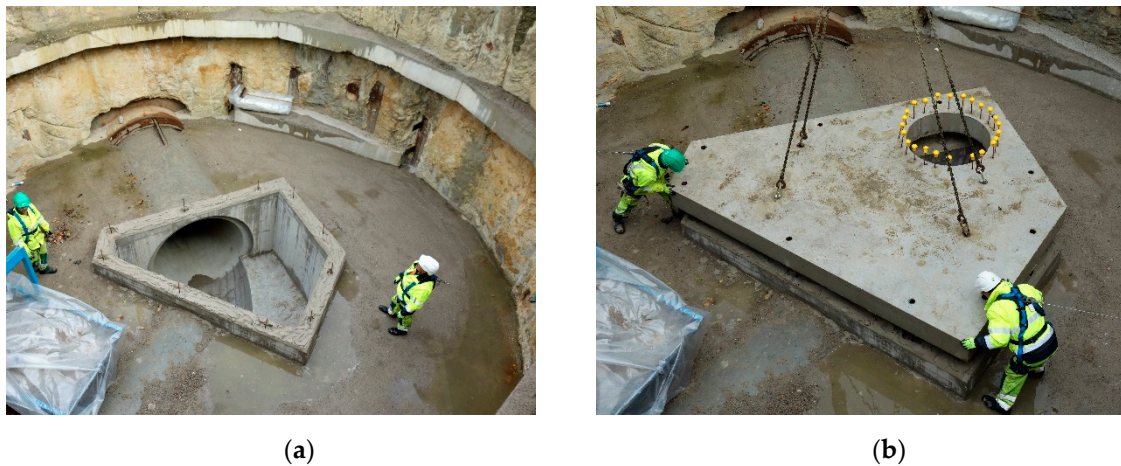
Figure 17. (a) Building pit prior to installation of the roof slab. (b) Installation of the roof slab on the inspection chamber inside the construction pit.

Approximately 5 weeks after casting, the roof slab was moved from its position next to the construction pit and was installed on the inspection room. Figure 17a shows the building pit prior to installation of the roof slab and Figure 17b shows the installation of the roof slab on the inspection chamber. More than one year after casting, the bottom side of the roof slab was examined. No cracks were found during this inspection. A possible explanation could be that the backfilling of the construction pit happened quite late, therefore, the concrete had obtained its full strength potential when it was loaded by the ground layer. Additionally, it is unlikely that the most severe load combination (including an axis load of a fully loaded truck, i.e., de dominant load) occurred. The backfilling was one of the last tasks on the construction site and so there was almost no more construction traffic.

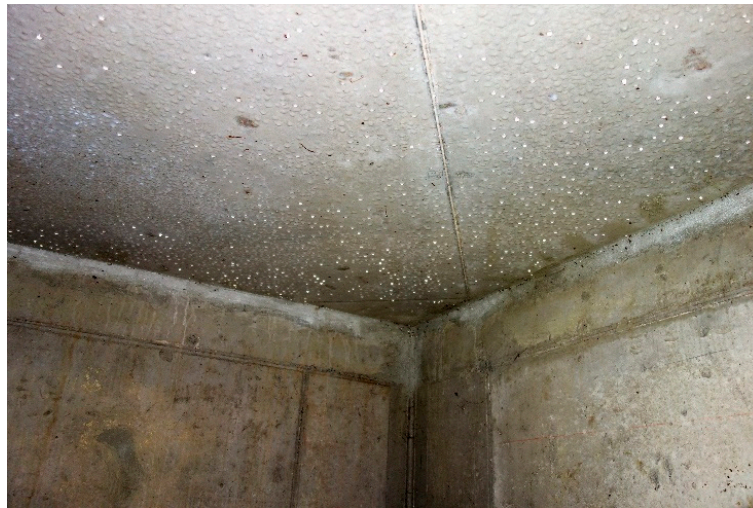
Figure 18. Condensation on the bottom side of the roof slab when the inspection pit and the connecting drainage pipes are operational.

Despite the fact that no cracks were found, it was positive to observe that there was condensation on the bottom side of the roof slab, see Figure 18. About 30% of the roof slab was covered by large condensation drops, even though the water level in the drainage pipes was quite low. This indicates that the conditions in the inspection chamber are favorable in case cracks would form. As indicated in Section 4.2, contact with liquid water is required in order to have a significant crack closure due to healing.
