Case report

Combining a hip arthroplasty stem with trochanteric reattachment bolt and a polyaxial locking plate in the treatment of a periprosthetic fracture below a well-integrated implant

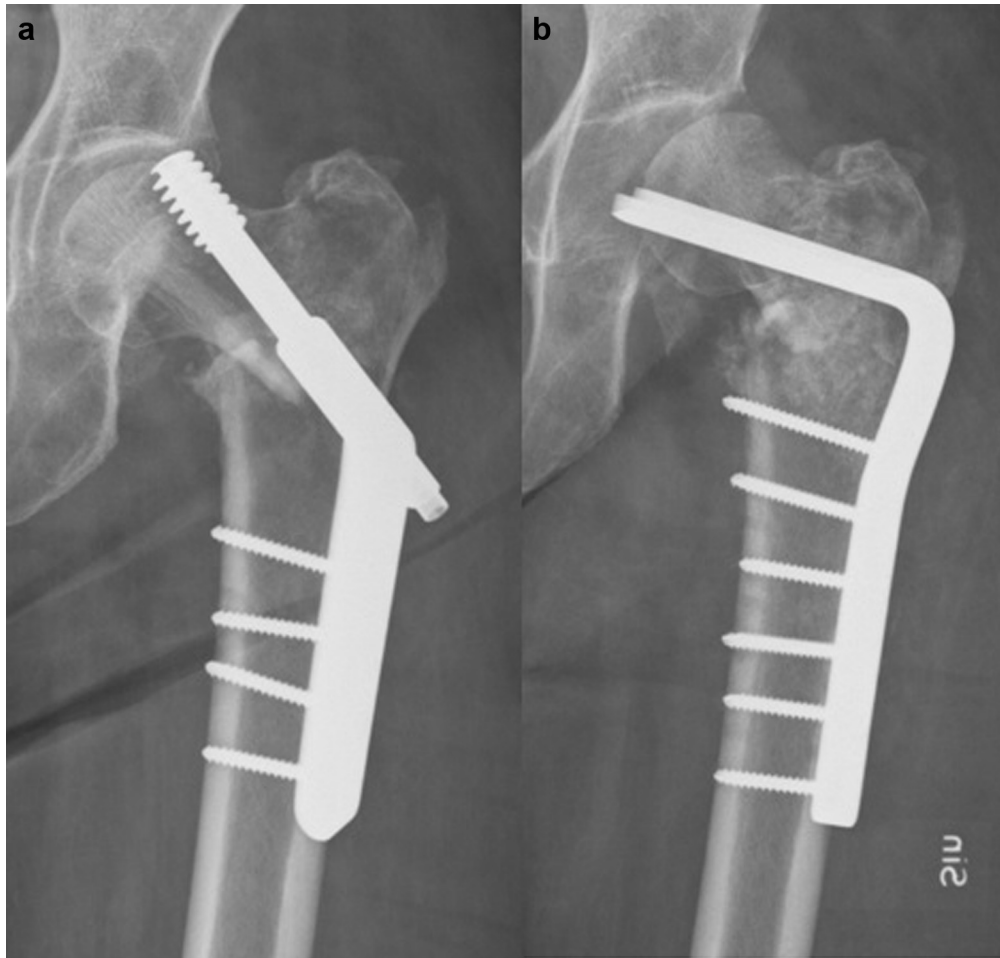
Figure 1. (a) Anteroposterior radiograph of the left proximal femur after failure of a dynamic hip screw and (b) subsequent AO 95° condylar blade plate fixation of a pertrochanteric fracture.

in her nursing home in January 2014. She was treated with internal fixation with a plate and a sliding screw. The osteosynthesis was insufficient, and she was reoperated 2 months later with an AO (DepuySynthes, West Chester, PA) condylar plate, but the femoral head and the acetabulum were destroyed by screw and plate cutout without any signs of fracture healing (Fig. 1a and b). A total hip arthroplasty with a trochanteric osteotomy was performed with the Arcos Modular Femoral Revision System (Biomet Inc., Warsaw, IN) without any complications during surgery (Fig. 2a and b), and 5 cultures from the previous plate were negative. The hip system has been used at our institution since March 2012, and we participated in an international multicenter study on hip revisions 2013–2014 (Ethical Committee GU # 575-13, 2013-09-10), although this elderly lady did not fit the inclusion criteria.

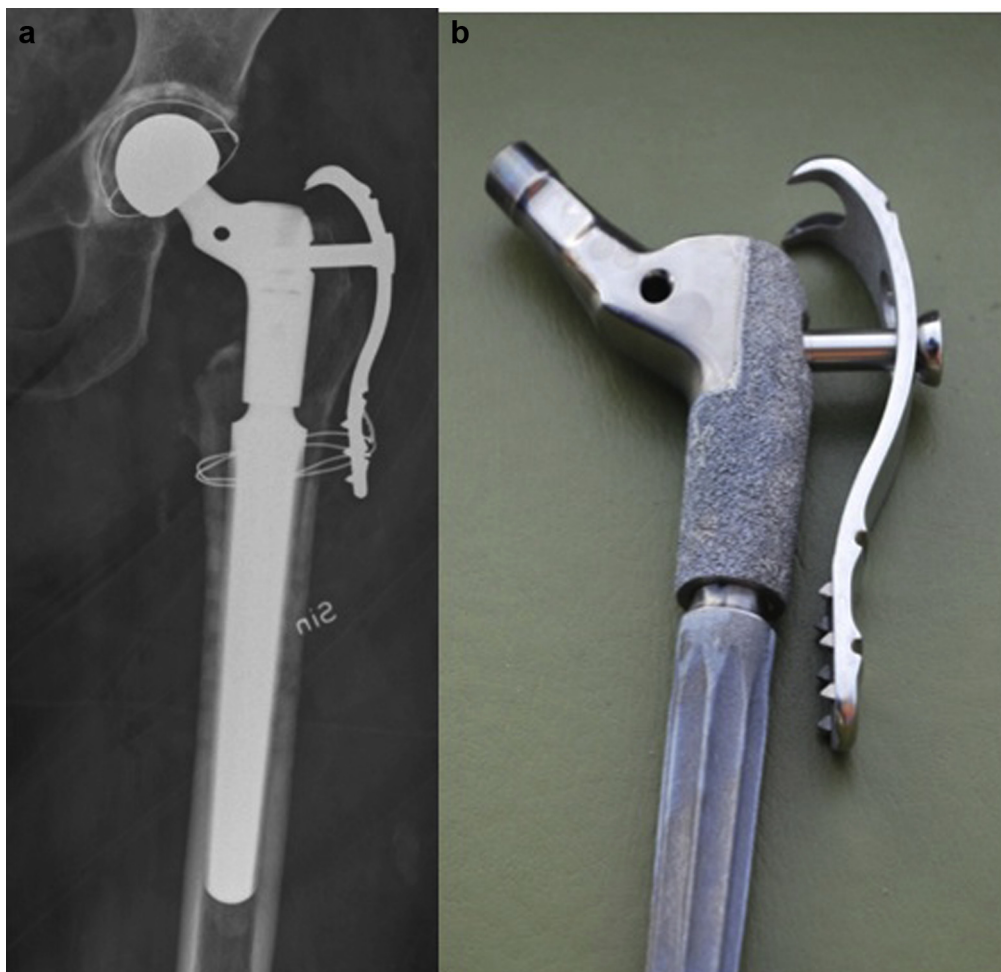
Figure 2. (a) Anteroposterior radiograph of the left proximal femur after removal of the plate and conversion to total hip arthroplasty with an Arcos modular STS stem, claw plate with trochanteric reattachment bolt, and a Lubinus/Link cemented acetabulum cup articulating against a 32-mm Cr-Co-Mo head. (b) Photograph of a proximal Arcos hip prosthesis with claw plate and trochanteric reattachment bolt.

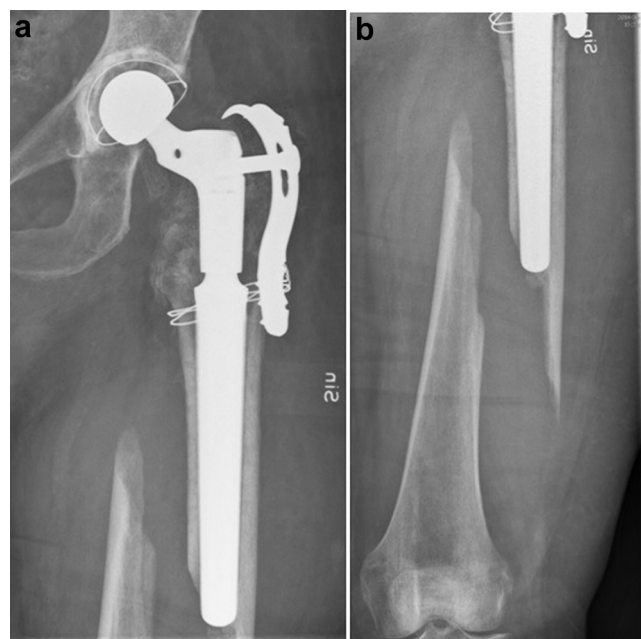
Figure 3. Anteroposterior radiograph of the left femur (a) proximally and (b) distally. A periprosthetic fracture classified as Vancouver type B1 is noted. The trochanteric osteotomy appears healed.

Four months later, she fell at her rehabilitation facility and sustained a periprosthetic Vancouver B1 fracture with the prosthesis in place (Fig. 3a and b). There were no signs of subsidence, osteolysis, or zones around the hip implant, but her erythrocyte sedimentation rate was 99. The wound had healed, but the skin was red and edematous, and we suspected a deep infection.

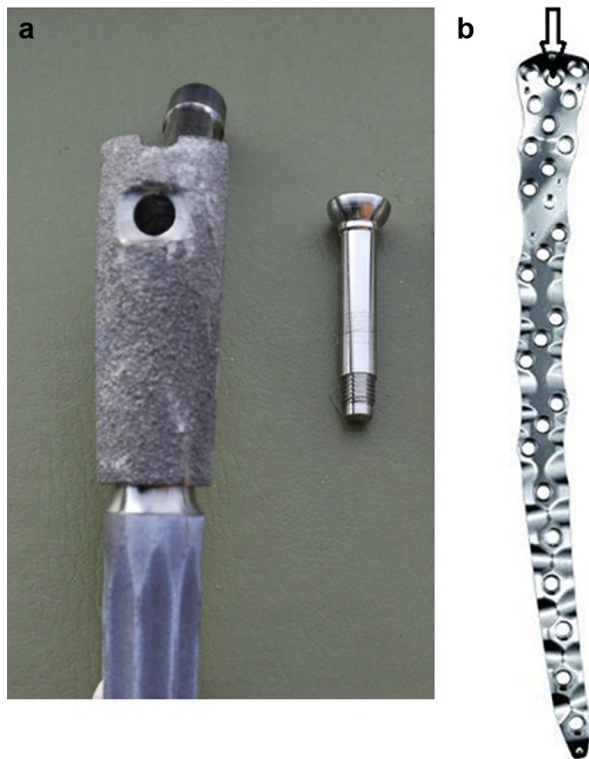
Figure 4. (a) Photograph of lateral view of a proximal Arcos hip prosthesis with reattachment bolt and (b) Zimmer noncontact bridging plate with arrow indicating the hole that was enlarged in the plate.

We found that the longest available NCB Periprosthetic Proximal Femur Plate (Zimmer, Warsaw, IN) with 21 holes and 401 mm long would be sufficient. There is a trochanteric extension with locking screws available for this plate which provides desirable trochanteric support, but we had no such device available at our hospital. To fit the femur, the plate was instead contoured using an AO large plate bending press. While keeping it stable in that tool, the middle of the proximal plate holes was slightly enlarged to fit the 5.5–6 mm stepped bolt screw of the Arcos system, using an Anspach Black

Max pneumatic drill (Soma Technology, Cheshire, CT) with a high-speed metal burr to remove the screw threads of the locking plate (Fig. 4a and b). This procedure and cleaning the plate took us <2 minutes once the shape of the plate was accepted.

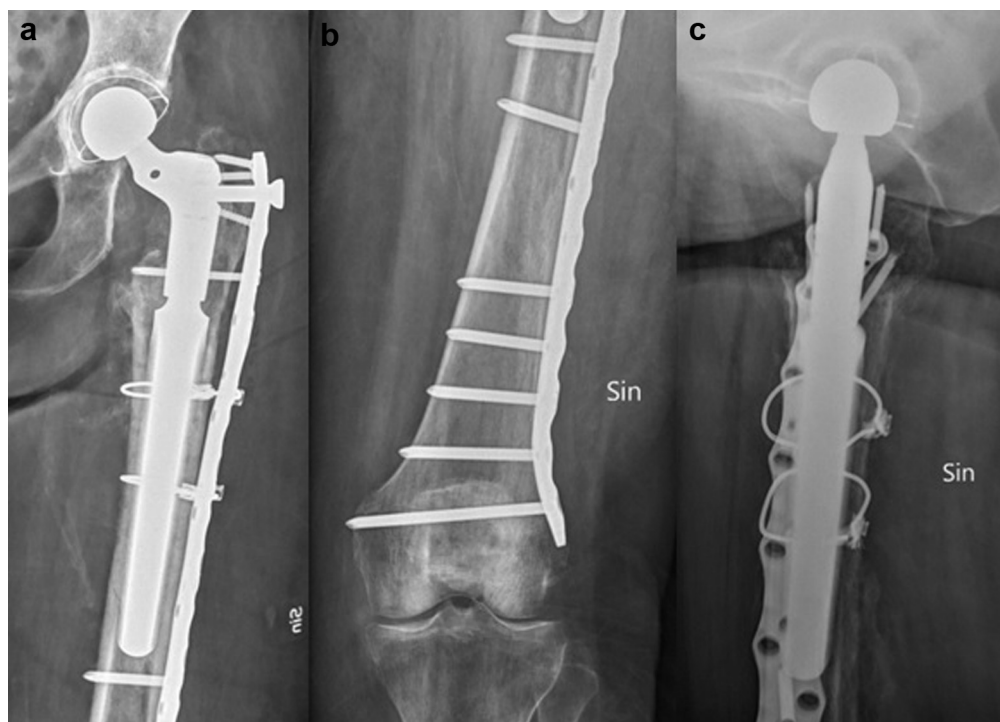
Figure 5. Anteroposterior radiograph of the left femur (a) proximally and (b) distally and (c) lateral radiograph. The fracture appears healed.
