# 'Pseudo'-D-shaped septum post-left ventricular assist device implantation

Department of Cardiology, Erasmus MC University Medical Center Rotterdam, Dr Molewaterplein 40, 3015 GD Rotterdam, The Netherlands

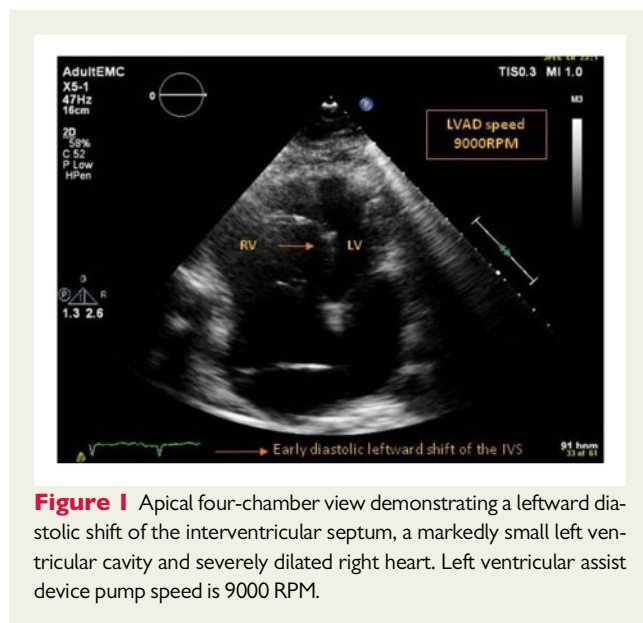
**Figure 1** Apical four-chamber view demonstrating a leftward diastolic shift of the interventricular septum, a markedly small left ventricular cavity and severely dilated right heart. Left ventricular assist device pump speed is 9000 RPM.

early diastolic leftward shift of the IVS, creating a 'D-shaped' septum as seen in a volume overloaded RV (Figure 1; Supplementary material online, Videos S1 and S2). There was no clinical or echocardiographic explanation for RV volume or pressure overload, which led to the possibility that the 'pseudo' D-shaped septum was related to suction of the LV due to relatively high LVAD speed settings. After stepwise lowering of the LVAD speed to 8400 RPM, the D-shaping of the LV and the frequent PI events diminished (Figure 2; Supplementary material online, Video S3).

In this case, an overly high degree of LV unloading resulted in a volume overloaded RV and subsequent under filling of the LV, causing low flow events. This combined with reduced pulmonary capillary

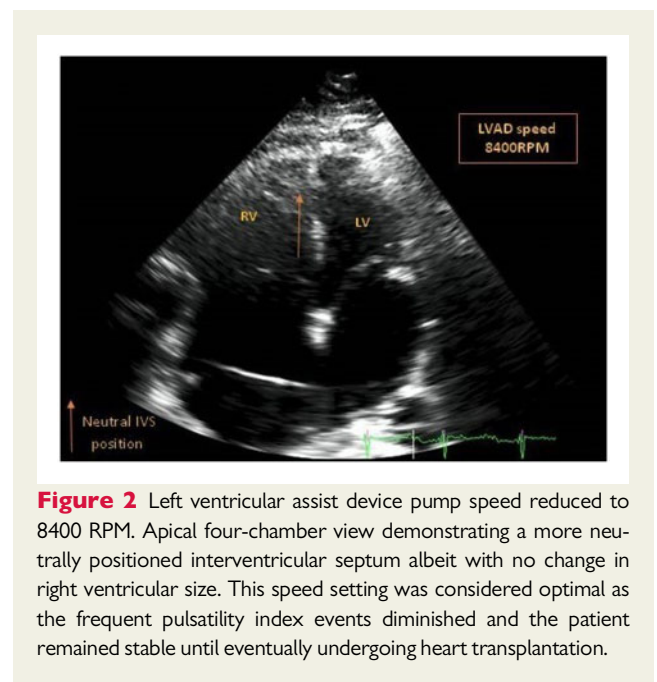
**Figure 2** Left ventricular assist device pump speed reduced to 8400 RPM. Apical four-chamber view demonstrating a more neutrally positioned interventricular septum albeit with no change in right ventricular size. This speed setting was considered optimal as the frequent pulsatility index events diminished and the patient remained stable until eventually undergoing heart transplantation.
