# Knee Squeaking Secondary to Intra-articular Nonabsorbable Suture

## A Report of 2 Cases

*Investigation performed at the Rothman Institute at Thomas Jefferson University Hospital, Philadelphia, Pennsylvania, USA*

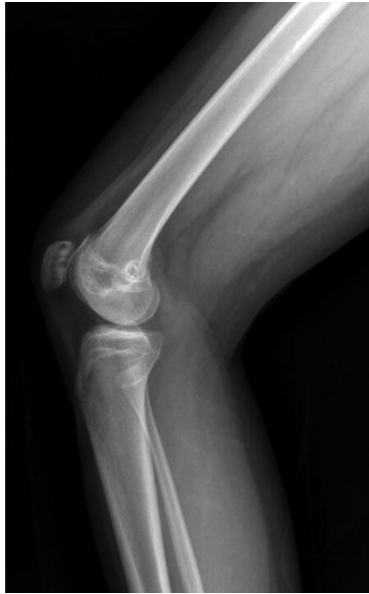
**Figure 1.** Lateral radiograph of the right knee demonstrating 2 patellar tunnels and 1 tunnel in the femur for case 1.

Plain radiographs of the knee demonstrated postsurgical changes consistent with prior MPFL reconstruction, with 2 patellar tunnels and 1 tunnel within the femur (Figure 1).

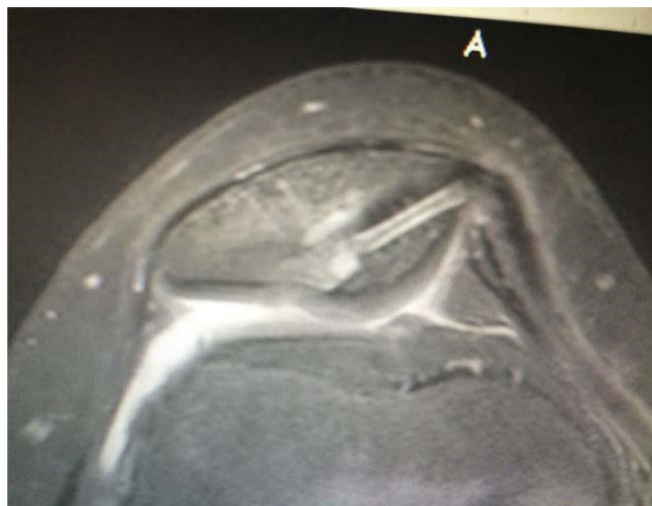
**Figure 2.** Axial magnetic resonance image demonstrating distal anchor within the patella with possible chondral penetration, but no suture or other structure visualized in the intra-articular space.

Magnetic resonance imaging (MRI) of the knee demonstrated the 4.75-mm PEEK SwiveLock anchors (Arthrex) in each patellar tunnel. The lateral facet cartilage immediately underneath the more distal anchor appeared to be irregular, suggesting possible chondral penetration; however, no structure could be visualized penetrating beyond the subchondral bone into the joint space (Figure 2). In addition, the proximal anchor appeared to breach the proximal patellar cortex and protrude into the quadriceps tendon, which corresponded with a site of tenderness on physical examination. Finally, the femoral tenodesis screw was prominent.

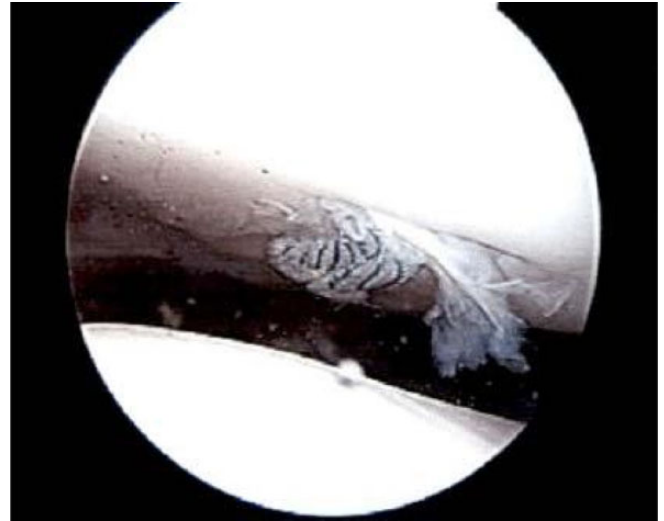
**Figure 3.** Intra-articular perforation of suture from distal anchor.

Given these findings and the failure of extensive physical therapy prior to presentation, the patient was indicated for diagnostic arthroscopy and removal of hardware with possible revision MPFL reconstruction. On entry into the patellofemoral joint from a standard anterolateral arthroscopic portal, it was noted that there was Fiberwire suture (Arthrex) protruding into the joint from the more distal anchor (Figure 3). While directly visualizing the patellofemoral articulation, the suture was seen to engage into the trochlea with knee flexion beyond 70°. This was consistent with the timing of the audible squeak with active range of

motion (Supplemental Video 1). The suture was debrided using an arthroscopic shaver, and the proximal anchor, which could not be seen arthroscopically, was removed by drilling from the outside in and removing it. The prominent femoral tenodesis screw was removed through a small open incision. Patellar stability was tested, and there was no increased translation after hardware removal.

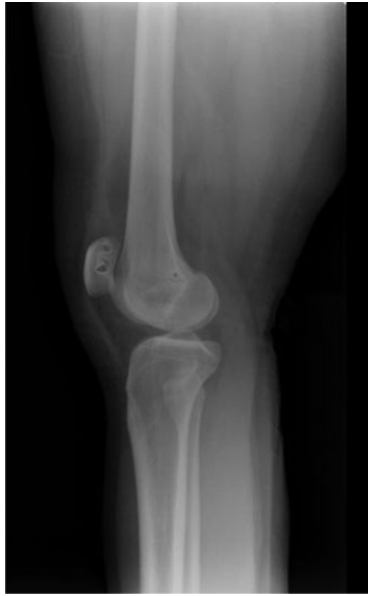
**Figure 4.** Lateral radiograph of the right knee demonstrating 2 patellar tunnels and 1 tunnel in the femur for case 2.

of dissatisfaction and concern. Physical examination of her knee on presentation demonstrated no effusion. She had full range of motion from 0° to 140° with audible squeaking in flexion (Supplemental Video 2). There was no crepitation or tenderness over her medial or lateral patellar facet and no increased lateral translation. Plain radiographs demonstrated adequate tunnel placement from her MPFL reconstruction (Figure 4).

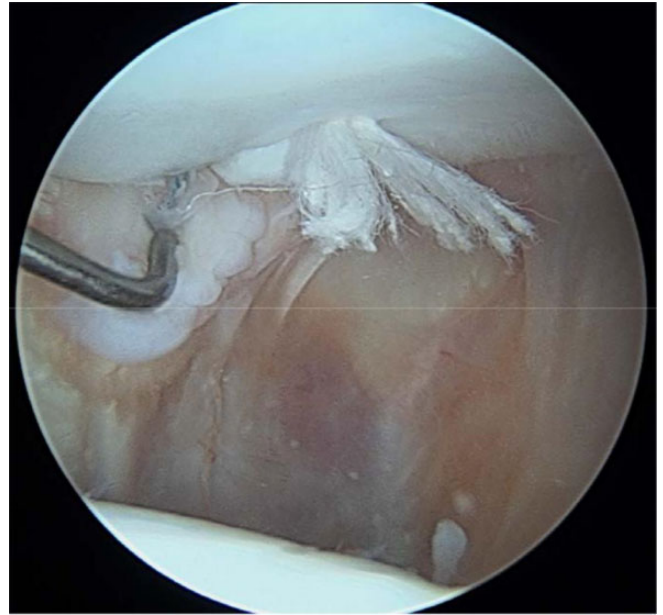
**Figure 5.** Suture penetration into lateral patellar facet and synovial junction.

Given these findings, the patient was indicated for diagnostic arthroscopy of the knee. At the time of surgery, Orthocord suture was noted to be protruding into the joint at the lateral patellar facet and synovial junction (Figure 5). The remainder of the patellofemoral articulation showed no significant chondral damage. The suture was removed with a basket forceps and shaver. No anchors were prominent or required removal. The patient's MPFL graft was intact, and she had normal patellar stability.
