North American Spine Society Journal (NASSJ)

Systematic Reviews /Meta-analyses

Pseudotumor after total disc replacement in the lumbar spine: A case report and review of the literature

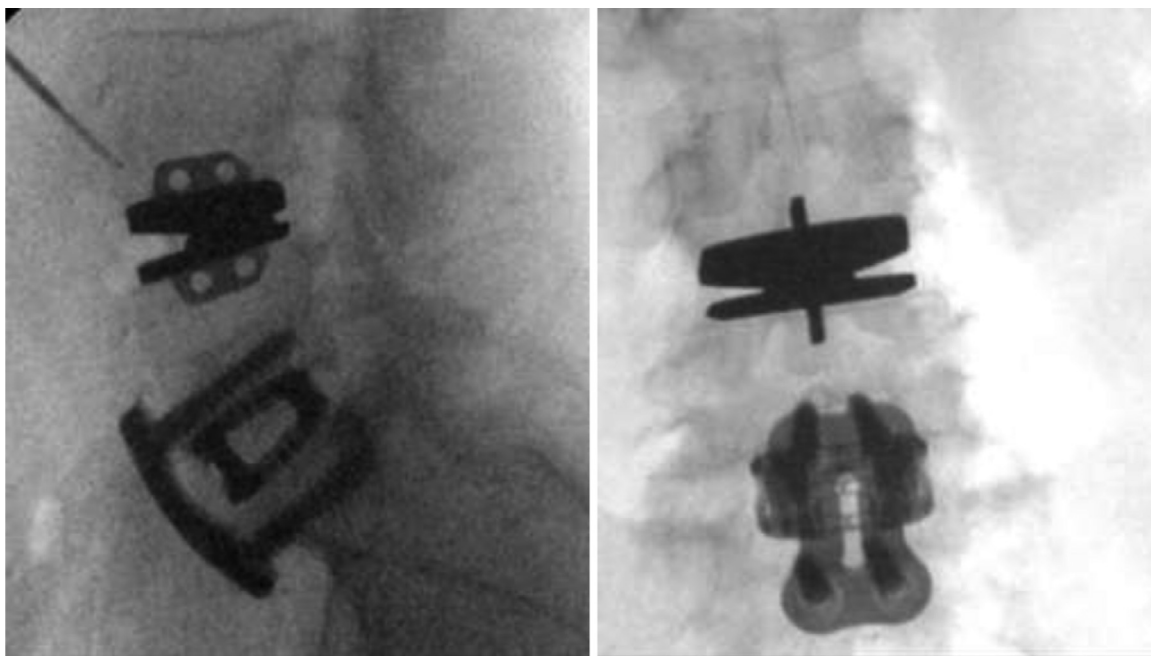
Fig. 1. Intraoperative anteroposterior and lateral fluoroscopic images showing L4/L5 total disc replacement (TDR) and L5/S1 anterior lumbar fusion.

A 49-year-old-female that underwent L4/L5 disc replacement and L5/S1 anterior fusion secondary to degenerative disc disease (Figs. 1 and 2). On her one-year follow-up, she developed progressive worsening pain in the back radiating down the legs with no weakness. Her imaging was delayed and she had her CT scan and MRI at sixteen months post operatively. The imaging demonstrated a tissue mass around the prosthesis and left hydronephrosis. A urologic consult and subsequent installation of a double J tube in her left ureter occurred 2 weeks following the CT scan. Leg swelling and neurogenic leg pains led to both a contrast venogram and CT myelogram eighteen months post implan-

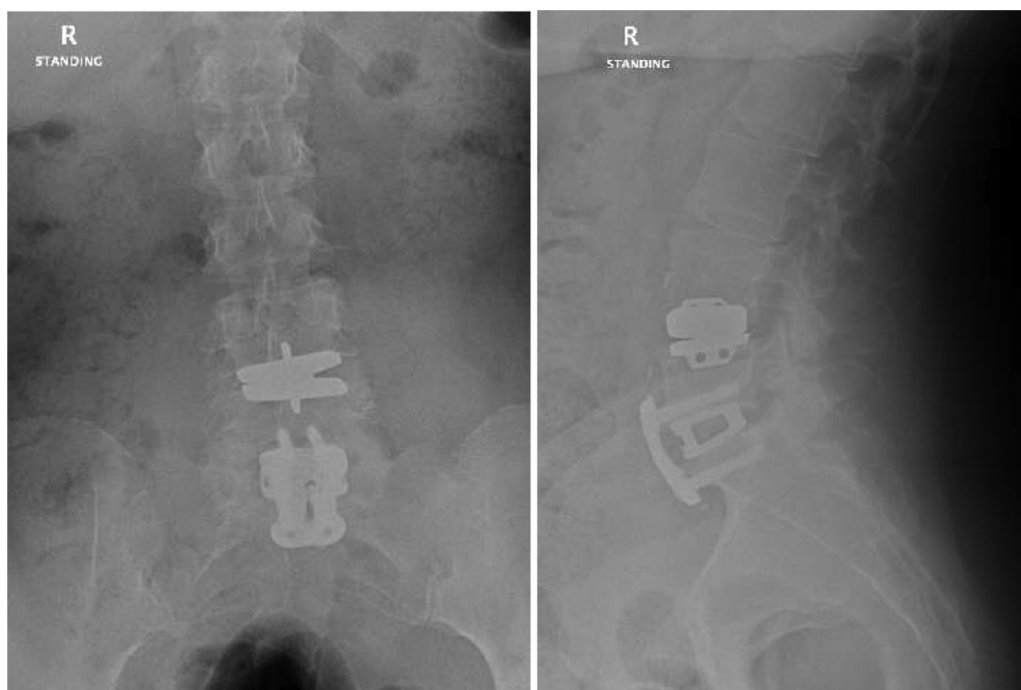
Fig. 2. Anteroposterior and lateral lumbosacral X-rays at 6 weeks post L4/L5 total disc replacement and L5/S1 anterior lumbar fusion.

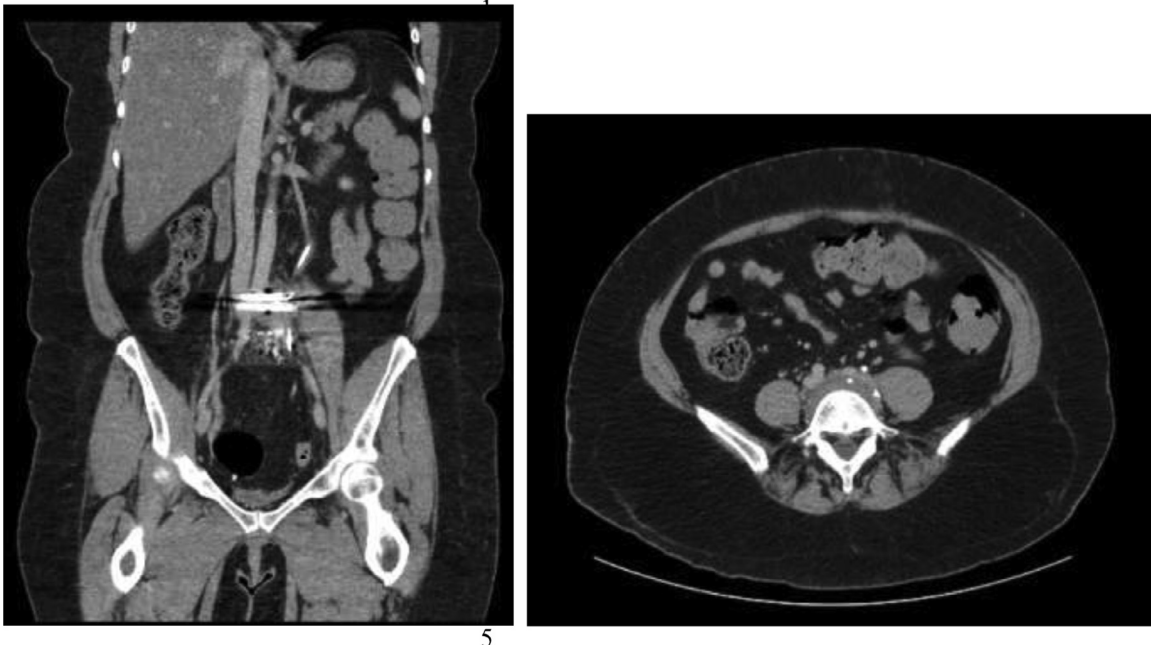
Fig. 3. Coronal and axial cuts of the CT Venogram demonstrating soft tissue bulge at L4/L5 disc space, causing a May-Thurner type of occlusion of the left common iliac vein.

tation. The venogram (Fig. 3) demonstrated total occlusion of the left common iliac vein and CT myelogram (Fig. 4) showed compression of the cauda from the pseudotumor. Owing to concerns about pulmonary embolism, a vena cava filter was implanted at eighteen months post implantation and a revision surgery date was selected eighteen months plus one week post implantation.

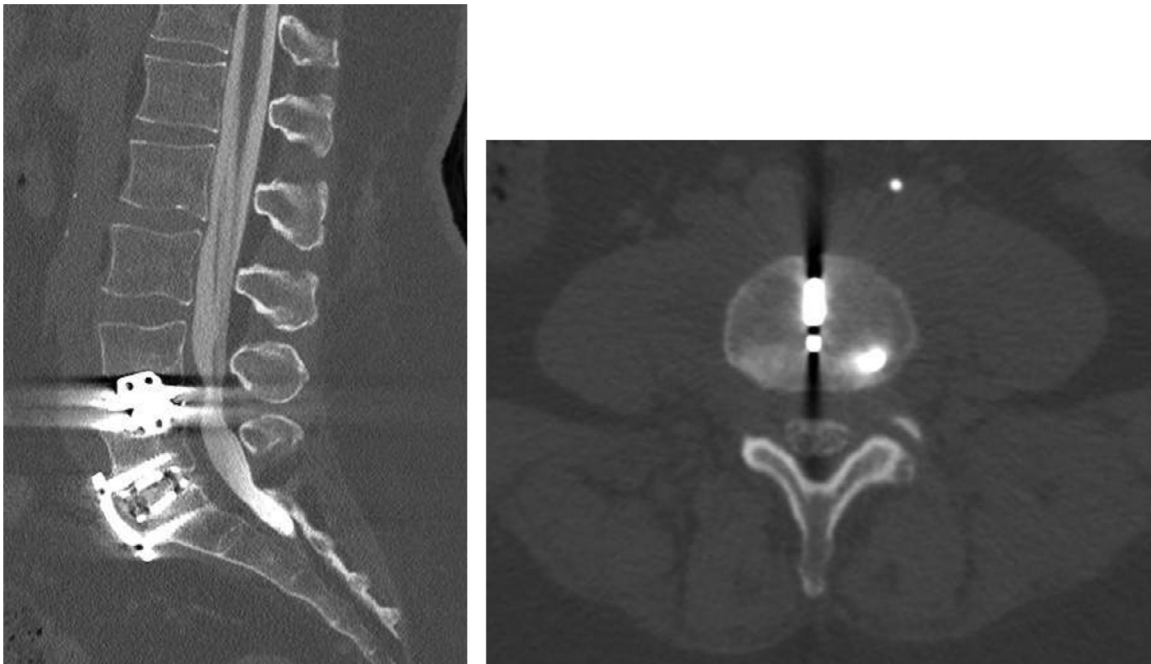
Fig. 4. Sagittal and axial cuts of the CT myelogram showing cauda compression from the pseudotumor.

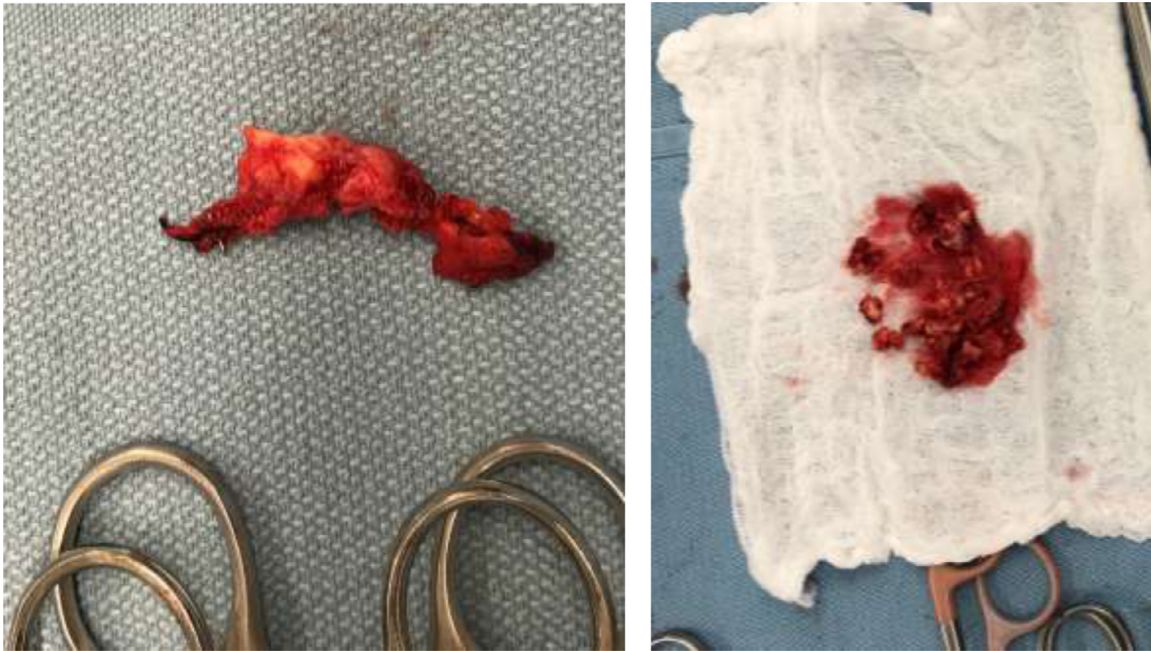
Fig. 7. Intraoperative pictures of the pseudotumor excised.

Vascular surgery was consulted to carry out a transperitoneal approach (Figs. 5 and 6) at which time, a left ureterolysis was carried out by the urology team. At the time of surgery, the left common iliac vein was noted to be occluded with organized clots. It was divided to give access to the prosthesis. The pseudotumor (Fig. 7) appeared highly organized and infiltrative. There were no clean planes between it, the dura, the bone or the vascular or urologic structures. The TDR (Fig. 8) was removed without incident and replaced by an allograft fusion cage and plate (Fig. 9). While pulses were palpable preoperatively, there were no iliac artery doppler flow toward the end of the case. Bilateral common iliac arteries thrombectomy was carried out. Immediately following closure, she again developed pulseless legs and required bilateral femoral artery exploration and thrombectomy. The histopathol-

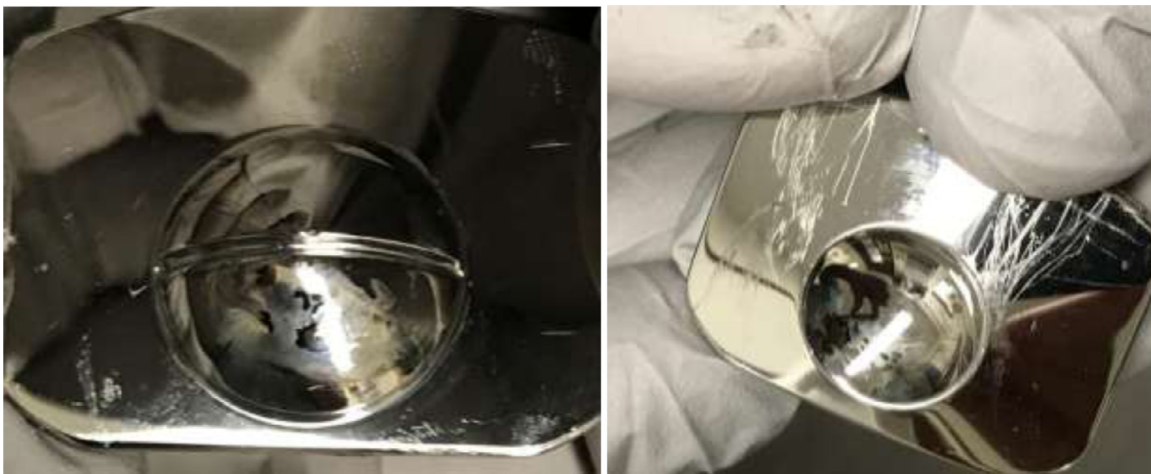
Fig. 8. Total disc replacement (TDR) implants showing signs of wear.

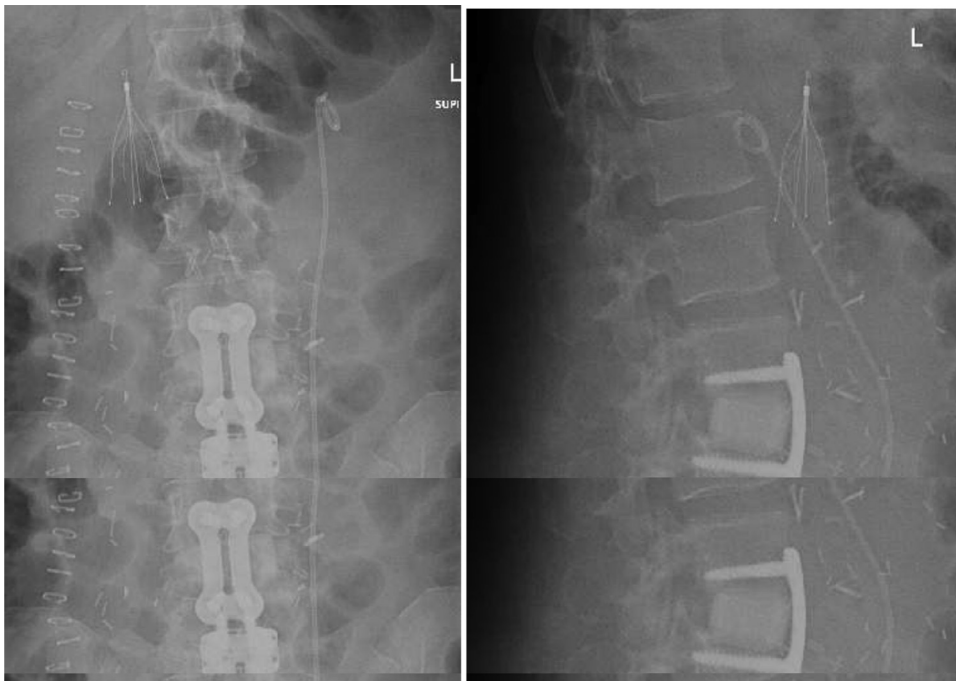
Fig. 9. Postoperative anteroposterior and lateral lumbo-sacral spine X-rays following removal of the total disc replacement (TDR) implants and placement of an allograft fusion cage and plate.

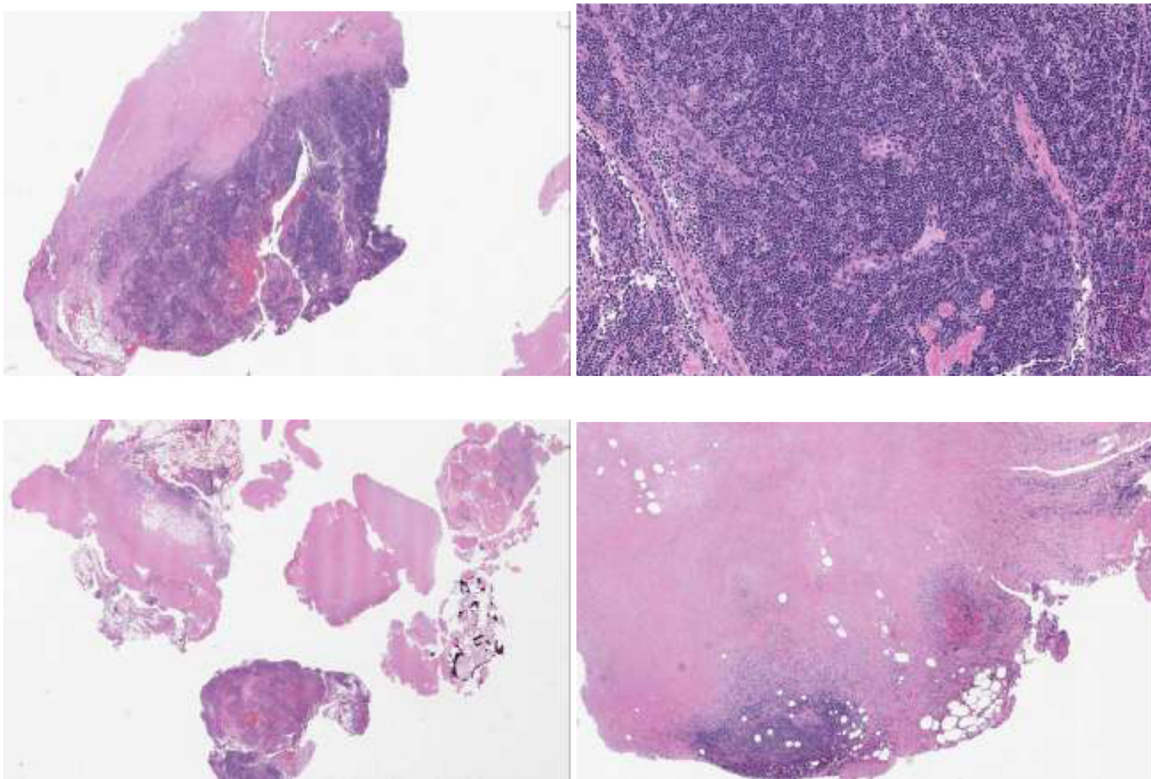
Fig. 10. Histopathology slides showing a cystic peri-implant mass (pseudotumor)/aseptic lymphocyte-dominant vasculitis-associated lesion (ALVAL).

ogy report was compatible with a cystic peri-implant mass (pseudotumor)/aseptic lymphocyte-dominant vasculitis-associated lesion (ALVAL) (Fig. 10). Despite the prolonged operative course, the patient has been doing well post-operatively and was discharged out of the hospital within ten days. At two years post-operatively, she is able to do all basic daily activities, but has not been able to return to work (Fig. 11).

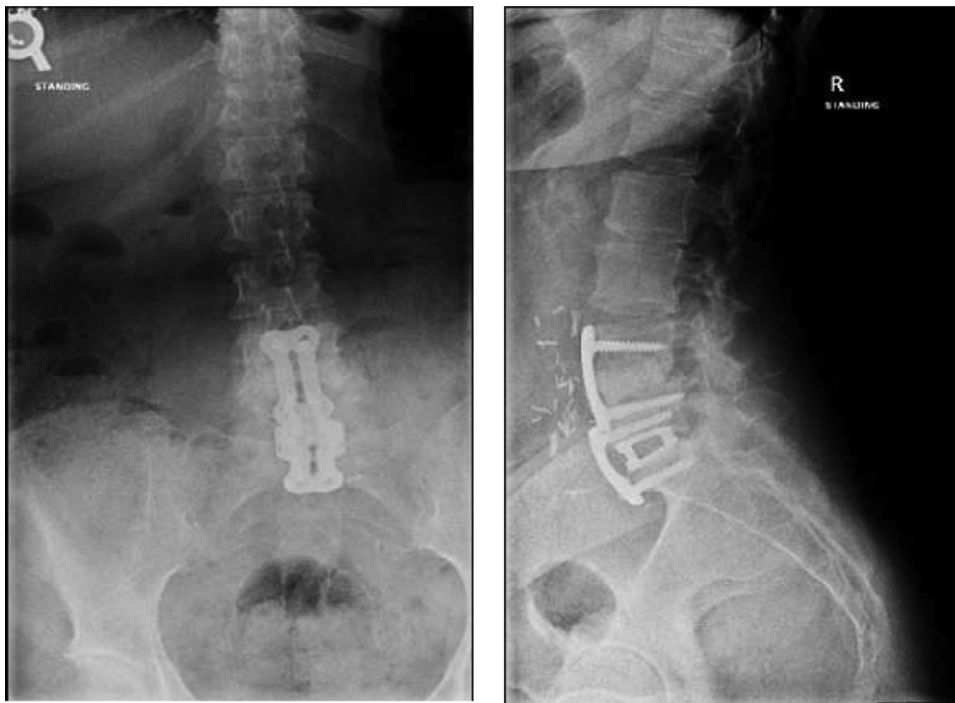
Fig. 11. Anteroposterior and lateral lumbo-sacral spine X-rays at two-years follow up.
