CASE REPORT

Reversible, non-plaque-induced marginal bone loss around an osseointegrated implant: A case report

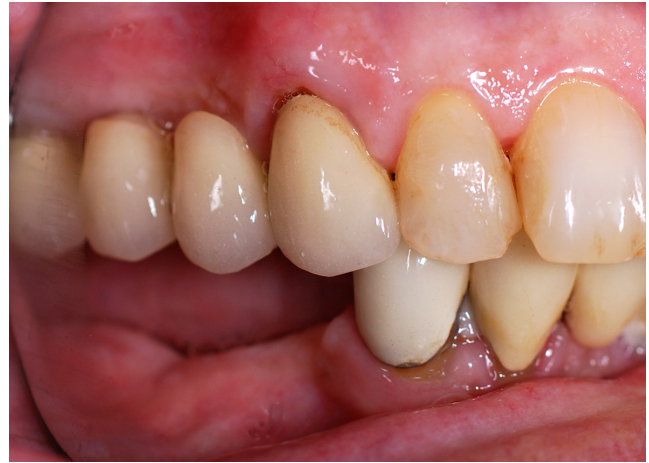
FIGURE 1 February 2017, case with missing teeth distal to 43

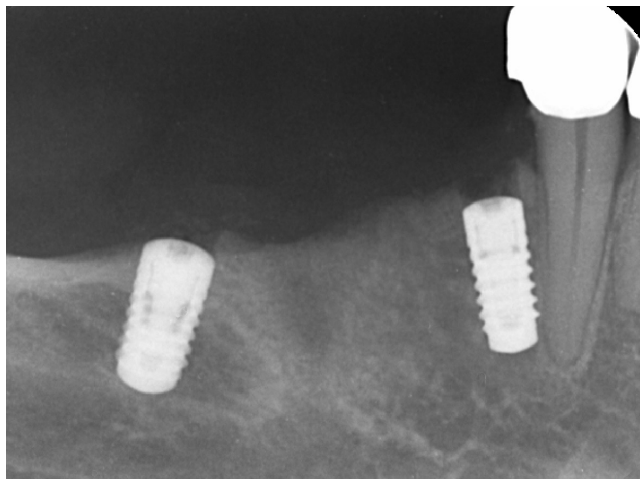
FIGURE 2 November 2017, postsurgical radiograph taken immediately after placement of two single implants in positions 44 and 46. Note the proximity of the implant in position 44 to tooth 43

due to perioperative xenograft augmentation of the alveolar ridge and a limited crestal bone width. Furthermore, the proximity of the implant to tooth 43 most likely made the thin bony wall mesial to the implant extremely sensitive to stress forces and impaired blood supply. In addition, the possible effect of restoration misfit has to be considered, particularly relevant when direct, rigid connections between implant and restoration are used. Although the resultant permanent stress to the surrounding bone may not *per se* lead to tissue harm,³³ it will nevertheless add to the total amount of stress transmitted.

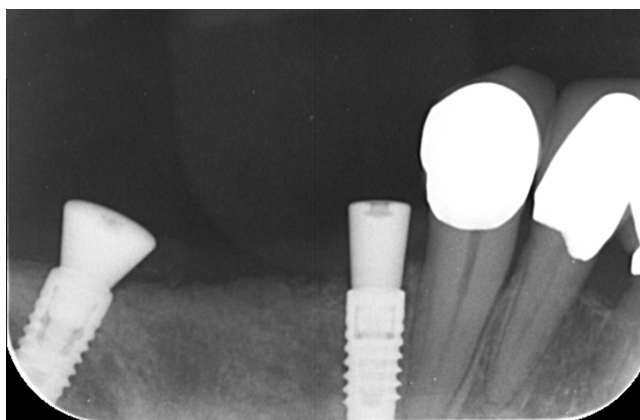
The patient was enrolled in a periodontal maintenance program and recalled every 3 months during the implant healing time. Nine months postoperatively, in August 2018, radiological examination indicated osseointegration of both implants. Abutment surgery was performed, and healing abutments were placed on implant 44 with NC Ø3.6 mm and on implant 46 with RC Ø6.0 mm (Figure 3).

FIGURE 3 Nine months postoperatively, radiographic examination indicated successful osseointegration of both implants and abutment surgery was performed

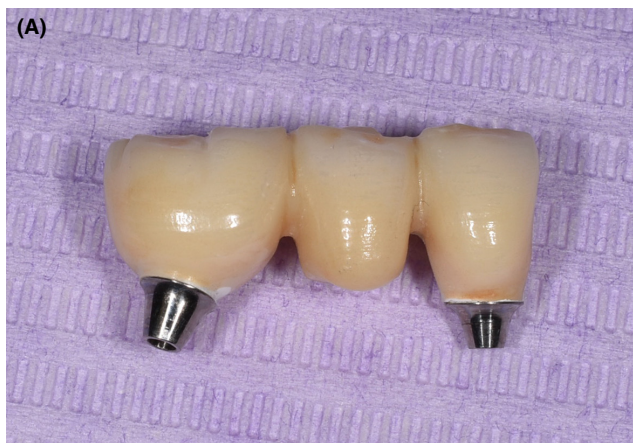
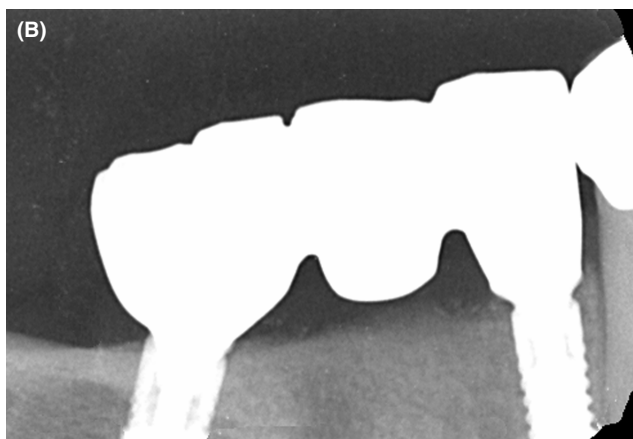
After an uneventful healing period of 2 weeks, sutures were removed, and the patient was referred for prosthodontic rehabilitation. A monolithic zirconia bridge with Straumann® Variobase® was screw-retained directly on to the implants, and the final restoration was completed in late October 2018 (Figure 4).

FIGURE 4 October 2018, a monolithic zirconia bridge was screw-retained directly on to the implants. (A) A three-unit implant-supported dental bridge. (B) Radiographic control after placement

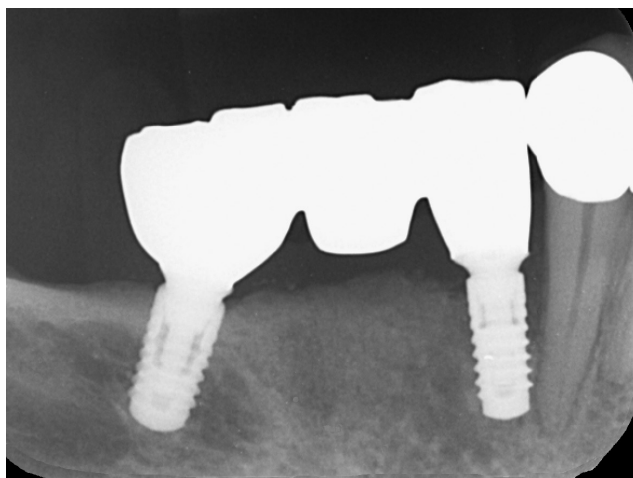
Supportive periodontal treatment was carried out in early January 2019. The patient then complained about soreness and discomfort around implant 44, which had begun immediately after insertion of the bridge. An intraoral radiograph disclosed severe bone loss mesial to

implant 44 (approximately 50%), and intraoral examination showed a probing depth of 7 mm at the mesial surface with bleeding but without suppuration (Figure 5).

FIGURE 5 In January 2019, about 2½ months after insertion of the bridge, the radiographic control showed an extensive mesial bone loss on implant 44

The implant bridge was immediately removed and replaced by healing abutments. About 2 months thereafter, the patient had no symptoms and reported that the discomfort disappeared the day the bridge was removed. The mesial probing depth on implant 44 of 7 mm had disappeared and no BoP was observed. The intraoral radiograph documented complete bone fill (Figure 6).

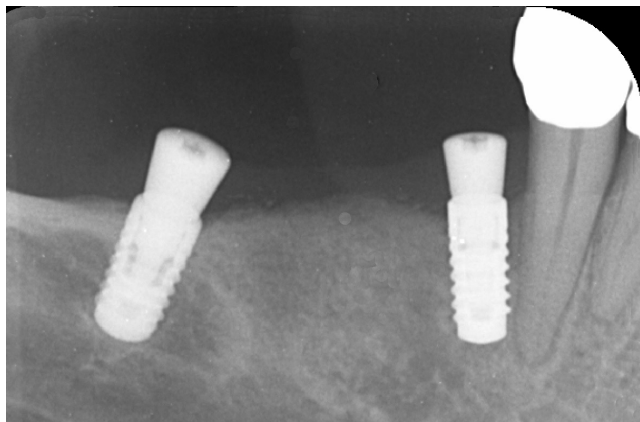
FIGURE 6 About 2 months later, March 2019, the radiograph documented complete bone fill at the mesial surface of the implant in position 44

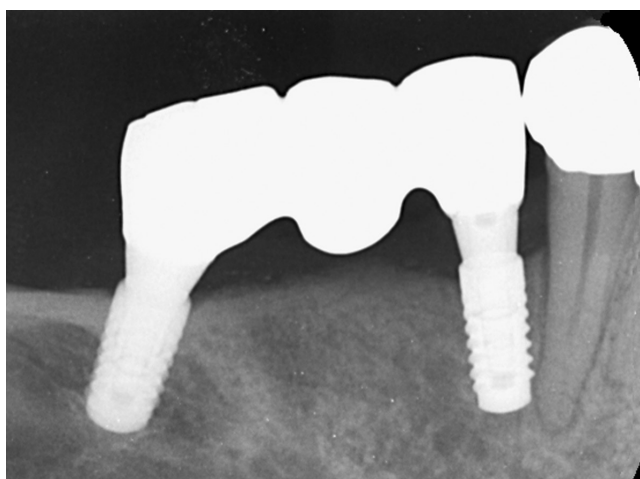
FIGURE 7 About 4 months after removal of the bridge (May 2019), a new screw-retained bridge with a slender emergence profile was inserted. Unlike the previous bridge, which was directly connected at implant level, this one was connected to the implants via multiunit abutments

A decision was made to allow further healing time and make a new bridge with a significantly slenderer emergence profile and to use a multiunit abutment connection (SRA abutment, Straumann®) to the superstructure rather than a direct connection at the implant level. The patient was recalled monthly during this period, with no sign of inflammation recorded. About 4 months after the removal of the bridge (May 2019), a new bridge was constructed

as planned (Figure 7). The antagonist dentition was also adjusted to avoid occlusal interference and thus lateral occlusal forces.

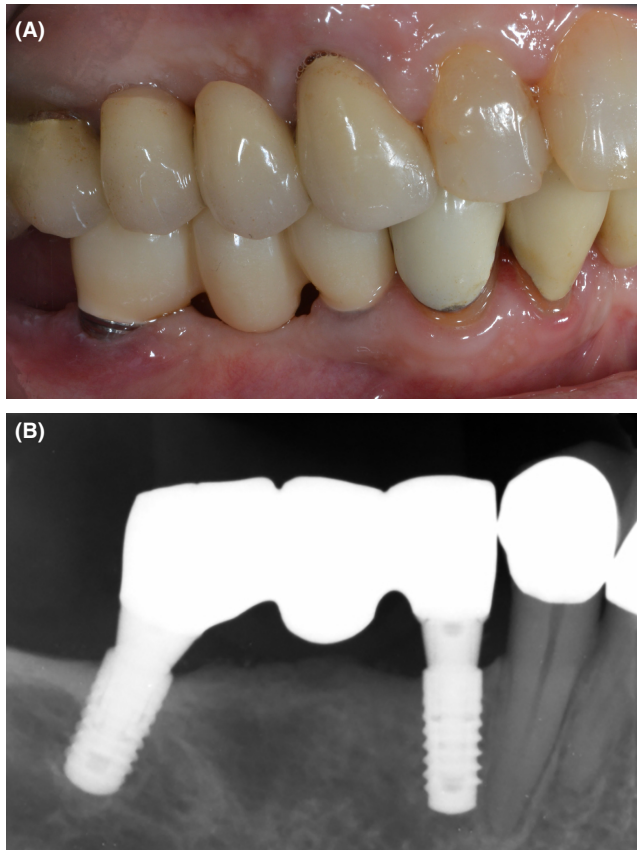
The patient was followed every 3 months for supportive periodontal care. Two and a half years after rapid mesial bone loss and subsequent bone fill, the patient has no complaints, and the radiograph shows a stable peri-implant bone level around implant 44 without clinical inflammation (Figure 8).

FIGURE 8 Two and a half years after rapid mesial bone loss and subsequent bone fill (October 2021), the radiograph documented a stable peri-implant bone level around implant 44. (A) The three-unit fixed implant-supported dental prosthesis in position 44 and 46. (B) Radiographic control
