Trauma Case Reports

Case Report

Intramedullary reamer failure in orthopaedic surgery: Two case reports and practical recommendations for prevention

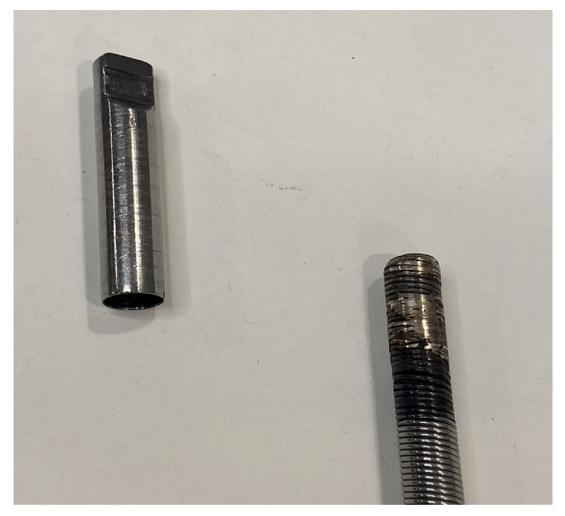
Fig. 2. Picture of intramedullary reamer showing dissociation of the reamer head from the shaft. Note burnishing of the reamer shaft.

fixation with a reconstruction femoral nail. During the operation, the femoral canal was sequentially widened starting with the 9 mm front-cutting reamer. However, while withdrawing the 12.5 mm reamer, the surgeon noted a sudden change in sound and resistance. Flouroscopy revealed that the reamer head and a part of the distal shaft was separated from the main body of the reamer but still cannulated by the guide wire. Attempts to remove the reamer head by withdrawing the ball tip guidewire were unsuccessful. Using a direct lateral approach, a corticotomy was made in the proximal femur allowing the reamer head to be easily removed (Fig. 2). The corticotomy was closed and the surgery completed in routine fashion (Fig. 1B). On post-operative day one (1), the patient suddenly became dyspneic and tachycardic before falling into a coma. Resuscitative efforts were unsuccessful and a post-mortem revealed that the patient died from a massive pulmonary embolism.

There are many factors that can affect the risk of reamer failure. Müller et al. analysed the impact of reamer shape on failure and discovered that the Synthes® reamer generated the highest intramedullary pressure compared with other designs, potentially increasing the risk of incarceration [8]. Another study found that dull reamers increase intramedullary pressure and tangential strain leading to reamer failure, particularly if the reamer is damaged [9]. A Swiss study conducted across 10 hospitals investigated the impact of reamer use on their condition. The study showed that frequent use led to both damage and dulling of the reamers, with reamers between 11 mm and 13.5 mm exhibiting the greatest degree of damage and dullness. Predictably, the degree of damage and dullness were found to be directly proportional to the number of intramedullary nailing procedures performed in each hospital. Hospitals that conducted 40–60 procedures annually were observed to have the most damaged and dull reamers. These findings suggest a causal relationship between frequency of use and structural deterioration. The authors concluded that a protocol for maintenance and replacement should be established to minimize the risk of reamer failure [10].

Our local data at a single institution indicate that 80 intramedullary reaming procedures on average are performed annually at the hospital. The reaming sets have been used for over five (5) years and are used at several hospitals nationwide. We found no evidence that either set was inspected by the Biomedical department since being put into service. This is at odds with the industry standard that recommends regular medical equipment inspection to ensure proper and safe functioning.

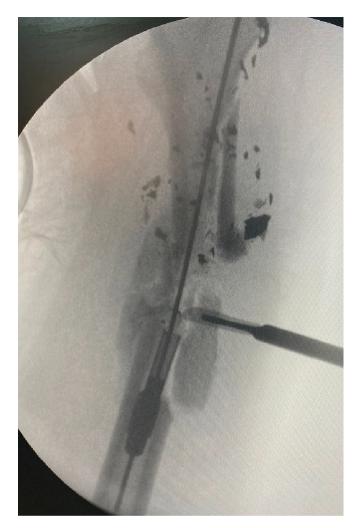
Fig. 4. Intraoperative fluoroscopic image showing the broken distal end of the reamer shaft.

A 60-year-old female sustained a gunshot injury to her thigh during a home invasion resulting in a Gustilo-Anderson IIIA comminuted fracture of the proximal femur (Fig. 3A). After stabilisation the patient was scheduled for definitive surgery using a reconstruction femoral nail. During the operation the surgeon encountered greater than anticipated resistance while using the 11 mm reamer to cross the fracture site but was able to ream the canal up to 12.5 mm. However it was while withdrawing the reamer that failure occurred leaving the head incarcerated distal to the fracture site (Fig. 4). It was impossible to remove the reamer head using the ball tip guide wire and a corticotomy of the proximal femur was used to retrieve the broken reamer (Fig. 3B). Despite a longer operation time, the patient tolerated the procedure well and 48 h later she was ambulating with a walker and discharged home.
