Magnetic resonance imaging after cochlear implants

Naif Bawazeer^{a,*}, Hella Vuong^b, Sophie Riehm^c, Francis Veillon^c, Anne Charpiot^b

Case reports: Among the six patients who had MRI after receiving implants at our center, we report three cases with adverse events related to the examination. The first case was complicated by magnet displacement with partial demagnetization. The second case showed total demagnetization, which necessitated removal and re-implantation of the implant. The third case involved severe pain sensation which disrupted the MRI scan. The smallest artifact was found with 3D MRI angiography, and largest artifact was found with diffusion and T2 FLASH.

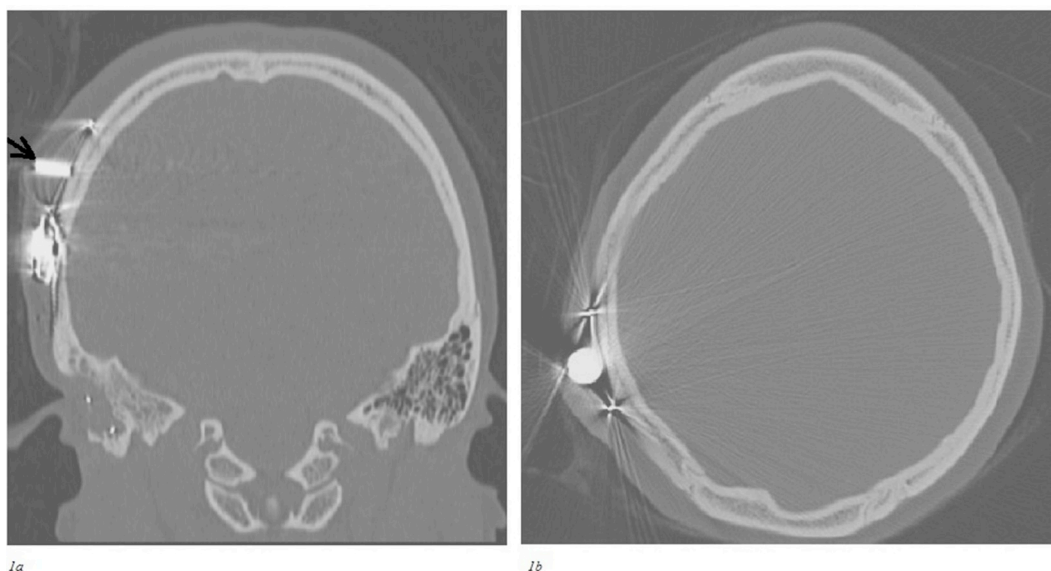
Fig. 1. (a, b). Patient 1, CT scan of cranium: magnet rotation is visible, perpendicular to its housing (arrow).

Case 1: a 28-year-old patient who had been fitted with an implant because of progressive congenital deafness (cochlear model CI422). A brain MRI was requested in 2012, eight months after implantation, due to a progressive neurological illness that was difficult to diagnose, associated with progressive blindness and an ataxia of the cerebellum. A 1.5 T Siemens MRI with sagittal FLAIR sequences and axial T1, T2 and FLAIR sequences was carried out, strictly following the updated recommendations at that time, with the head wrapped. The patient experienced pain during the MRI and clinical examination showed clear evidence of magnet migration, with the magnet rotated 90° from its initial position under the skin. An emergency cerebral CT scan was performed, confirming magnet rotation without total implant displacement within the cochlea (Fig. 1). Emergency surgical intervention was organized, but shortly before entering the operating theatre,

examination showed that the magnet had reverted spontaneously to the correct position and orientation. However, there was a slight loss of magnetism which made it necessary to increase the external magnet power. Auditory performance remained stable after MRI.

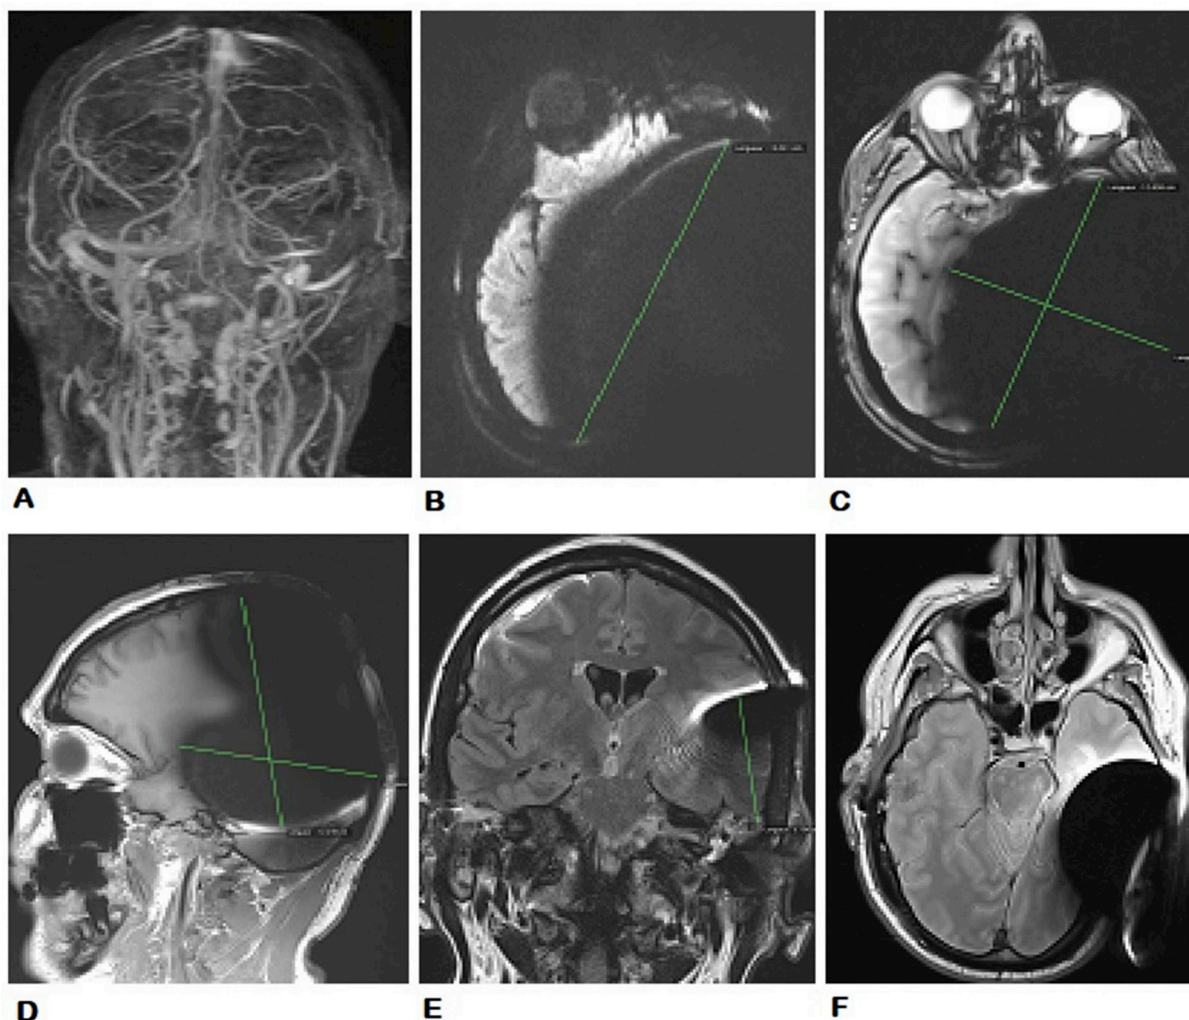
Fig. 2. 3D (1.5 T) MRI Angiography (a), Diffusion sequence (b) and T2 FLASH sequence (c), T2 Flair sequence (d) and T1 (e), T2 Sequence (f). The green lines correspond to the longest in-axis diameter.

Among the six patients, the sequences producing the smallest artifacts were the venous 3D gadolinium MRI angiography sequences. The sequences with the largest artifacts were the diffusion and T2 FLASH sequences. The T1, T2 and T2 FLAIR sequences presented intermediate artifacts (Fig. 2).

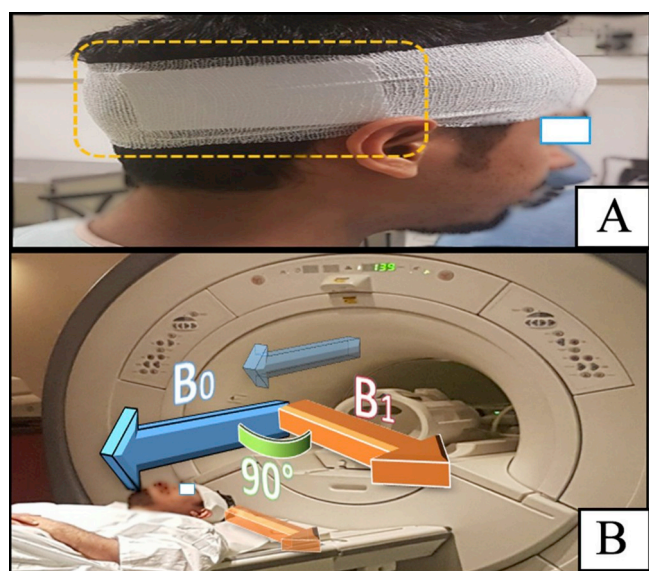
Fig. 3. (A) Application of the plastic splint on the implant site. (B) Demonstration of the B0 MRI and the B1 implant magnetic fields orientation that need to be respected.

need for the MRI, agreement (among the doctor ordering the MRI, the otolaryngologist, the radiologist and the patient), the manufacturer's authorization, a time interval between device implantation and MRI of at least six months, the systematic removal of the implant's external component and the fitting of an external, close-fitting compressive bandage (Dubrulle et al., 2011). The bandage should be 10 cm wide and should pass around the head in at least two layers (Fig. 3).

The presence of an experienced physician is important to prevent iatrogenic complications. The angle between the B0 MRI magnetic field and the implant's internal magnet (B1) must remain less than 90° to eliminate risk of implant magnet demagnetization. The critical zone of the magnetic field starts 30 cm from the MRI entrance tunnel (Vincent et al., 2008). A supine position with head straight (no inclination or deviation) will ensure the perpendicularity of the magnetic fields, with negligible risk of demagnetization (Vincent et al., 2008). Nevertheless, the orientation of the magnetic fields, the compatibility of the implant, the need for removal of the internal magnet and the need for application of other special instructions must be verified by consulting the manufacturer. We propose the use of an arrow drawing to be held by the patient, indicating the implant's B1 magnetic field orientation, to minimize error. In addition, we recommend the use of a protective splint (if there was no protective material provided by the manufacturer) with a bandage, regardless of implant brand. This could help in minimizing the risk of magnet displacement and pain (Fig. 3). The splint may be a piece of A4 paper folded into five lengthwise or a plastic card.
