## Case Report

# Fracturing of revision of a cobalt-chrome femoral head after fracturing of a ceramic femoral head, with diffuse metallosis. Case report

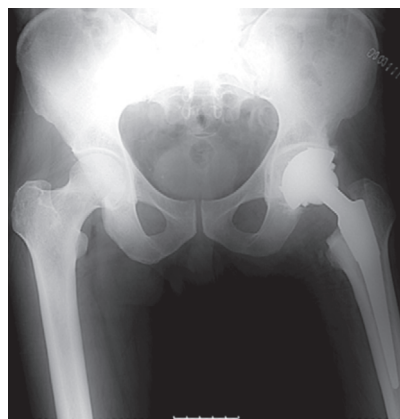
**Fig. 1 - Immediate postoperative X-ray on left-side total hip arthroplasty.**

The approach used was a posterior route (Gibson approach) and the procedure took place without intercurrents, in accordance with the surgical technique put forward by the manufacturer. The patient was released from hospital on the fifth postoperative day (Fig. 1).

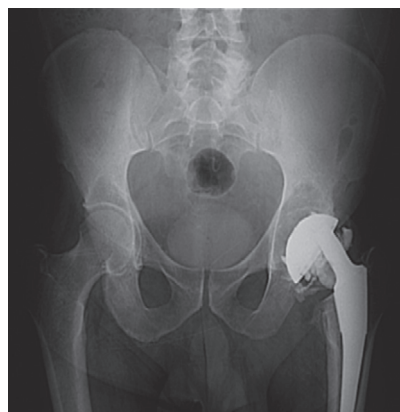
The patient was followed up for two years without intercurrents or joint pain, and presented good joint mobility. However, during the third year after the operation, in October 2009, he came to our emergency department because of a acute left hip pain with incapacity to mobilize the hip, following a fall. A radiological examination showed a comminuted fracture of the ceramic femoral head (Fig. 2).

**Fig. 2 - Ceramic femoral head fracture after trauma.**

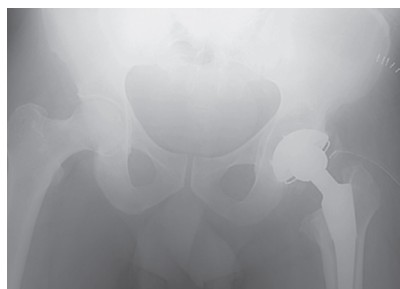
**Fig. 3 - Revision on ceramic femoral head fracture, with replacement by a cobalt-chrome femoral head.**

The patient remained hospitalized until the revision surgery, which was performed one week later. During the operation, multiple fragments of the ceramic femoral head and central wear of the polyethylene were observed, but without any visible macroscopic abnormalities of the femoral neck or detachment of the femoral stem or acetabular component. Abundant lavage was performed using a pressure gun, with surgical debridement and removal of the ceramic fragments. The polyethylene acetabular component was replaced by another one that was the same, but indicated for metal heads (48 mm); and the ceramic femoral head was replaced by a Lafitt 28 mm cobalt-chrome head with a medium neck (Fig. 3). The remainder of the hospital stay passed by without

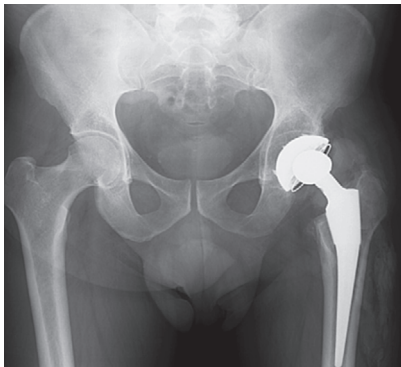
After another six months of follow-up, the patient was found to be free from painful complaints or abnormalities of mobility, and there was only a slight density increase on the lateral face of the thigh (region of the fascia lata) (Fig. 4).

**Fig. 4 - Six-month follow-up showing increased radiological density on the lateral face of the right thigh.**

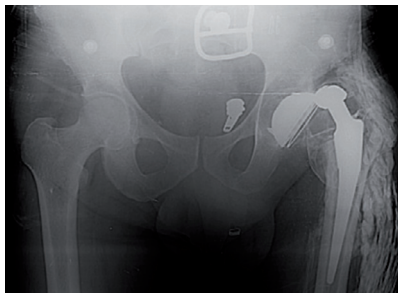
service presenting pain and functional incapacity of the left leg, with the hip flexed and externally rotated, compatible with posterior dislocation of the total hip prosthesis. Radiologically, dislocation of the total hip prosthesis was confirmed, with apparent fracturing of the cobalt-chrome femoral head and increased radiological opacity of the muscles of the lateral face of the thigh (Fig. 5). Closed reduction of the dislocation was performed under general anesthesia (Fig. 6), and subsequent revision surgery was advised, which was done in November of the same year.

**Fig. 5 - Dislocation of total hip prosthesis with apparent fracturing of the cobalt-chrome femoral head and increased radiological opacity of the muscles of the lateral face of the thigh.**

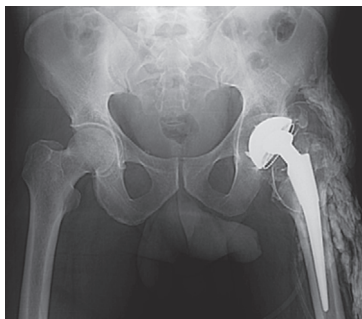
**Fig. 6 - Radiological control after reduction of the dislocation.**

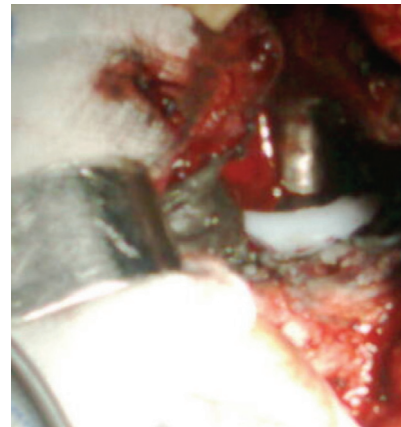
During the operation, diffuse metallosis of the muscle and cartilage tissues was seen (Fig. 7), along with central wear of the

**Fig. 7 - Diffuse metallosis of the periarticular tissues.**

In total synovectomy, the principles of tumor resection should be applied: lavage and surgical debridement with a wide safety margin). In our case, it was not possible to fully remove the metallosis, given that it was very extensive. As much surgical debridement as possible was performed, in order to be able to close the surgical wound and avoid joint instabilities.

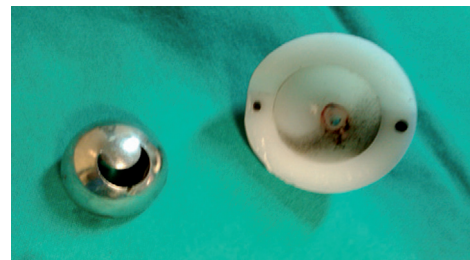
polyethylene and fracturing of the cobalt-chrome femoral head, in a half-moon shape (Fig. 8). Once again, the femoral stem and acetabular component were found to be well attached and stable, with slight abrasions of the femoral neck. Wide-ranging surgical debridement was performed, with abundant lavage and replacement of the previous polyethylene acetabular component and femoral head by equal components (Fig. 9).

**Fig. 8 - Fracturing of the cobalt-chrome femoral head (left) and polyethylene wear (right).**

Currently, there is no guidance in the literature for cases of fracturing of cobalt-chromium femoral heads. In our case, since the femoral stem was stable and the medullary cone did not present any relevant macroscopic alterations, it was decided to replace the polyethylene and the cobalt-chrome cup with others that were the same. It was not possible to study the material extracted. Because of the variety of cases of cobalt poisoning that have been described, it is important to carry out rigorous clinical and analytical surveillance on the patient.<sup>28</sup> Thus, the present authors aim to draw attention to this clinical adversity in order to avoid similar situations.

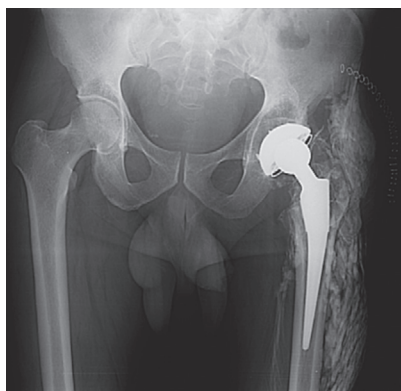
**Fig. 9 - Immediate postoperative period after revision of the total hip prosthesis, with new cobalt-chrome femoral head.**

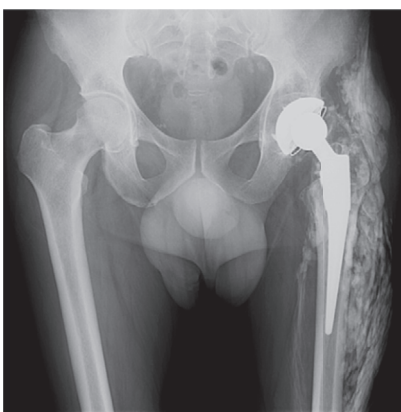
After 12 months of follow-up, the patient does not present any painful complaints and has good mobility for activities of daily living and professional activities. Radiologically, he does not show any signs of detachment or wear of the prosthetic components (Fig. 10).

**Fig. 10 - Follow-up 12 months after the operation.**
