## Case Report

# Management of dental erosion induced by gastro-esophageal reflux disorder with direct composite veneering aided by a flexible splint matrix

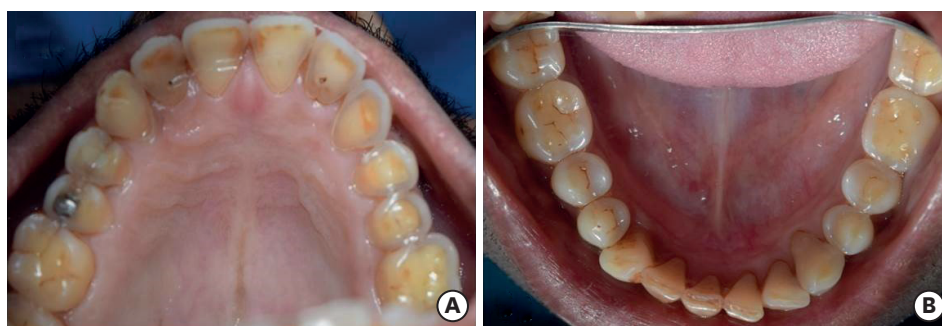
A 46-year-old male patient reported to the outpatient Department of Conservative Dentistry and Endodontics with the chief complaint of pain in the upper left back tooth for 3 weeks. The pain was due to food lodgment. The patient's medical history revealed that he had suffered from frequent episodes of vomiting and stomach upset for a period of 8 months, 1 year ago. Examination of the patient's medical file revealed that he had been diagnosed with gastro-esophageal reflux disease (GERD) and was currently under medication (Aciloc-RD 20, Cadila Pharmaceuticals, Ahmedabad, India) for the same, and had not reported episodes of vomiting for 4 months. This medication is a proton pump inhibitor with the generic name of omeprazole. An oral examination revealed a class II mesio-occlusal carious lesion on tooth #25 (World Dental Federation system). Additionally, the loss of enamel and a shiny appearance of the dentin on the palatal surfaces of the maxillary teeth (teeth #11–17 and teeth #21–27) were noted (**Figure 1A**). A similar appearance was seen on the occlusal surfaces of the mandibular posterior teeth (teeth #34–37 and teeth #44–47, **Figure 1B**).

**Figure 1.** Pre-operative. (A and B) The pre-operative status of the dentition reveals erosion of the palatal surfaces of the maxillary teeth and the occlusal surfaces of the mandibular teeth.

The carious lesion on tooth #25 was restored. The patient was informed of the treatment plan of palatal composite veneering for the erosion-induced damage, as per the ACE classification. Alginate impressions were taken of both arches, and study models were poured. A wax-up of the palatal surfaces was done on the mounted casts (**Figure 2A** and **2B**). An alginate impression was taken of the wax-up, and poured. On the latter master cast, a vacuum-forming soft splint matrix (0.9 mm thick Sof-Tray Sheets, Ultradent Products, Inc., South Jordan, UT, USA) was adapted (**Figure 3A**). Holes were drilled on the palatal surfaces of the matrix to enable the injection of flowable composite (**Figure 3B**).

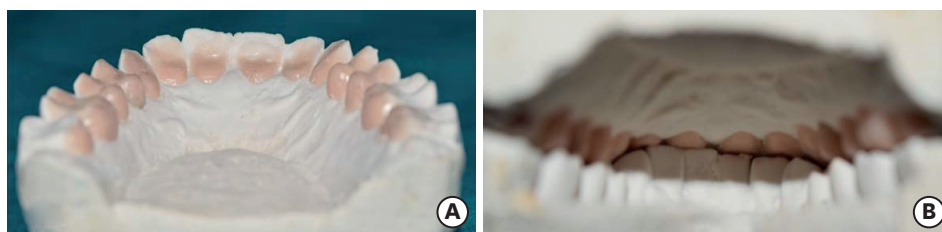
**Figure 2.** Wax-up. (A and B) Wax-up was done to build up the gingulum and functional cusps.

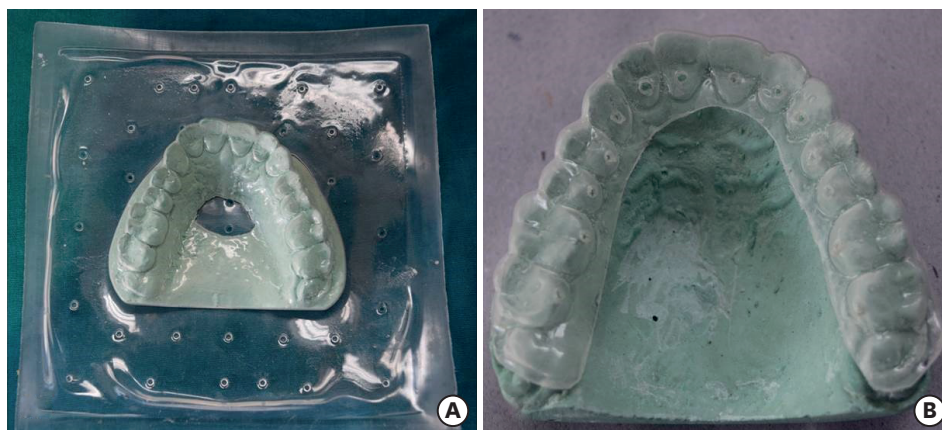
**Figure 3.** Fabrication of splint. (A and B) A vacuum-forming splint matrix was adapted and trimmed.

Holes were drilled into the matrix splint to enable the injection of the flowable composite and the extrusion of the excess. A valid alternative modality to the current protocol might be to place composite resin on the tooth surface and to press it with a splint to allow composite resin to extrude through the hole. However, the operator may be uncertain whether sufficient pressure is generated within each tooth segment of the flexible splint to ensure effective composite flow without voids. In the current injection technique, the operator was assured of the absence of dead space between the splint and tooth due to the transparency of the splint, and also by ensuring that the syringe tip was not retracted until the excess composite had extruded from the hole.

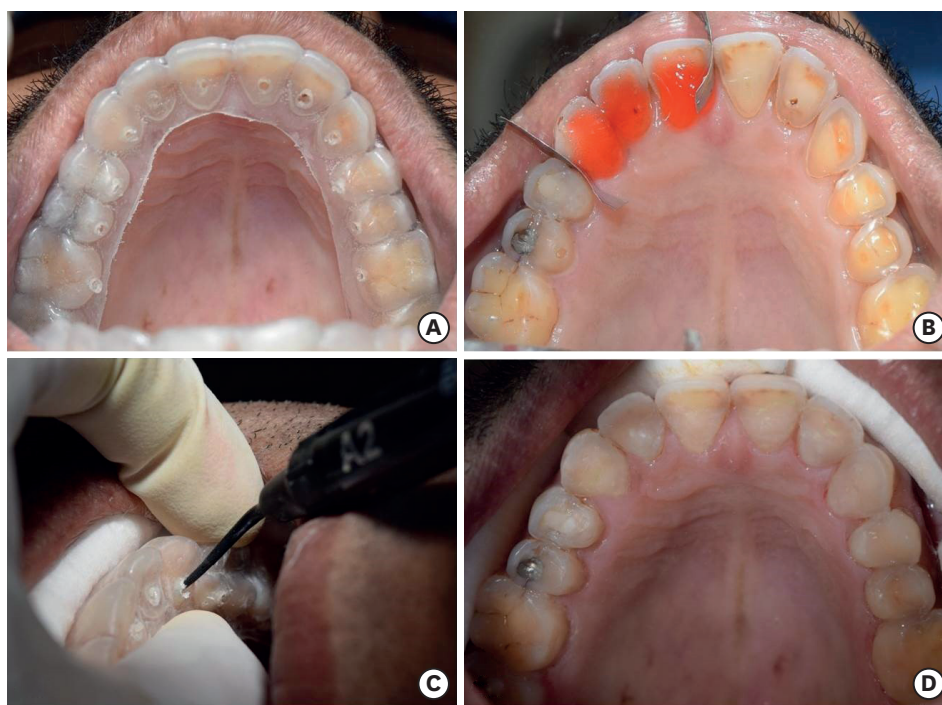
**Figure 4.** Restorative protocol. (A) Oral try-in of the splint matrix. (B) Acid etching of the teeth in segments. (C) After the bonding protocol, flowable composite was injected. (D) Composite restorations were finished and polished.

After try-in of the matrix (**Figure 4A**), the teeth were etched in groups (**Figure 4B**), and bonding agent was applied (Adper Single Bond 2, 3M ESPE, Bangalore, KA, India), air-thinned, and cured. Following placement of the matrix on the maxillary arch, flowable

composite resin (G-aenial Universal Flo, GC America, Alsip, IL, USA, shade A2) was injected (**Figure 4C**) and light-cured. The occlusion was checked by instructing the patient to bite in maximum intercuspation (static occlusion), and guiding the patient in mandibular lateral excursions (dynamic occlusion). The high points were removed. All restorations were finished and polished (SofLex contouring and polishing discs, 3M ESPE) (**Figure 4D**).

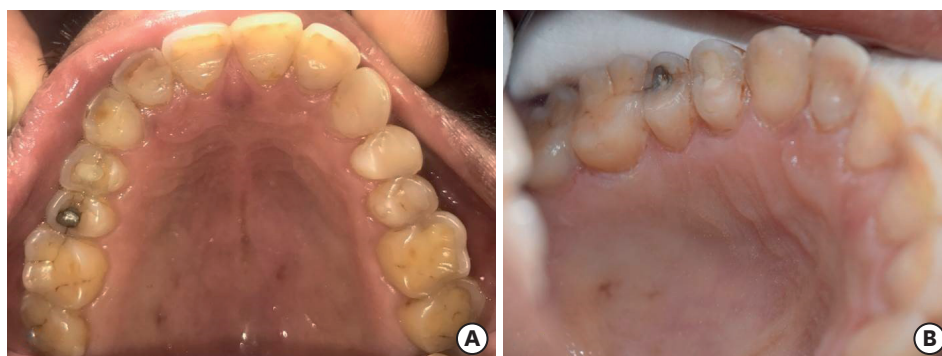
**Figure 5.** Follow-up at 13 months. (A) An occlusal view reveals satisfactory restorations. (B) Discolored margins were evident.

The follow-up at 13 months revealed satisfactory retention, marginal adaptation, surface texture, and anatomic form of the composite restorations (**Figure 5A**). All teeth responded to pulp sensibility tests (cold test and EPT). Discolored margins were evident at the gingival area (**Figure 5B**), and these restorations were finished and polished.

In the current case, marginal discoloration at the gingival margins was noted at the 13-month follow-up visit. Although stains accumulate more prominently near the gingival margins of teeth, it is also true that well-polished dental restorations rarely pick up stains [5]. In retrospect, the placement of retraction cords would have further facilitated the polishing procedure at the gingival margins of the composite restorations.
