Correspondence

Implant diagnostic imaging impaired by cosmetic gold thread therapy

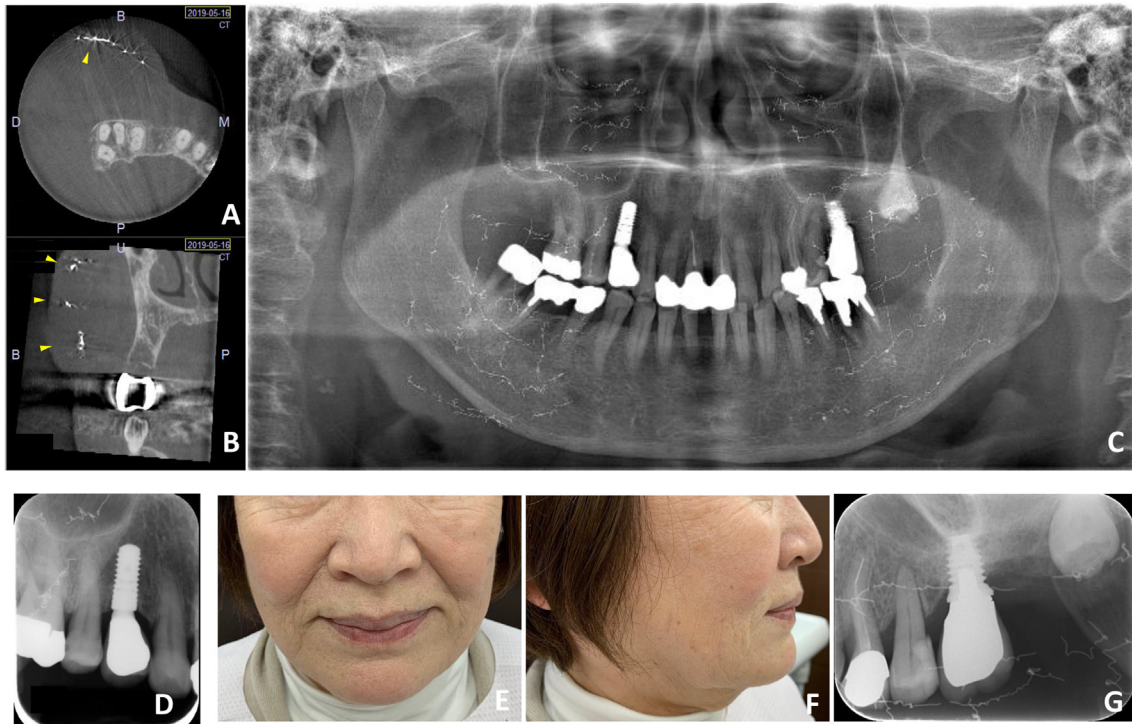
Figure 1 Radiographic and clinical photographs of our case. (A and B) Dental computed tomographic imaging taken with a surgical stent in the implant site in the maxillary right first premolar region. (A) Axial image showing a thin metallic radiopaque artifact in the soft tissue of the buccal region (arrowhead); (B) coronal image. (C) Random radiopaque artifacts can be seen overlapping in extensive areas of the maxilla and mandible, along with lattice-like structures. (D) Dental radiograph of the implant taken at the beginning of the maintenance phase showing linear radiopaque images overlapping maxillary sinus and maxillary right first molar root. (E) Facial appearance of the patient more than 20 years after gold thread therapy: frontal view. (F) Side view. (G) Implant placed in the past in the maxillary left first molar region. Overlapping linear radiopaque images interfere with the evaluation of bone resorption at the implant neck.

A 73-year-old female patient presented in 2019 for implant treatment of a maxillary right first premolar. She was a nonsmoker with no significant systemic medical history. Screening imaging by orthopantomography revealed a narrow radiopaque mesh-like pattern spread over the maxilla and mandible. The patient's interview revealed a history of cosmetic surgery using a gold thread lift technique in the soft tissue of the cheek area more than 10 years ago. After planning the placement of the implant in the maxillary right first premolar region, dental CT scans showed that all of these metallic structures were located in the buccal subcutaneous tissue (Fig. 1A and B). None of these structures were found in the maxillary bone tissue, so an implant was placed in a two-stage procedure (Straumann® Bone Level, 4.1 × 10 mm, Straumann, Basel, Switzerland). The superstructure was fabricated with a zirconia crown on a titanium base abutment. The patient has been under maintenance treatment for 3 years and no adverse events have been observed (Fig. 1C and D).

gold threads (0.1 mm diameter, 24 K gold) has been reported to improve skin structure and elasticity by increasing collagen production and delaying aging processes such as wrinkle formation (Fig. 1E and F).² This anti-aging treatment technique, in which a thin gold alloy is inserted into the buccal soft tissues under local anesthesia, is less invasive than an incisional method and is more easily tolerated by patients. However, as yet no clear evidence exists for the effectiveness of the treatment. Unlike earrings and necklaces or removable prosthetic devices, gold threads placed in vivo are not removable. Adverse events after the treatment include infection and allergic reactions to the gold alloy implanted in the skin, migration in the body, and exposure outside the skin, as well as fever during magnetic resonance imaging. Although rare, several cases in the craniofacial and dental fields have been reported in recent years.^{3,4,5}

Radiopaque mesh-like images overlapping the implant site may make imaging assessment of bone resorption and other parameters more difficult (Fig. 1G). During diagnostic imaging, great care must be taken not to mistake gold threads for electrostatic discharges, imaging plate injuries or defects, or ligature lines from orthodontic treatment. It is suggested that gold thread artifacts may make accurate reading of the intended implant placement site difficult. We emphasize the importance of having a thorough knowledge of the imaging of patients who have been treated with these specific anti-aging therapies, because the patient may not remember the history of these therapies.
