Case report

Fatigue fracture of a cemented Omnifit CoCr femoral stem: implant and failure analysis

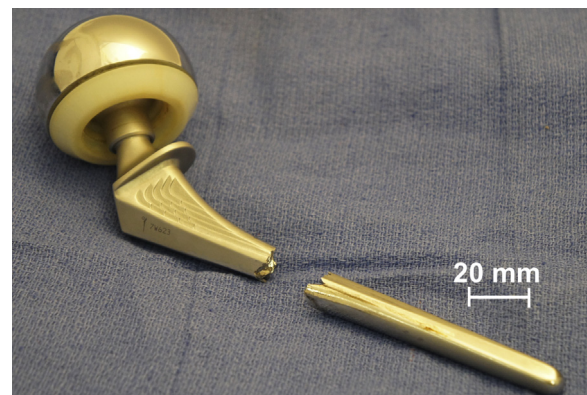
Figure 2. Photograph showing failure at the midportion of the stem, at approximately 38% of the stem length, measured from the collar.

Optical inspection of the implant revealed failure at the mid-portion of the stem, at approximately 38% of the stem length, measured from the collar (Fig. 2). Low-magnification photographs (Fig. 3) show a large apparent grain structure at the location of fracture.

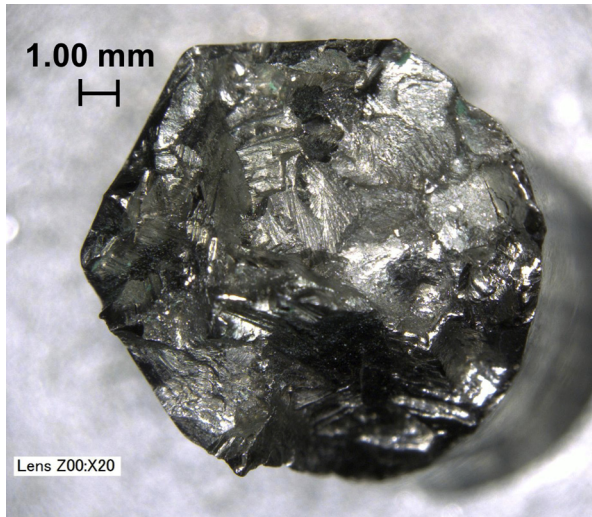
Figure 3. Low-magnification photographs reveal a large apparent grain structure at the location of fracture.
