# Deformation Prediction of Unstable Slopes Based on Real-Time Monitoring and DeepAR Model

**Abstract:** With increased urbanization, accidents related to slope instability are frequently encountered in construction sites. The deformation and failure mechanism of a landslide is a complex dynamic process, which seriously threatens people's lives and property. Currently, prediction and early warning of a landslide can be effectively performed by using Internet of Things (IoT) technology to monitor the landslide deformation in real time and an artificial intelligence algorithm to predict the deformation trend. However, if a slope failure occurs during the construction period, the builders and decision-makers find it challenging to effectively apply IoT technology to monitor the emergency and assist in proposing treatment measures. Moreover, for projects during operation (e.g., a motorway in a mountainous area), no recognized artificial intelligence algorithm exists that can forecast the deformation of steep slopes using the huge data obtained from monitoring devices. In this context, this paper introduces a real-time wireless monitoring system with multiple sensors for retrieving hig

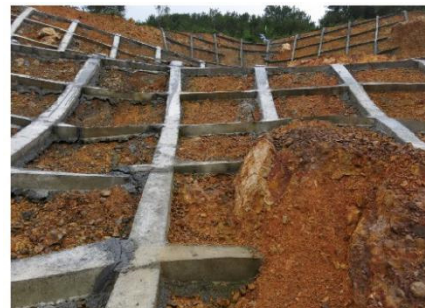
damage of the grille retaining wall

**Figure 5.** Cracks and deformation after disposal measurement.

Cracks in the #6, #10 and #12 slopes were attributed to the combined action of unloading at the slope foot, loading at the slope top, change of groundwater level and disturbance in the geological structure during the construction process. Unloading was mainly caused by the excavation of the slope. The higher the excavation, the more extensive the breaking

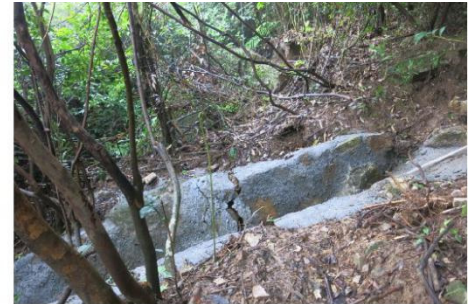
crack in the intercepting ditch for #12 slope

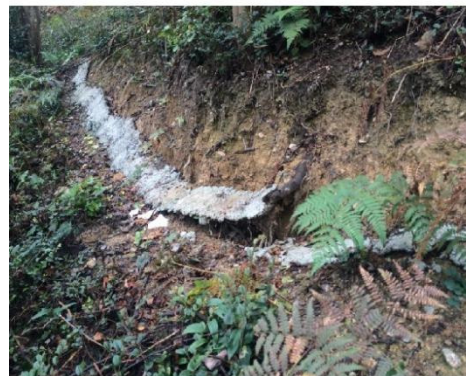
cracks in #10 slope (still active after sealing)

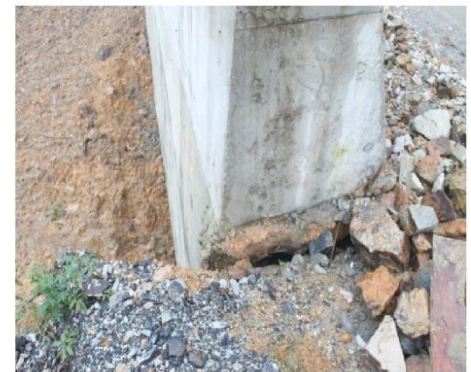
crack in the retaining wall for #12 slope

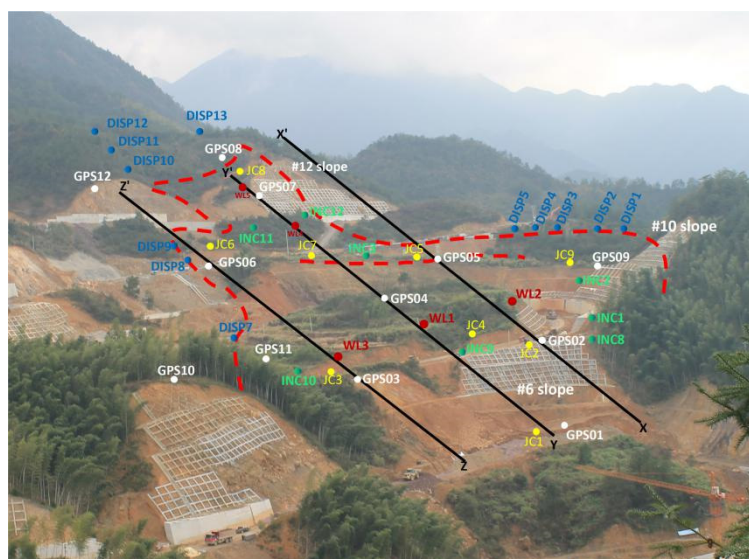
The deployment of monitoring devices is shown in Figure 6. It was designed based on the results of the field survey and the existing geological survey. Due to the large volume and wide range of potential sliding bodies on the project site, both the overall and local deformation characteristics were considered. Three monitoring profiles were investigated, covering the entire landslide body ( $X-X'$ ,  $Y-Y'$ ,  $Z-Z'$  in Figure 6). The monitored parameters included displacement in the surface, displacement in the depths, width of gravity-induced joints, meteorological data and groundwater level.

**Figure 6.** Deployment of the monitoring system in the project site, in which the red dashed dots indicate the landslide outline. White circles indicate the GPS benchmarks, yellow circles indicate the deep inclinometers, green circles indicate the tilt meters, dark blue circles indicate the crack meters and dark red circles indicate the groundwater level indicators.

In the project site, five water level indicators (red solid circles in Figure 6) were installed in the drilled observation holes. They were powered by solar energy and were fitted with smart data acquisition devices to receive and send signals collected by sensors. Storage management and data analysis were performed on the system platform.

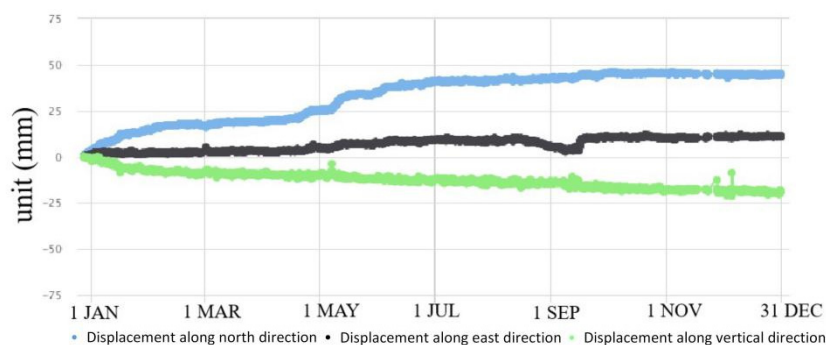
Figure 7. Displacements recorded by GPS 04 in 2016.

month of monitoring. From 31 January to 20 April, the deformation rate reduced and the total displacement to the north was 7 mm during this time. From 21 April to 7 June the deformation rate increased due to heavy rainfall of 637 mm. Then the deformation rate turned stable. GPS 05 recorded 13 mm displacements to the north in the first month of monitoring. From 4 February to 20 April the deformation rate was stable. From 21 April to 7 June the deformation rate increased due to heavy rainfall and the total displacement to the north was 24 mm during this time. GPS 05 was removed due to construction work in August. GPS 06 moved 13.6 mm to the north in the first month of monitoring. From 31 January to 20 April, the deformation rate was stable. The displacement to the north reached 41 mm during the rainy season from 21 April to the end of June. The slope where GPS 09 was installed showed significant deformation and subsidence. The device moved toward north by 20 mm, east by 60 mm and in a vertical direction by 50 mm.

GPS 04, 05, 06 and 09 had significant displacement trends, accompanied by surface subsidence (Figures 7–10). GPS 04 recorded 14 mm displacements to the north in the first
