Case report

Severe Corrosion of Modular Dual Mobility Acetabular Components Identified During Revision Total Hip Arthroplasty

Mohammad S. Abdelaal, MD, Eric Zachwieja, MD, Peter F. Sharkey, MD *

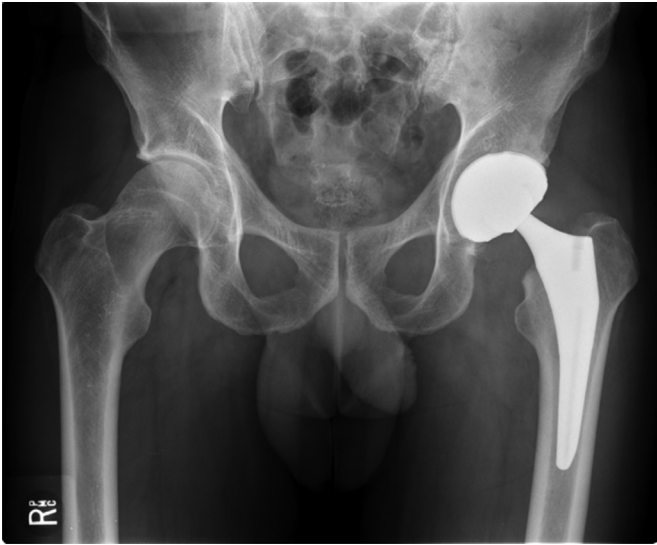
Figure 1. Anteroposterior radiograph of the pelvis at 6 weeks postoperatively, showing well-aligned stem and properly positioned cup.

The patient's immediate postoperative course was unremarkable. At his sixth week postoperative appointment, the patient reported pain relief and restoration of function, and his radiographs showed well-aligned component (Fig. 1). He was seen at 6-month follow-up and was doing well with no remarkable findings.

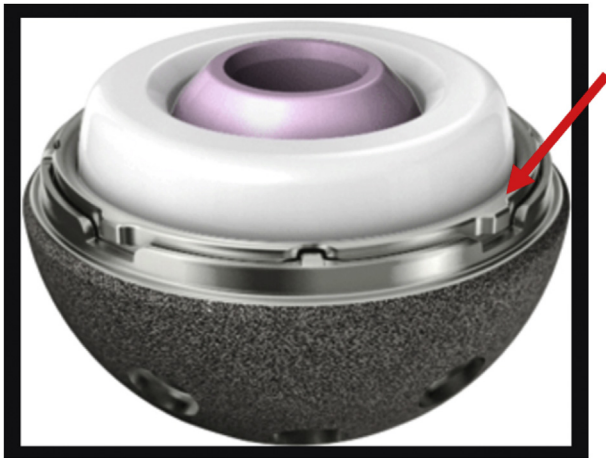
Figure 8. Stryker Orthopedics (Mahwah, NJ) modular dual mobility (MDM) hip system. Note the elevated acetabular insert (red arrow) that may be a source of femoral neck impingement, leading to micromotion at the modular surface and ultimately, mechanically assisted crevice corrosion (MACC).

Stryker Orthopedics MDM cobalt-chromium liner has a lip extending above the titanium acetabular shell (Fig. 8). Impingement of the femoral neck on this elevated lip is certainly possible and likely, particularly in younger active patients. This impingement could easily create the interface micromotion needed to facilitate MACC for this modular device. To our knowledge, there is no current biomechanical evidence to support this theory, thus further research into the subject is warranted.

In summary, this case report proves that MACC of MDM devices does occur. While the frequency of this problem is unknown, the authors strongly recommend (1) judicious use of MDM technology with restriction of use limited to only patients at very high risk of instability, (2) further basic science and biomechanical investigation into our proposed mechanism for MACC of MDM components, (3) redesign of these components to reduce the potential for liner-

femoral neck impingement and liner-locking mechanism enhancement, and (4) routine evaluation of patients who have had THA using MDM components for elevated serum metal ions levels and ALTR.
