Article

# Fouling of Polymeric Hollow Fiber Heat Exchangers by Air Dust

Heat Transfer and Fluid Flow Laboratory, Faculty of Mechanical Engineering, Brno University of Technology, Technicka 2, 616 69 Brno, Czech Republic; Ilya.Astrouski@vut.cz (I.A.); Miroslav.Raudensky@vut.cz (M.R.); Tereza.Kroulikova@vut.cz (T.K.)

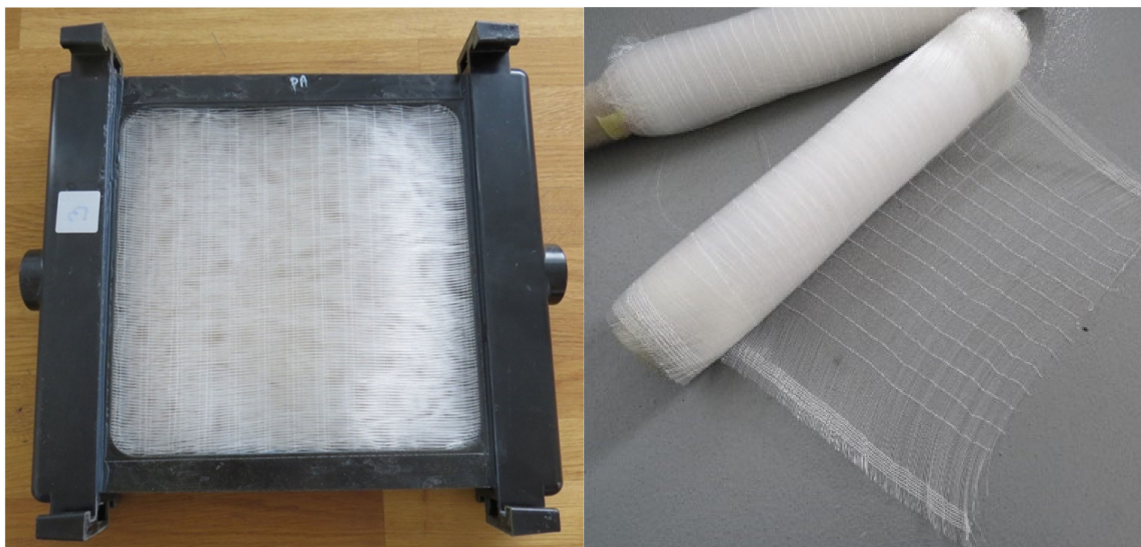
**Figure 1.** Tested heat exchanger made of polypropylene fiber fabric (**left**) and woven heat transfer surface with separated fibers (**right**).

A heat exchanger made of fiber fabric was tested (see Figure 1). An original approach was utilized to achieve a uniform distribution and separation of fibers—fibers were woven to create a carpet. Fibers with an outer/inner diameter of 0.6/0.48 mm were used, and the fabric density was 55 fibers per 100 mm. The fibers were fixed in frames and formed layers of heat transfer fabric. The heat exchanger air cross-section was 250 mm × 250 mm. There were 140 fibers per layer and in total 14 layers were used. The total fiber number in the heat exchanger was 1960 and the outside surface area was 0.89 m<sup>2</sup>.

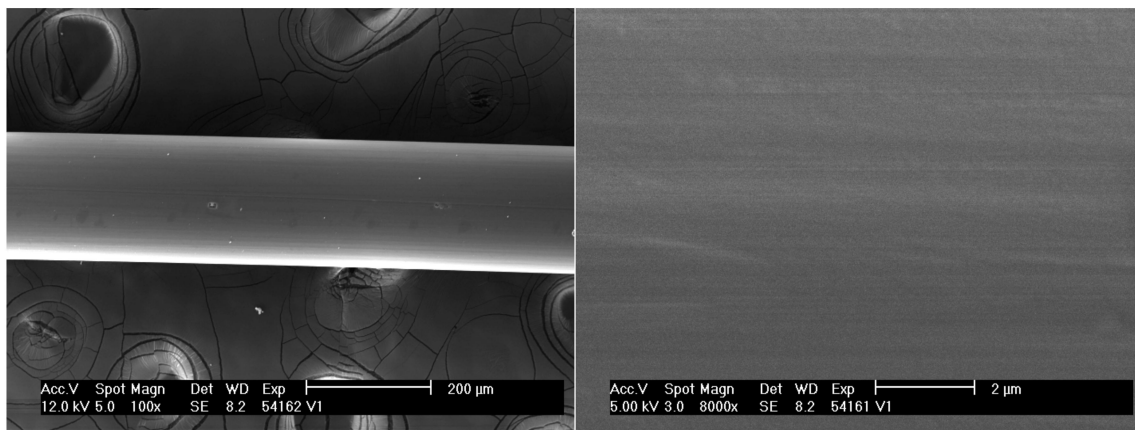
**Figure 2.** The polypropylene hollow fibers, macroscopic photo with no defects (on the **(left)**) and the surface quality with  $\times 8000$  magnification (**right**).

The superior particulate fouling resistance of the hollow fibers was predominantly linked to their surface quality. The hollow fibers were made by extrusion and their final shape was obtained by elongation of the polymeric melt behind the extrusion head. The elongation and solidification of the melt took place concurrently, and the resulting surface of the fiber was very smooth due to the action of the surface tension forces. Figure 2 shows the typical surface quality of an extruded hollow fiber made of polypropylene. The left photo in Figure 1 shows a single fiber with a diameter of 0.6 mm and no macroscopic defects. The right photo shows the details of the surface. It was very smooth and, in the large zoom, there was visible roughness parallel to the fiber axis, which is typical for extruded surfaces.

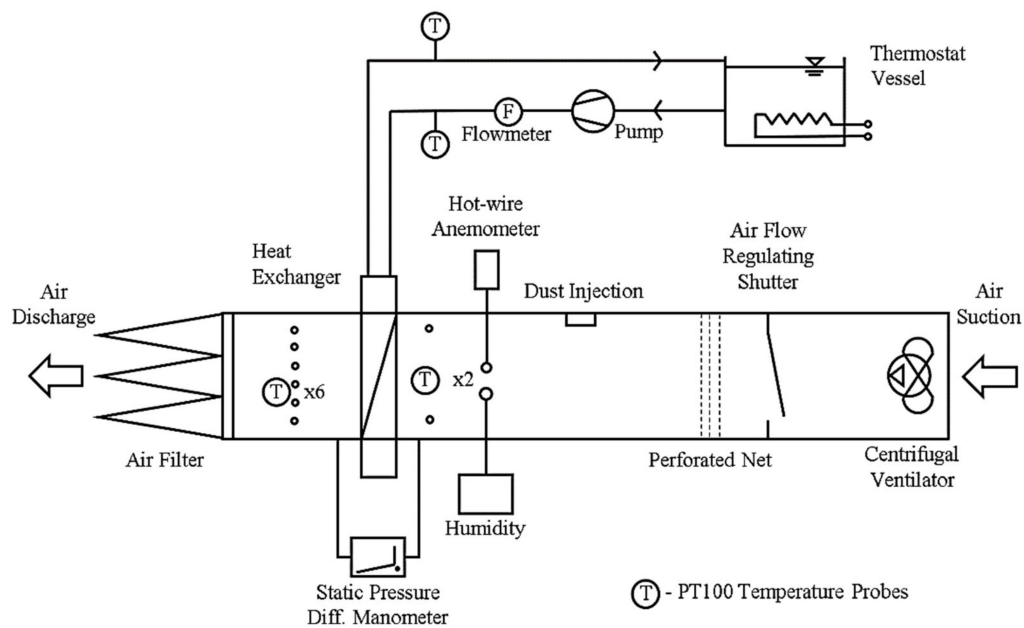
Figure 3. Diagram of the experimental setup.

The diagram of the experiment (Figure 3) shows the water and air circuits. The equipment allows long-term heat transfer tests to be performed with continuous dust injection into the air circuit. The thermal performance data were computed based on the data acquired in the water circuit. The tests were done in conditions typical for the operation regime of indoor HVAC equipment, fan coils and air handling units. The following constant parameters were maintained: air inlet temperature 20 °C, air velocity  $1.5 \text{ m}\cdot\text{s}^{-1}$  (air velocity dropped during tests as fouling increased and was adjusted using a shutter to regulate air flow), relative humidity 20–30%, water inlet temperature 50 °C and water flow rate 430 L/h (this relatively high water flow rate was chosen in order to achieve uniform temperature distribution on the fiber surface).

Test dust was injected into the system twice a day for 10 min periods. Throughout the fouling evolution the air-side pressure drop rose due to the deposits in the air filter and on the heat exchanger, and thus the regulating shutter should be used to maintain constant air velocity of 1.5 m/s.

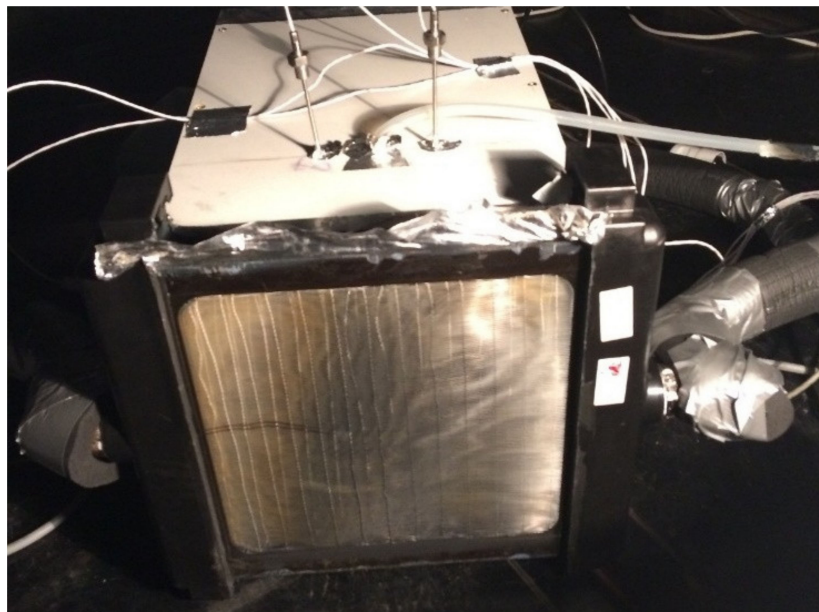
Figure 4. Front side of the heat exchanger connected to the entrance of the wind tunnel after injection of 200 g of the test dust.

A picture showing the heat exchanger connected to the entrance of the wind tunnel can be seen in Figure 4. Connection of air temperature sensors and the pressure connection to the differential manometer can also be seen.

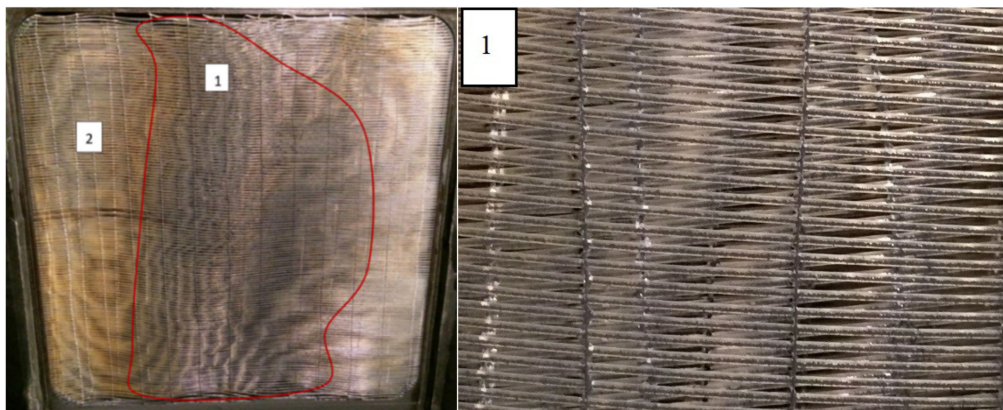
**Figure 5.** Heat exchanger surface after injection of  $400 \text{ g m}^{-2}$  of test dust (left). There is seen that the fouling is not uniform across the heat exchanger cross-section. Fibers of zone 1 (see magnification on the (right)) are more fouled with lot of deposit on the frontal part of the fibers, while the surface of the fibers in zone 2 has only separated particles.

In the following section, some important points of the experiment are described and photographically documented. After 4 days of an experiment and the injection of  $400 \text{ g m}^{-2}$  of test dust, there are only a small number of separated particles on the fibers (see Figure 5). There was a small reduction in the heat transfer rate (4%) and the pressure drop was not affected. It can be seen that the deposit was not completely uniformly distributed across the heat exchanger frontal area, with the middle (zone 1) more fouled and the rest (zone 2) less. This can be explained by the position of the dust injection window, which is in the middle of the tunnel. Even the 1 m long gap between the injection window and the heat exchanger was not enough to uniformly mix the dust into the airflow.

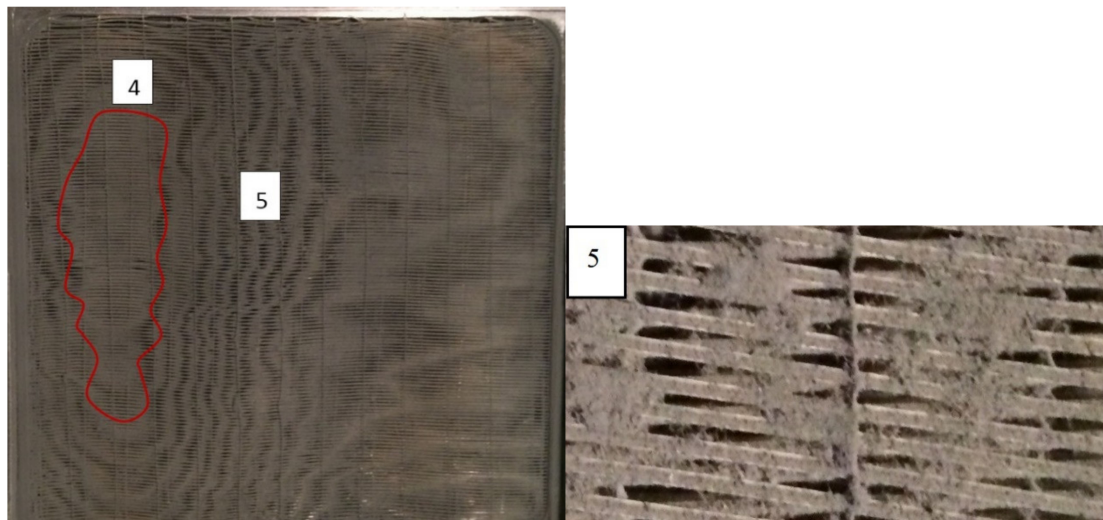
**Figure 6.** Heat exchanger surface after injection of  $1200 \text{ g m}^{-2}$  of test dust (left). The majority of the front surface of fibers is covered with the deposit layer. There are zones where the deposit blocks the gap between the fibers (as in zone 4) or creates the lines of the blocked zones (as in zone 5, see details (right)).

After the injection of  $1200 \text{ g m}^{-2}$  of test dust, the fibers were covered not by individual particles but by a layer of dust deposit (Figure 6). Fouling was not homogeneous and the deposit evolution was distributed according to some kind of pattern. This pattern may be related to air velocity distribution across the frontal area. There was no additional reduction in the heat transfer or increase in pressure drops comparing to lower loads of the dust.

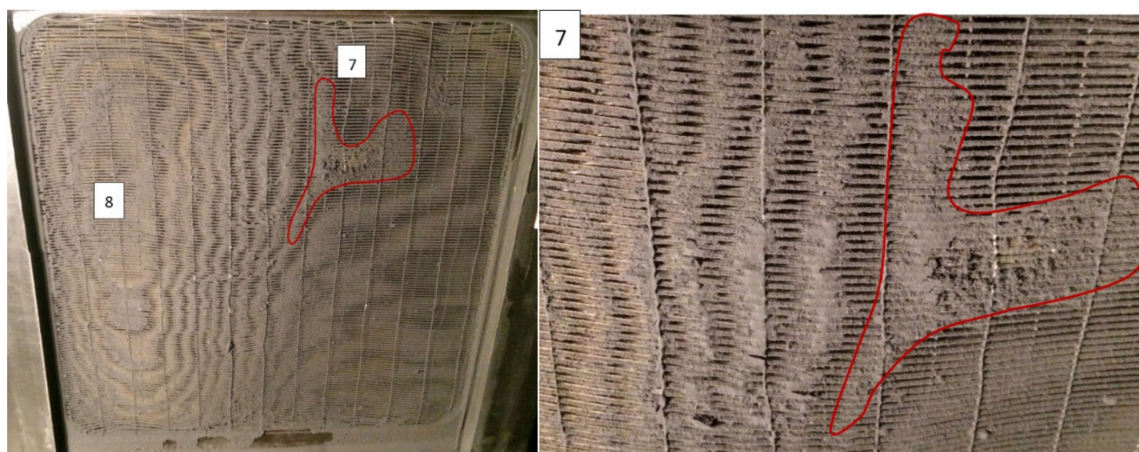
**Figure 7.** Heat exchanger surface after injection of  $2800 \text{ g m}^{-2}$  of test dust (left); and magnification of the highly fouled zone 7 with complete blockage of the surface (right)

After the injection of  $2800 \text{ g m}^{-2}$  of the test dust, all the fibers were covered not only by separated particles, but by a layer of dust deposit and the fouling pattern can be seen very clearly (see Figure 7). It can be seen that the fouling pattern (see zone 8) corresponded to one found before (zone 4 on Figure 6). There was also a massive dust deposit clogging the frontal area (zone 7). The heat transfer rate was 15% lower and pressure drops increased by 32%.

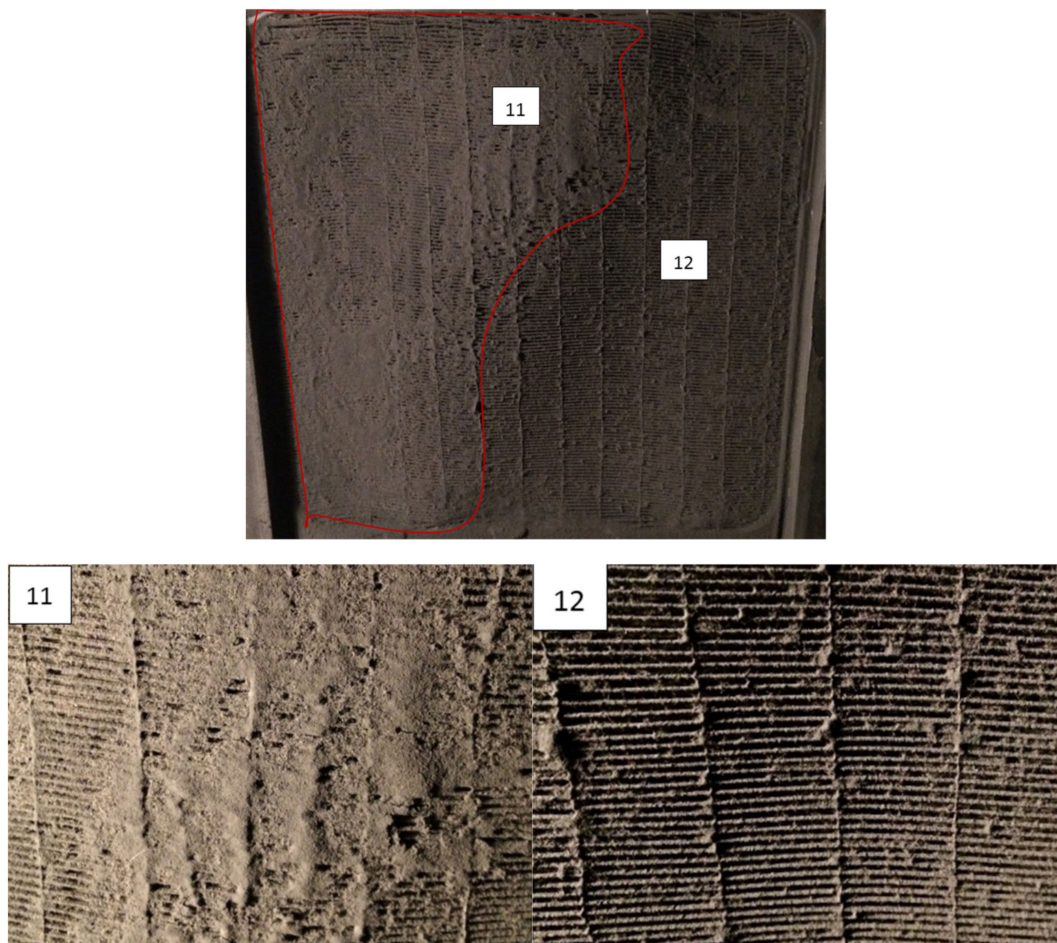
**Figure 8.** Heat exchanger surface after injection of  $4000 \text{ g m}^{-2}$  of test dust at the end of measurement. Zone 11 consists of the fibers clogged by the dust, so air cannot flow through. In zone 12, there is a large deposit of the dust on the fibers, but there is no complete clogging of the heat transfer area.

After 18 days of testing, the total dust injection reached  $4000 \text{ g m}^{-2}$  of test dust and the heat exchanger was massively fouled (38% decrease in heat transfer rate and 91% increase in pressure drops). The experiment was then stopped (see Figure 8). Half of the frontal area (zone 11) was clogged by the dust so air could not pass through. The hollow fibers in zone 12 were covered in dust but air could still flow through. The injection of additional dust would have caused zone 11 to grow, with a very fast rise in pressure drops. In real-life operation of air conditioning there was no regulation of the fan capacity, so the air flow rate would be significantly reduced, causing a deterioration in thermal performance.

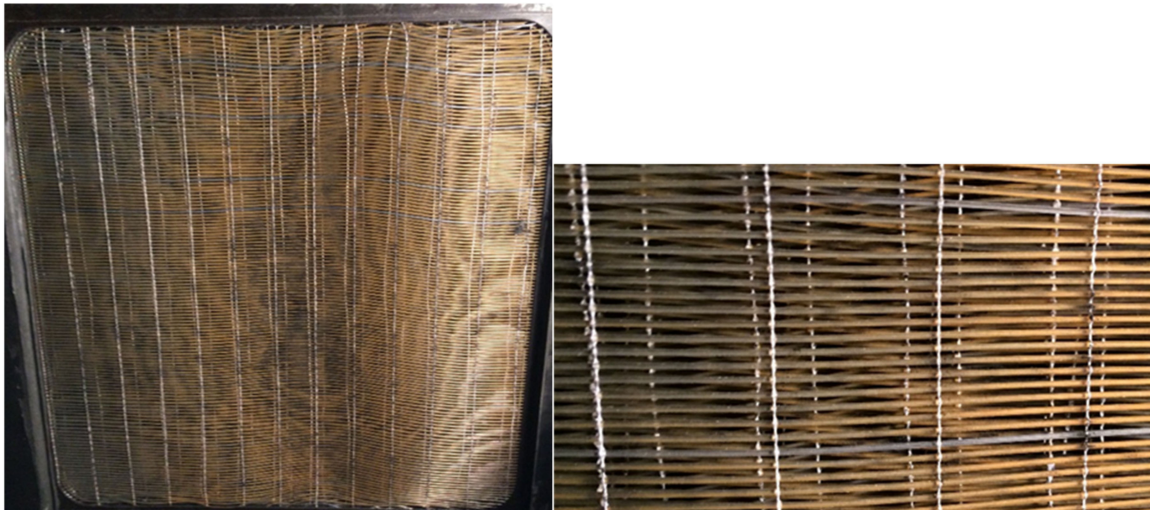
**Figure 9.** The back of the heat exchanger at the end of measurement. The fiber surface attaches only separated particles with no massive deposit layers.

At the end of the experiment, the frontal area of the heat exchanger was partially blocked by the foulant deposits, but the thermal performance was not so bad. It should be noted that the heat exchanger was formed by 14 layers of fibers. The figure of the back of the heat exchanger after the tests shows that the fiber surface was clean and mostly free of massive deposits of dust particles (see Figure 9). The majority of fouling appeared on the first fiber layers and did not penetrate deeper. It confirms the conclusion that the significant reduction in transferred heat was mainly caused by the clogging of the heat exchanger frontal area. This conclusion was in line with the results found for field operated air conditioner evaporators [14] and for a laboratory tested dry cooler [19]. The fouled samples tested in the wind tunnel [14] show no decrease (in some cases even a small increase due to the more turbulent air flow) in heat output when the air flow was kept at the same level as for clean samples. The results obtained for 15 heat exchangers show that long-term dust particulate fouling influences the thermal performance mainly through the rise of the pressure drop [14]. In the case of the tested dry cooler [15], a 50% increase in air pressure drops was found, and fouling had a slight impact on the thermal performance.

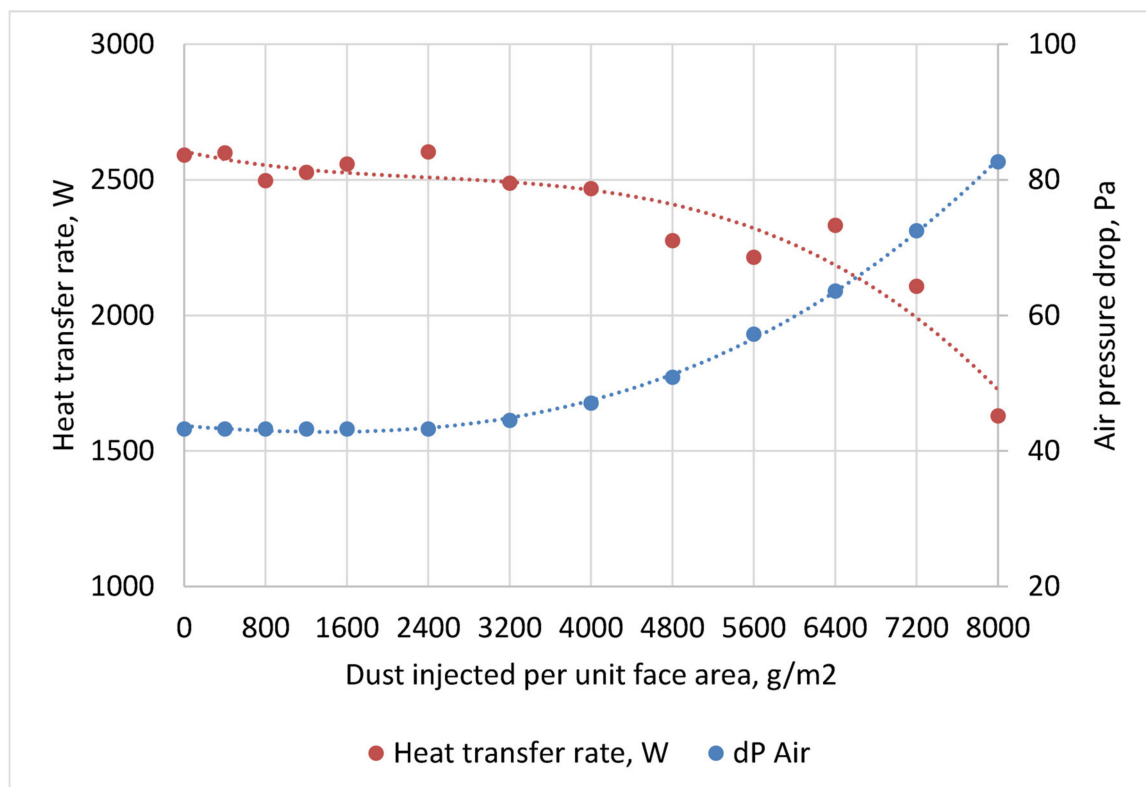
**Figure 10.** Influence of fouling evolution on heat transfer and pressure drops.

There is pronounced initiation period on the record of the time evolution of pressure drop and heat transfer rate (see Figure 10). The first six days of the test (injection of  $800 \text{ g/m}^2$ ) provided data in which no fouling effect can be observed. After a certain critical point (approximately  $2400 \text{ g/m}^2$  of test dust) the influence of fouling developed significantly faster.

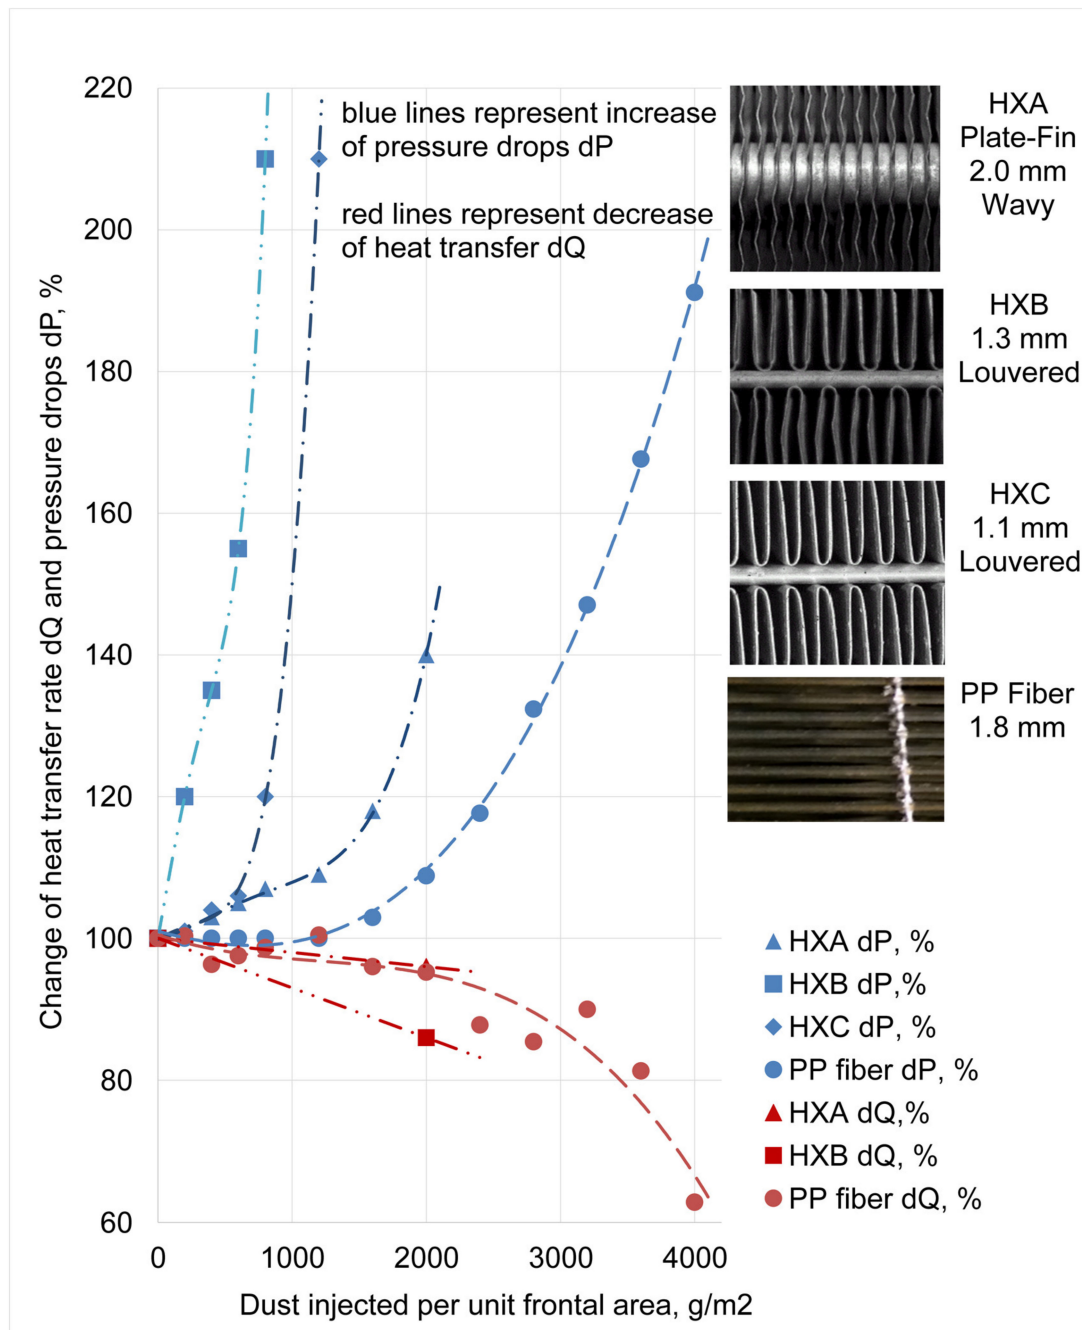
**Figure 11.** Comparison of fouling characteristics of finned tube heat exchangers HXA, HXB and HXC and polymeric hollow fiber heat exchanger. Data for HXA, HXB and HXC are adopted from Bell and Groll [13].

The fouling evolution results evaluated for the smooth polymeric hollow fibers in this study were compared with the data published for classical metal heat exchangers published in [15]. The first metal heat exchanger was made of copper circular tubes with thin aluminum wavy fins. These heat exchangers were extensively used in HVAC equipment as air heaters/coolers, evaporators

and condensers. The second metal type was the heat exchanger with louvered fins. This type of fins was connected by brazing them to the flat aluminum tubes. This type is widely used as automotive radiators. Figure 11 shows a comparison of pressure drops and the performance for metal and polymeric heat exchangers. The significantly better antifouling characteristics of the polymeric heat transfer surface can be observed. The amounts of dust that cause an increase of 50% in the pressure drop was 550 g/m<sup>2</sup> and 1000 g/m<sup>2</sup> respectively for the two sizes of louvered heat exchanger. For the plate-fin heat exchanger it was 2100 g/m<sup>2</sup> and for the polypropylene one it was 3200 g/m<sup>2</sup>.
