# On the Cleanliness of Different Oral Implant Systems: A Pilot Study

**Abstract:** (1) Background: This paper aimed to compare the cleanliness of clinically well-documented implant systems with implants providing very similar designs. The hypothesis was that three well-established implant systems from Dentsply Implants, Straumann, and Nobel Biocare were not only produced with a higher level of surface cleanliness but also provided significantly more comprehensive published clinical documentation than their correspondent look-alike implants from Cumdente, Bioconcept, and Biodenta, which show similar geometry and surface structure. (2) Methods: Implants were analyzed using SEM imaging and energy-dispersive X-ray spectroscopy to determine the elemental composition of potential impurities. A search for clinical trials was carried out in the PubMed database and by reaching out to the corresponding manufacturer. (3) Results: In comparison to their corresponding look-alikes, all implants of the original manufacturers showed—within the scope of this analysis—a surface free of foreign materials and reliable clinical documentation, while the SEM analysis revealed significant impurities on

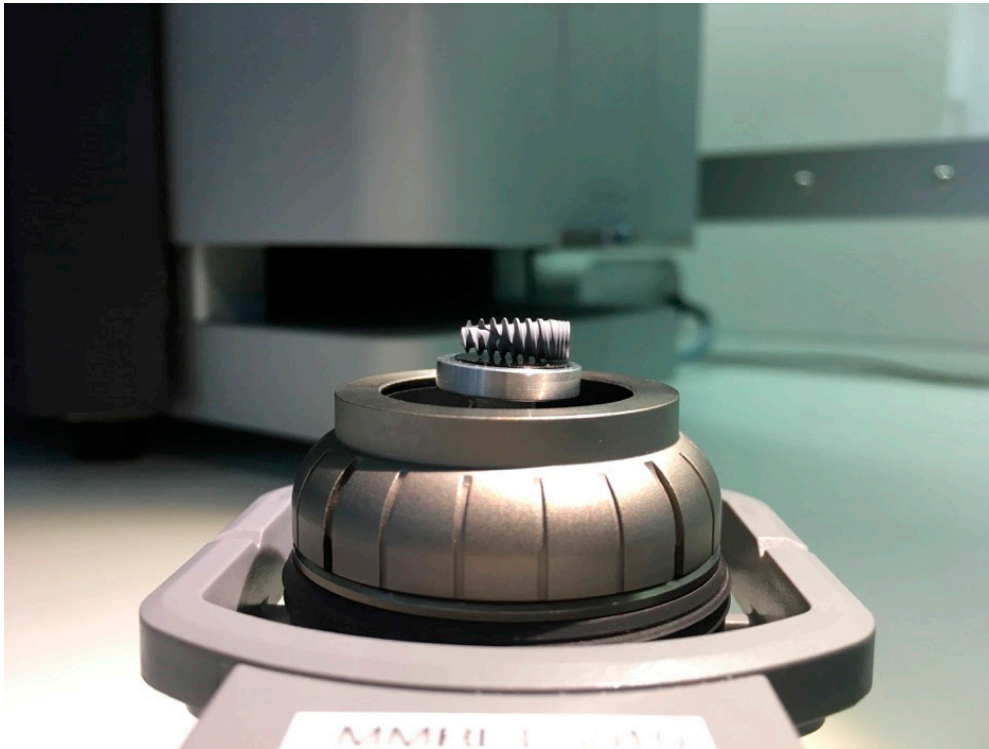
**Figure 1.** Implant sample with a length of 10 mm mounted on the SEM sample holder.

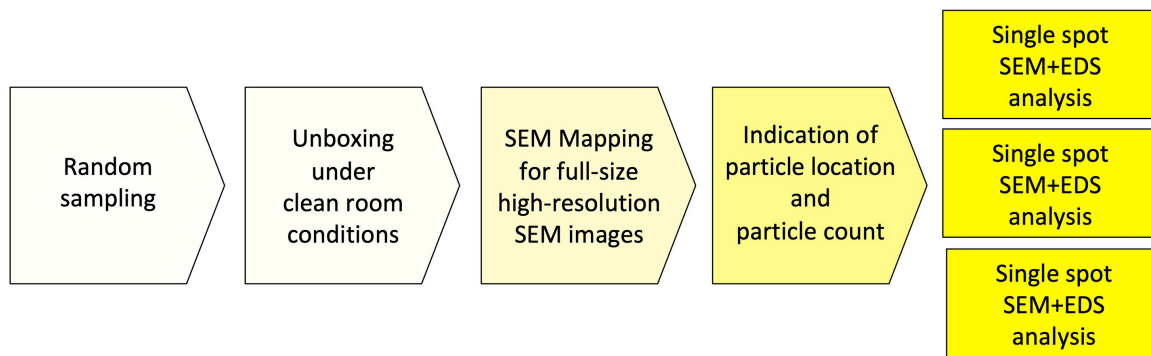
In order to achieve a complete overview of the horizontally mounted implant sample and comprehensive surface quality information in high resolution, implants were scanned at a magnification of 500× in the “Image-Mapping” mode prior to the detailed analysis of potential impurities. This technique produces up to 600 single high-resolution SEM images of the implant surface that were digitally composed into one large image, with an extremely high resolution. The composed SEM image, showing the full size of the implant from shoulder to apex, made it possible to count particles in the visible field (viewing angle of approximately 120°) and to identify areas of interest for a subsequent EDS spot analysis. After the mapping process, SEM images of impurities and other regions of interest were produced with 500×, 1000× 2500×, and 5000× magnification. In the next step, the elemental composition of particles was determined and, where possible, the differential spectra of particles were achieved to subtract signals from the core material and such focus on signals from the superficial contamination (Figure 2).

**Figure 2.** Workflow of the SEM/EDS analysis.

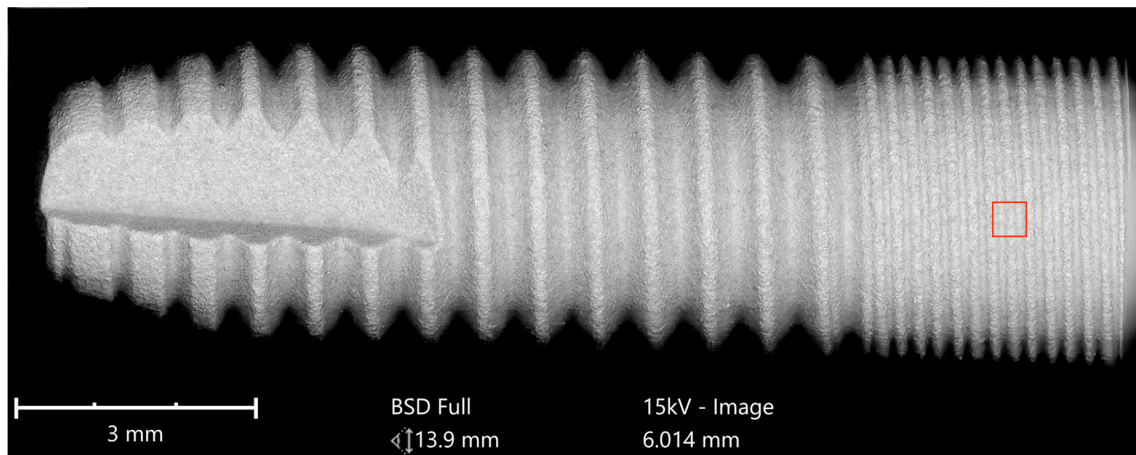
SEM image of the Astra Tech implant—digitally composed of 455 single SEM images (tiles)—showed a homogenous surface with no foreign material (Figure 3).

**Figure 3.** SEM mapping of OsseoSpeed implant (Astra Tech–Dentsply Implants). Magnification of the red marked area is shown in Figure 4.

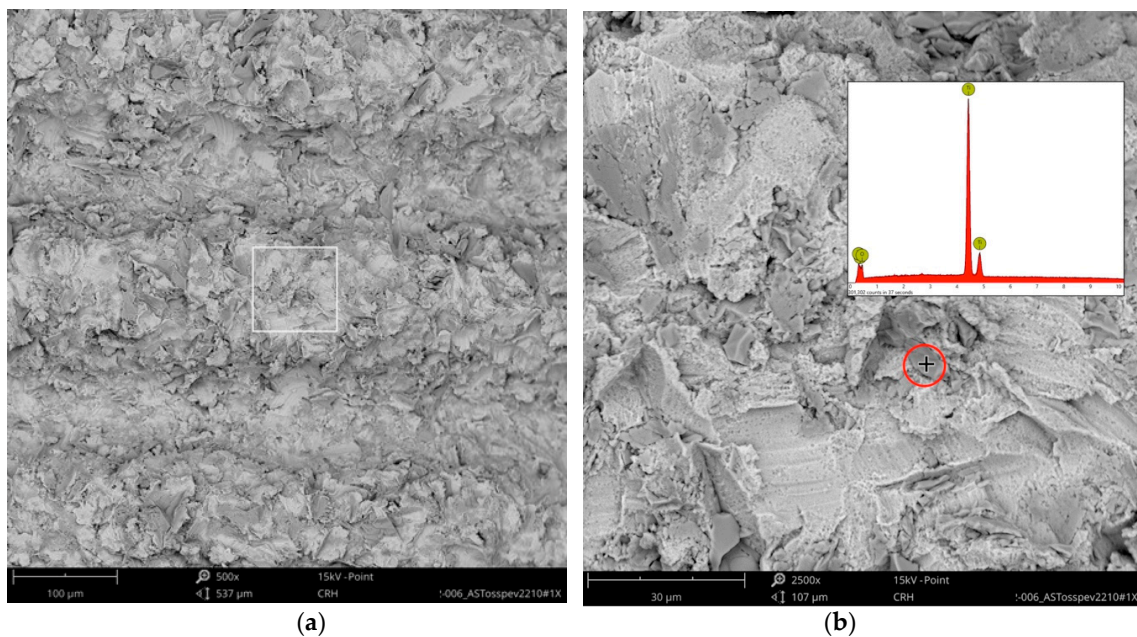
**Figure 4.** OsseoSpeed surface: (a) the red marked area in Figure 3 magnified 500×; (b) higher magnification (2500×) of the white marked area in the left image with EDS spot analysis of an embedded TiO<sub>2</sub>-particle (spot is marked with “+” in the red circle) showing only signals of the blasting material.

Higher magnification could identify the TiO<sub>2</sub> particles from the blasting process seen as sharp-edged particles of 5–10 mm embedded in the titanium surface. Elemental analysis of these particles only displayed signals of titanium and oxygen (Figure 4).

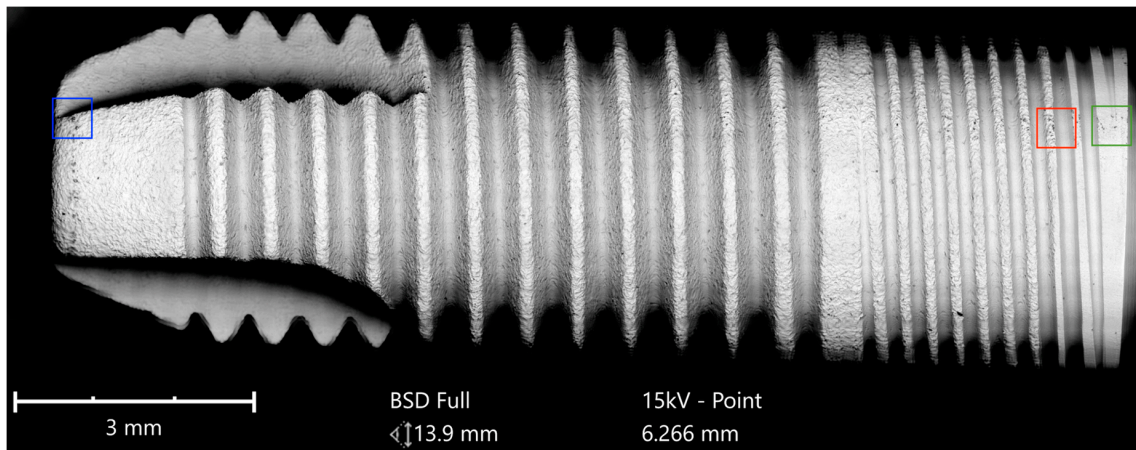
The Cumdente implant showed several anomalies in the correspondent full-size image, composed of 422 tiles (Figure 5).

**Figure 5.** SEM mapping of the AS Implant (Cumdente); Red marked area—see magnification in Figure 6, blue marked area—see magnification in Figure 7, green marked area—see magnification in Figure 8.

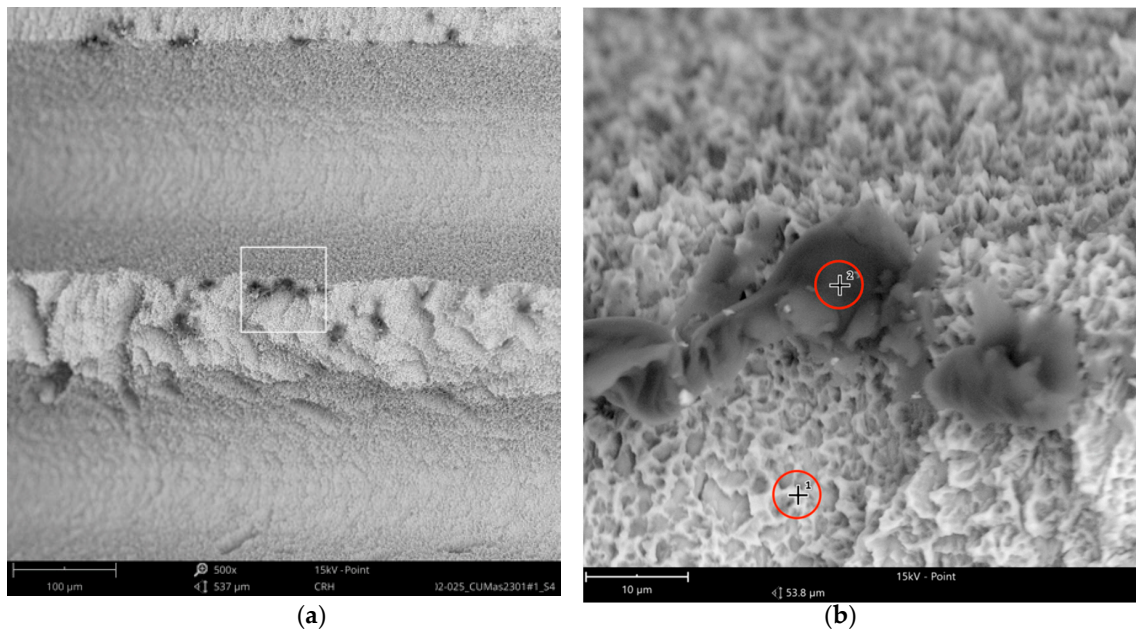
**Figure 6.** AS Implant (Cumdente) with organic particles (10–50 µm) at the implant shoulder: (a) systematic contamination of exposed threads, red marked area of Figure 5 in 500×; (b) magnification (5000×) of white marked area in the left image. The EDS differential measurement of the marked spots was identical to the particles in Figure 7.

The SEM images with higher magnification revealed systematic contamination with multiple (>100) organic particles (5–60 μm) on exposed parts of the implant, as seen on the micro-threads next to the implant shoulder (Figure 6) and near the implant’s apex (Figure 7).

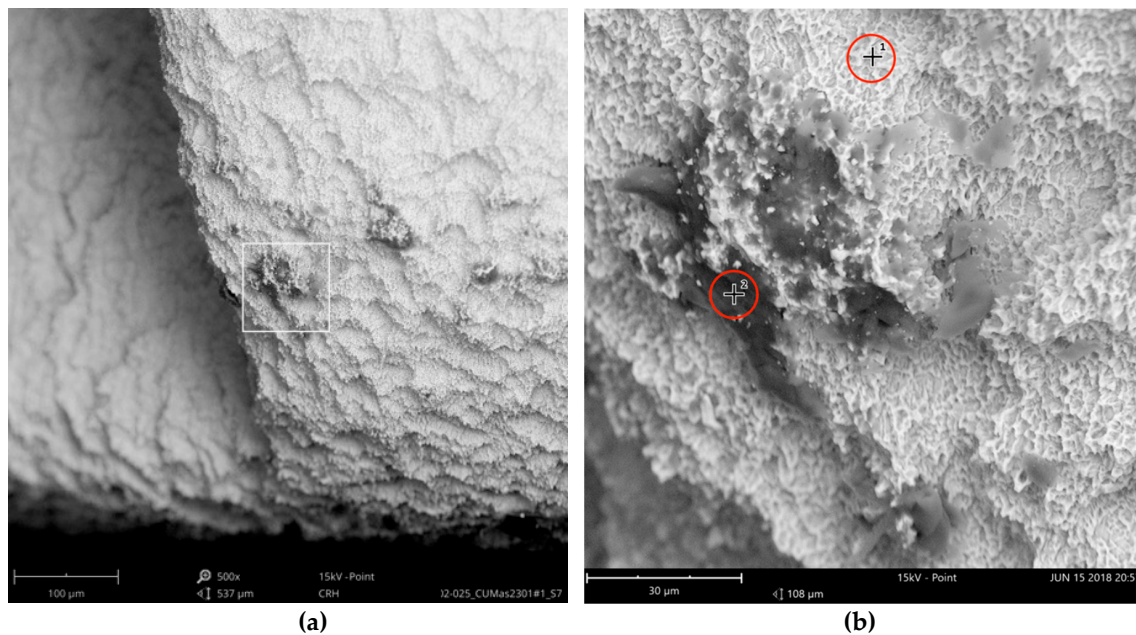
**Figure 7.** AS Implant (Cumdente) with organic particles (5–70 μm) at the implant’s apex: (a) blue marked area of Figure 5 in 500×; (b) magnification (5000×) of white marked area in Figure 7a; EDS differential measurement of marked spots is shown in Figure 8.

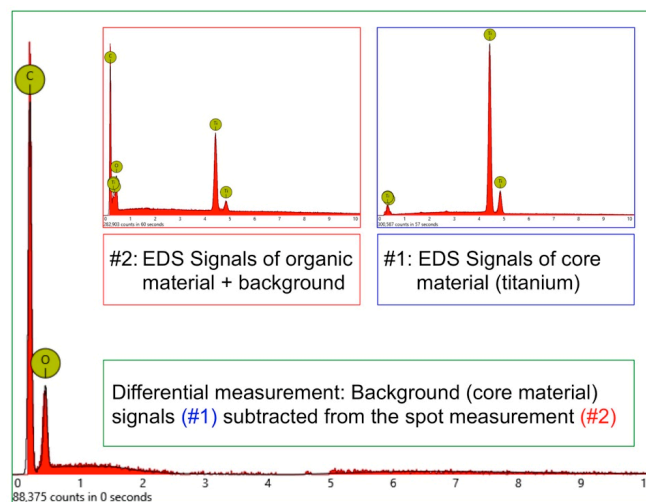
**Figure 8.** EDS differential measurement of the organic particle in Figure 7. Graph #1 shows titanium as the core material of this implant, with characteristic peaks at 0.452 KeV (La), 4.508 KeV (Lb), and 4.932 KeV (Kb). Graph #2 shows the spectrum of the particle with additional signals of the titanium background. The subtraction of X-ray quanta from the background material reveals the elemental composition of the impurity, which is carbon (characteristic Ka peak at 0.277 KeV) and oxygen (Ka peak at 0.523 KeV).

In order to receive information about the particles’ elemental composition, EDS measurement was performed with a spot focused on the foreign material, where background material was always detected as well, and another spot focused in direct proximity, where only the implant’s core material was detected (spot #1 and #2 in Figures 6b and 7b, respectively). Using a software application, it was possible to subtract the signals of the core material so that the differential measurement revealed

more precise information about the elemental composition of the foreign material. Figure 8 shows the differential EDS measurement of the particle in Figure 7, with a clear signal of carbon as the major element in this impurity.

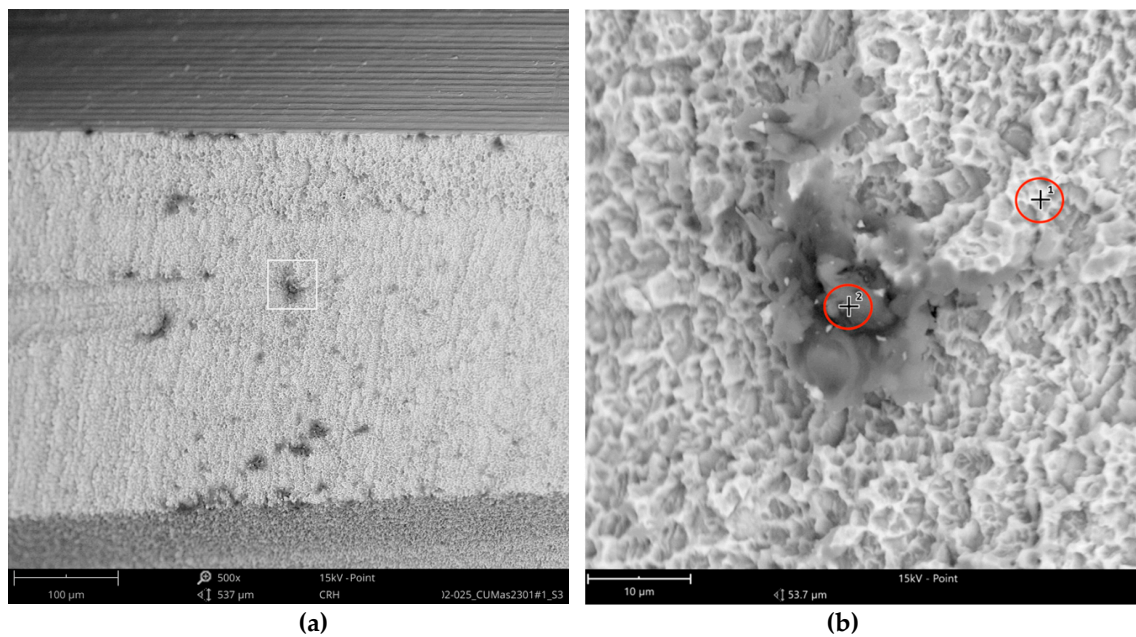
One larger area at the implant shoulder showed numerous particles (5–40 μm) (Figure 9) with significant signals, not only of carbon but also of fluorine, as seen in the differential EDS analysis (Figure 10). The texture and elemental composition of the foreign material suggest that these particles are most likely remnants of polytetrafluoroethylene (PTFE), used at different implant production stages.

**Figure 9.** Possible remnants of polytetrafluoroethylene (PTFE), AS Implant (Cumdente); (a) green marked area of Figure 5 in 500× shows a larger area of impurities; (b) magnification (5000×) of white marked area in the left image; EDS differential measurement of the marked spots is shown in Figure 10.

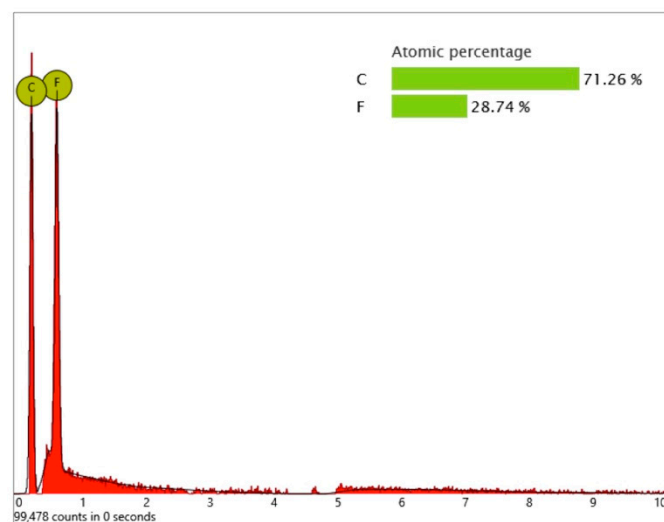
**Figure 10.** EDS differential measurement of the particles in Figure 9 with significant X-ray quanta of carbon and fluorine. Note that the quantitative information provided by the EDS analysis does not always reflect the precise stoichiometric relationship of the particle’s chemical elements.

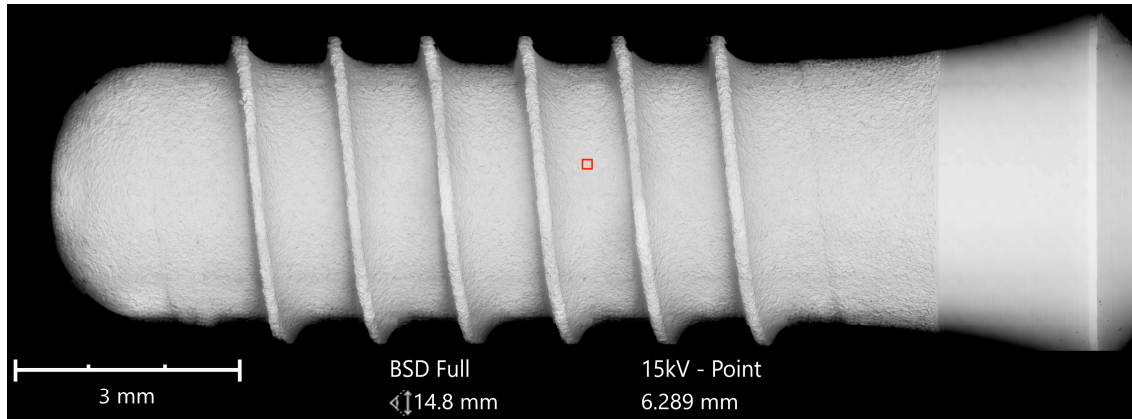
**Figure 11.** SEM mapping, Standard Plus SLA implant (Straumann); Magnification of red marked area is shown in Figure 12.

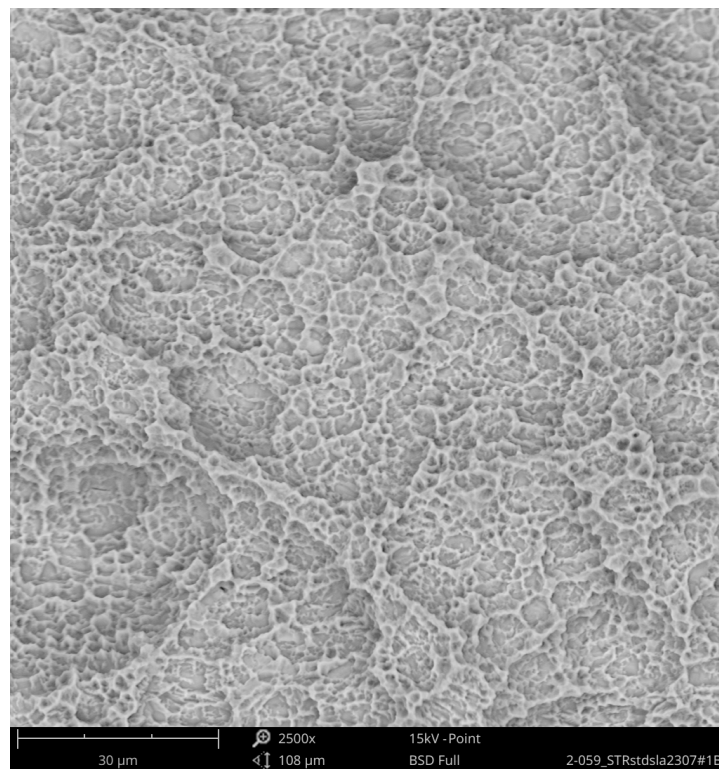
**Figure 12.** Surface of Standard Plus SLA implant (SEM 2500×); red marked area in Figure 11 with the typical texture of a sandblasted and acid-etched titanium surface, free of foreign materials.

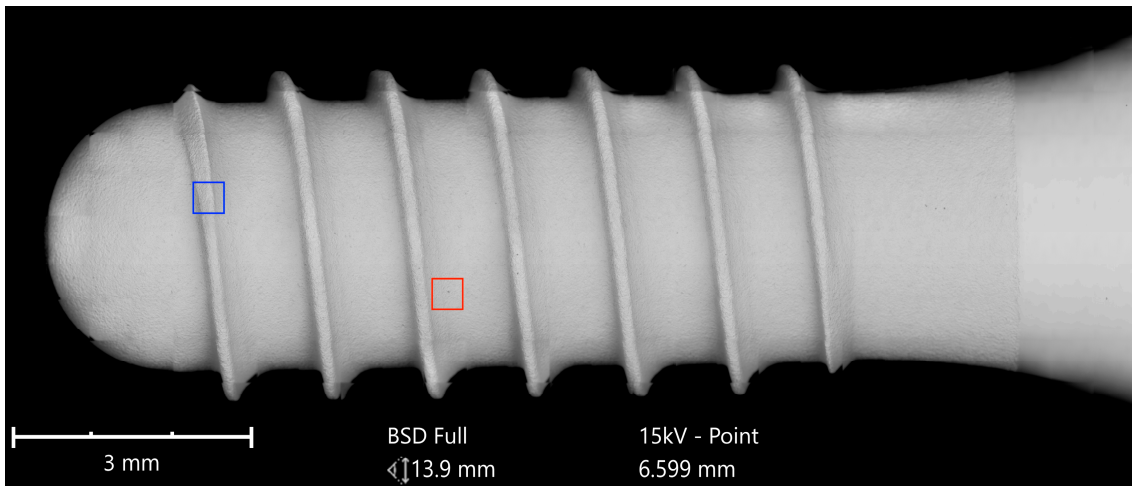
While the Straumann implant can be rated as clean at the micron level, the analysis of the Bioconcept implant revealed several impurities, although the full-size image showed no systematic larger contamination (Figure 13). With higher magnification, approximately 20 small organic particles (10–20 µm) were found on the implant’s surface, one particle showing additional signals of sulfur (Figure 15).

**Figure 13.** SEM mapping, Tissue Level Implant (Bioconcept); red marked area—see magnification in Figure 15, blue marked area—see magnification in Figure 14.

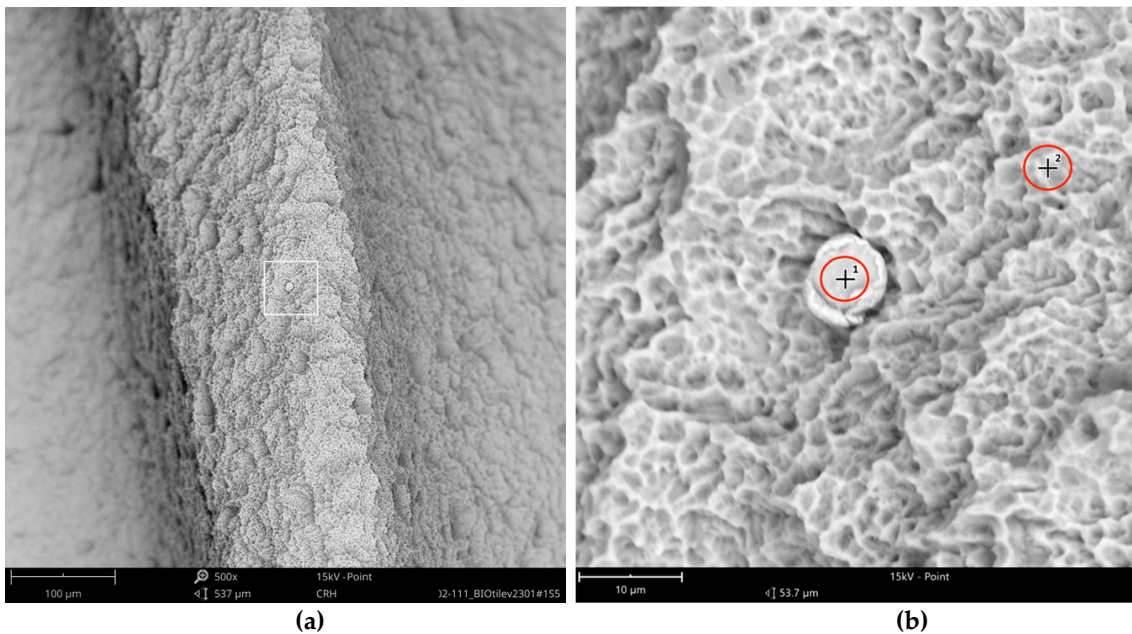
**Figure 14.** Metal particle on the surface of the Bioconcept implant; (a) blue marked area in Figure 13, SEM 500×; (b) magnification (5000×) of white marked area in the left image (a) showing bright metal impurity (8 μm) and 2 points of EDS spot measurement (#1 = metal particle, #2 = core material).

Surprisingly, one metal particle of 8 μm was found on the Bioconcept implant, seemingly entirely composed of iron, as the qualitative and quantitative elemental analysis and differential measurement of this particle revealed (Figures 14 and 16).

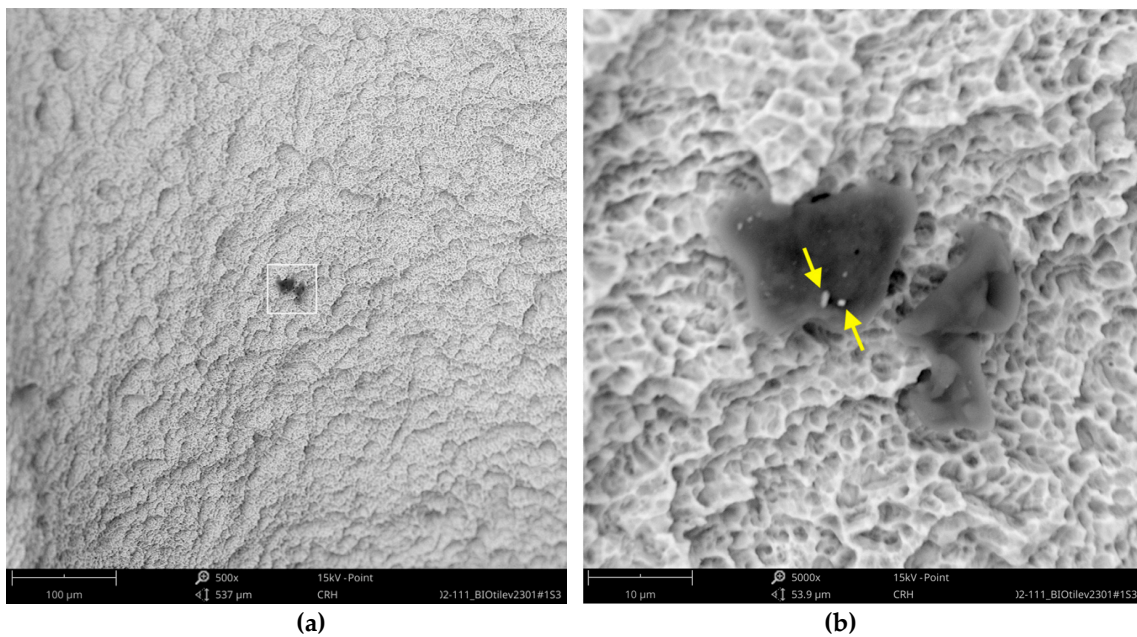
**Figure 15.** Bioconcept implant with organic particles (10–15  $\mu\text{m}$ ); (a) red marked area in Figure 13, SEM 500 $\times$ ; (b) magnification (5000 $\times$ ) of white marked area in the left image (a); arrows indicate two embedded metal particles (0.5–1  $\mu\text{m}$ ) showing significant iron signals in the subsequent EDS differential measurement.

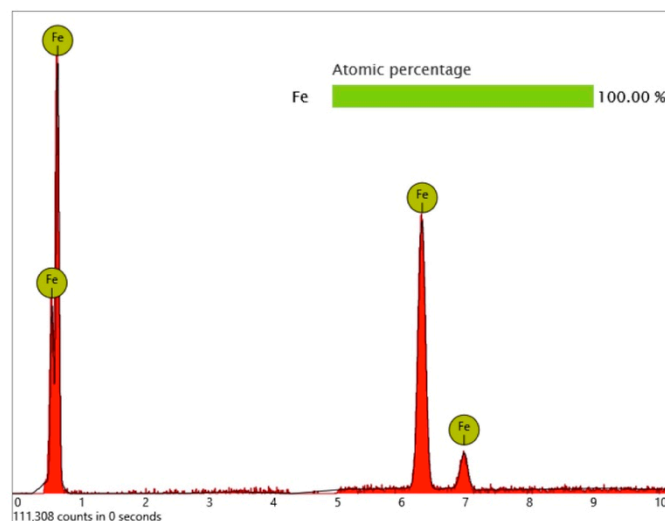
**Figure 16.** EDS differential measurement of the metal particle in Figure 14, revealing iron as the major element of the impurity.

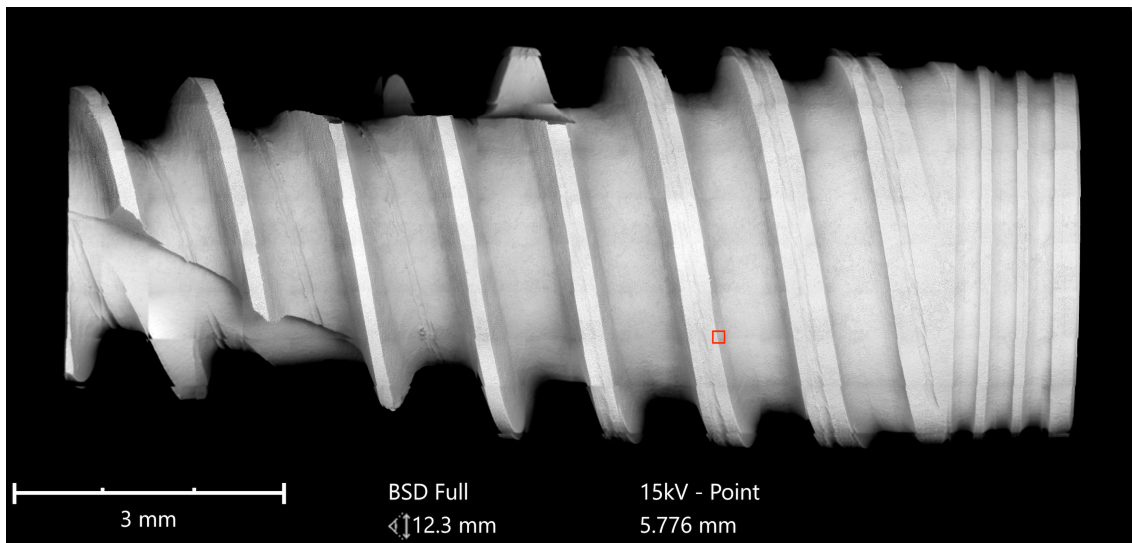
**Figure 17.** SEM mapping: NobelActive Internal RP implant (Nobel Biocare); red marked area—see magnification in Figure 18.

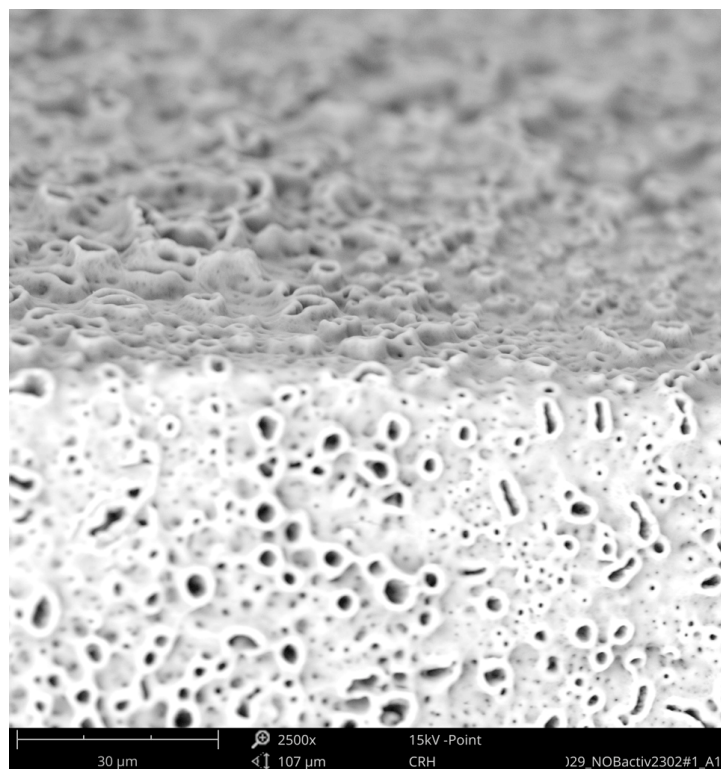
**Figure 18.** Surface of the NobelActive Internal RP implant (2500×); magnification of red marked area in Figure 17 with the typical texture of an anodized titanium surface, free of foreign materials.

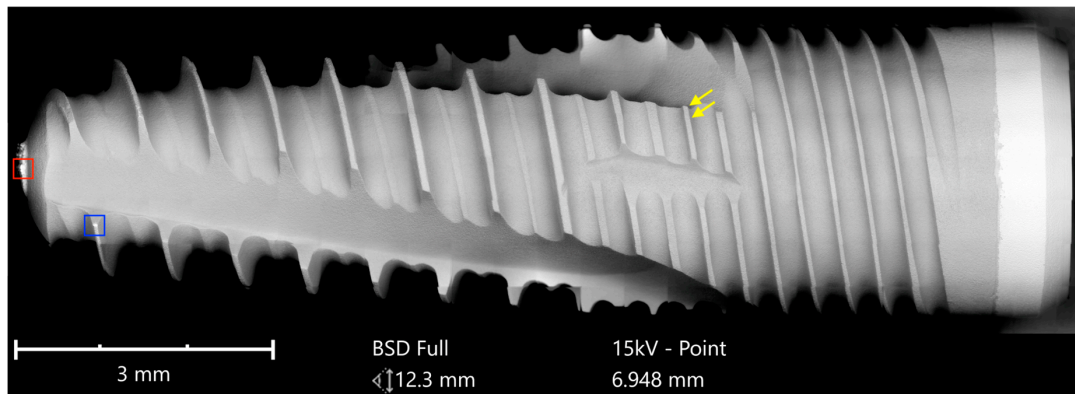
While the full-size SEM image of the Biodenta implant exposed no significant organic contamination (Figure 19), the area analysis of the core material showed, in addition to calcium, phosphorous, titanium, and oxygen, high levels of magnesium in the EDS (Figure 20) that were not seen on the Nobel Biocare implant.

**Figure 19.** SEM mapping: Dental Implant (Biodenta); yellow arrows indicate spots with aluminum as shown in Figure 21. Magnifications of the blue and red marked areas are shown in Figure 23.

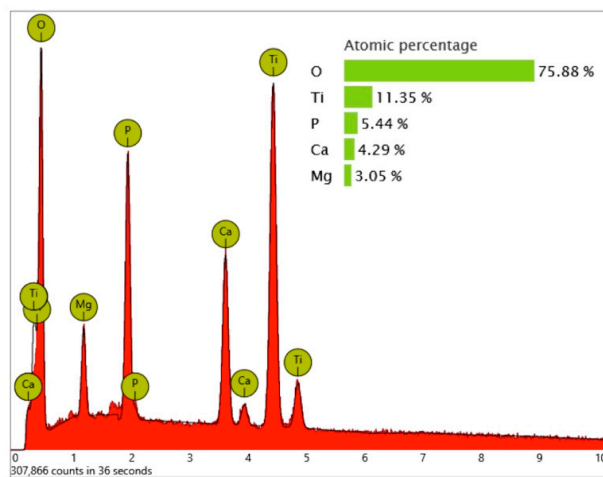
**Figure 20.** EDS area analysis of the implant’s core material (Biodenta).

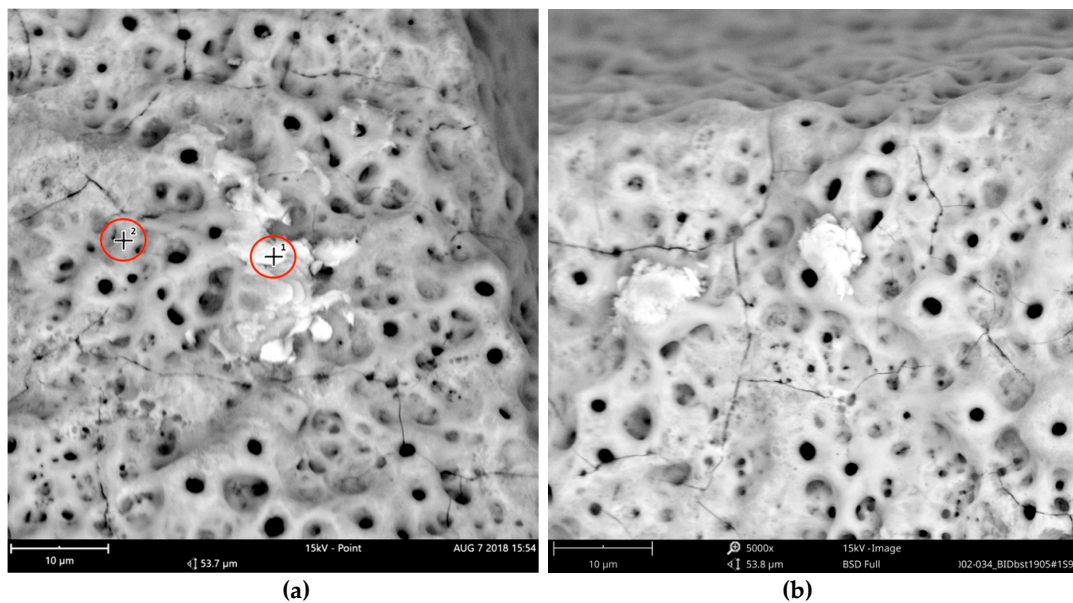
Significant traces of aluminum were detected in three areas of exposed threads and can be seen as bright particles (5–10 µm) in Figure 21. The graph in Figure 22 shows the correspondent EDS differential measurement of metal particles in Figure 20a.

**Figure 21.** Aluminum-containing particles (5–10 μm) on the surface of the Biodenta implant; location shown using yellow arrows in Figure 19; (a) SEM 5000× with 2 points of EDS spot measurement shown in Figure 22; (b) impurities with similar size in close proximity to particles shown in the left image (a).

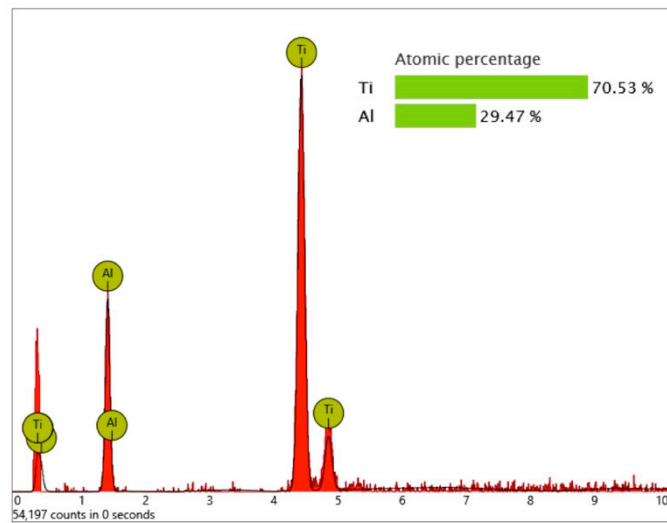
**Figure 22.** EDS differential measurement of the metal particle in Figure 20 (a), showing significant X-ray quanta of aluminum. The lack of oxygen signals indicates that these particles were not made of aluminum oxide.

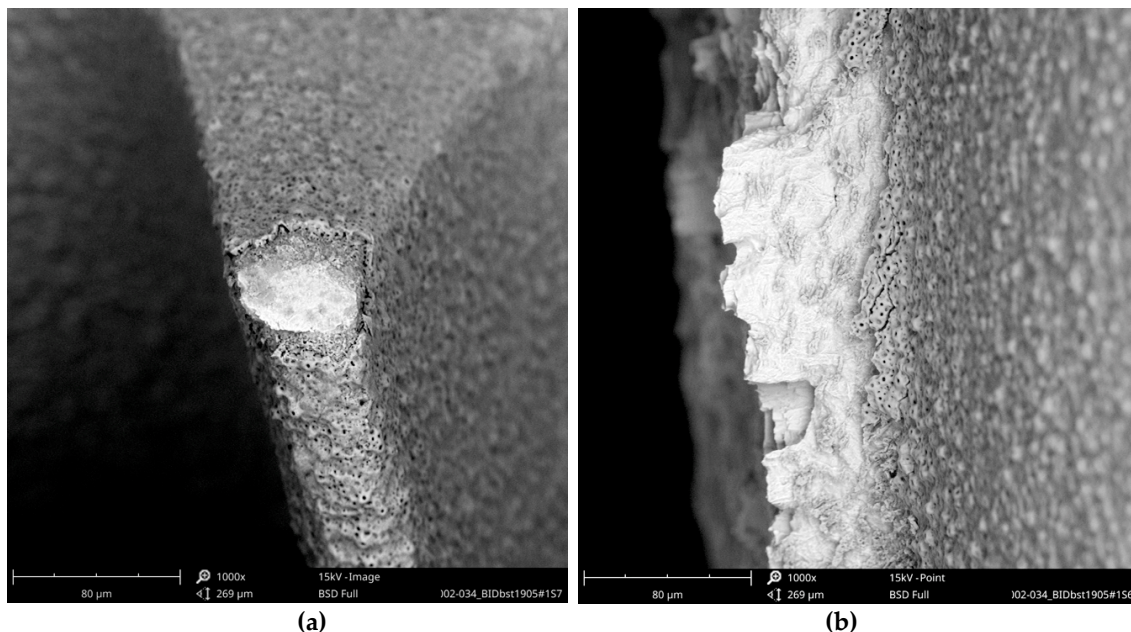
These aluminum-containing particles must be rated as inorganic impurities as they are not comparable with sharp-edged aluminum oxide particles, used for blasting procedures of other implants. Apart from this, it is noticeable that the approximately 3 μm thick oxide layer was damaged at several exposed locations of the Biodenta implant (Figure 23).

**Figure 23.** Damaged oxide layer of the Biodenta implant, SEM 1000×: (a) magnification of the blue marked area in Figure 19 showing the damage at the exposed implant thread; (b) magnification of the red marked area in Figure 19 demonstrates the large-area irregularity of the oxide layer at the implant apex.
