Trauma Case Reports

Unstable AO/OTA type 31-A1.2 intertrochanteric femur fracture: An unusual case report

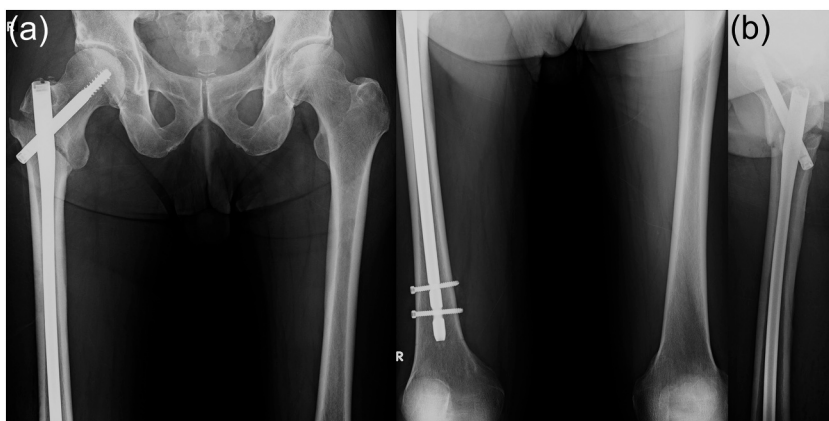
Fig. 2. Postoperative (a) anteroposterior and (b) lateral radiographs.

The patient was treated with direct traction of his proximal tibia to prevent shortening and maintain anatomical alignment. Four days were necessary in order to control blood glucose level after injury. An open reduction and internal fixation with the patient in a supine position on a traction table was performed using a Gamma3 long nail (Stryker, Kiel, Germany) in consideration of the instability of the fracture. Postoperative X-rays showed an acceptable reduction of the intertrochanteric femur with a slight fracture gap in extension on the lateral trochanteric side (Fig. 2). Passive and active range of motion of the hip joint was allowed immediately and full weightbearing was permitted after 4 weeks.

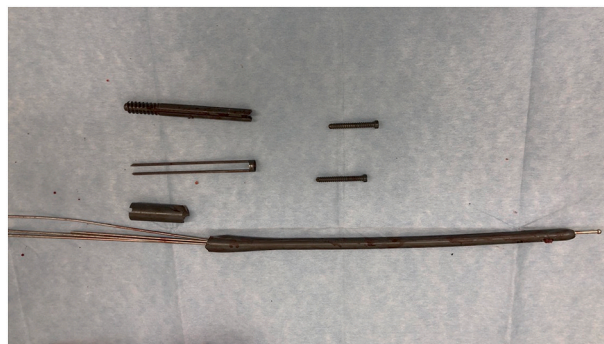
Fig. 4. Intraoperative view of the long cephalomedullary nail and screws after removal.

guide wire and the ball-tipped guidewire was used to remove the nail (Fig. 4). After removing the nail, valgus correction of 15–20° with a 95°-angled blade plate (Synthes, West Chester, Pennsylvania, USA) was performed to stabilize the fracture. A chipping procedure using a chisel without bone grafting also was performed at the non-union site (Fig. 5a). The patient was restricted to toe-touch weightbearing for 8 weeks but range of motion was allowed immediately. Fifty percent weight-bearing with a crutch was commenced from 9 to 12 weeks postoperatively and full weight bearing was permitted after that.

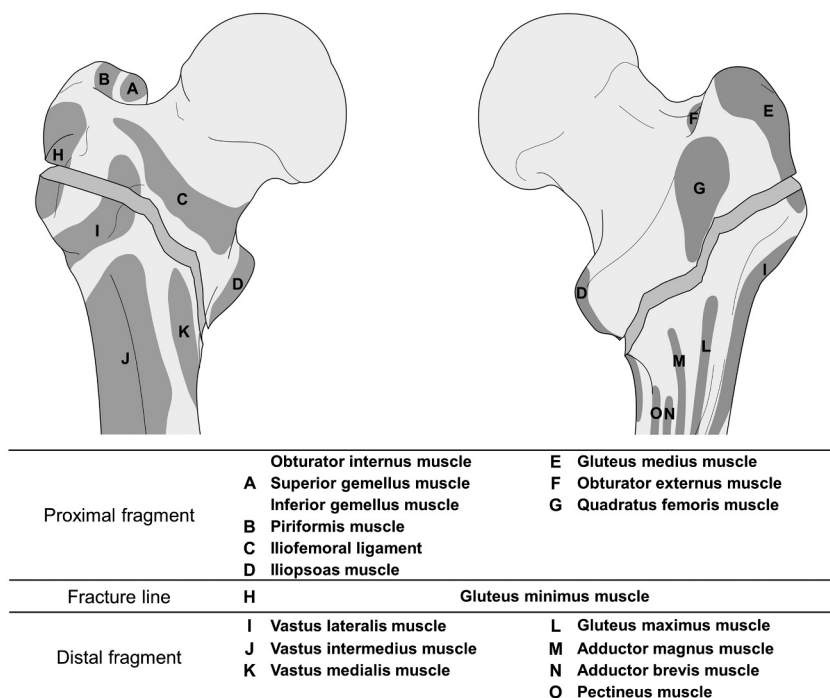
Fig. 7. Drawing of anatomical structures around the fracture line. Modified with permission from the Atlas of Human Anatomy, illustrated by Frank H. Netter, MD. All rights reserved.
