## Case report

# Do Not Postpone Revision of Worn Conventional Liners in Ceramic-on-Polyethylene Total Hip Arthroplasty: A New Dramatic Failure

Thorsten Gehrke, MD, Mustafa Citak, MD PhD, Hussein Abdelaziz, MD\*

Department of Orthopaedic Surgery, Helios ENDO-Klinik Hamburg, Hamburg, Germany

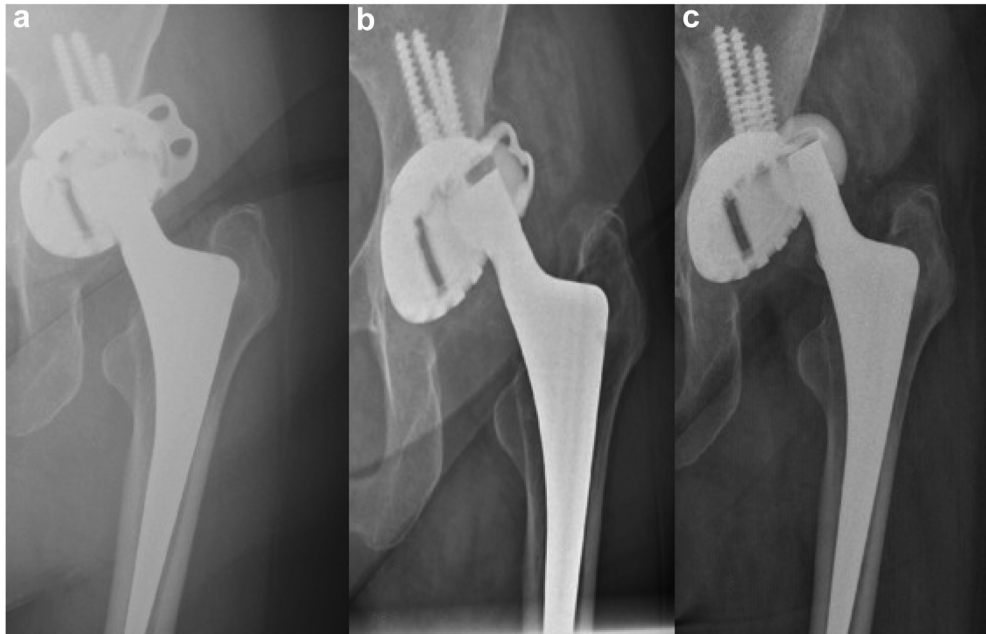
**Figure 1.** Radiographs from April 2019 (a), November 2020 (b), and January 2021 (c) showing the progression of the massive polyethylene and metal wear leading to penetration of the ceramic head through the superolateral part of the cementless titanium cup. The bubble sign of severe metallosis can be seen in Figure 1c.

On admission day, an eccentric position of the femoral head was observed on the preoperative standing view of the whole left leg (Fig. 1a). This finding was discussed with the patient, and revision surgery was recommended. At that time, she had no complaints

The patient presented again in November 2020, now 69 years old and with a body mass index of 27 kg/m<sup>2</sup>, complaining of mild pain, limping, and squeaking in her left hip for a few months. Radiographs showed worsening of the wear with subluxation of the femoral head and evidence of destructive metallosis showing a time interval of 18 months between only liner wear and complete

penetration of the metal cup. On admission day (January 2021), there was more deterioration as the head was superolaterally dislocated (Fig. 1b and c).

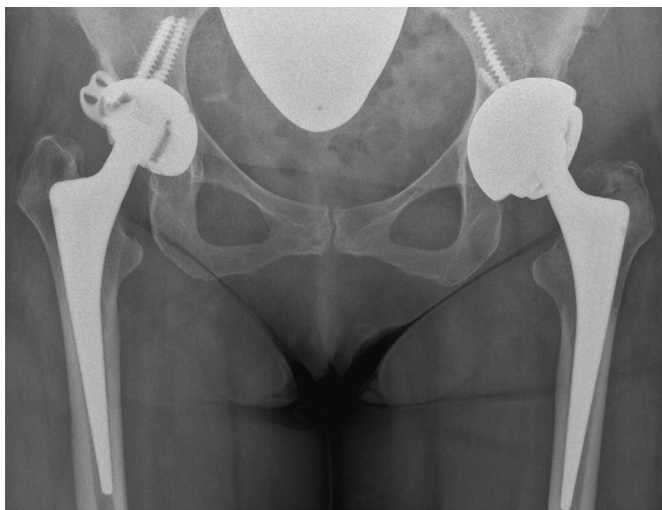
**Figure 3.** Postoperative radiograph showing the reconstruction of the left acetabulum with a revision tantalum shell. A dual mobility cup was cemented inside it. Eccentric head position can be noted on the right side with the same failed components on the left side; therefore, a future revision was scheduled.

We emphasize that patients with significant radiological signs of polyethylene wear, especially conventional liners, have to undergo the recommended revision as soon as possible, as the progression of the wear might be faster than thought. Recommendations during surgical consultation must be clear for patients with old thin and conventional polyethylene liners. Even in asymptomatic patients or those with mild symptoms, catastrophic failure might occur, requiring more complex revision procedures. Despite the proper-functioning gluteus medius, we revised our patient using a dual mobility cup to minimize the risk of dislocation, particularly after the needed debridement during surgery.
