Case report

Atraumatic Fracture of the Medial Femoral Condyle of a Total Knee Arthroplasty

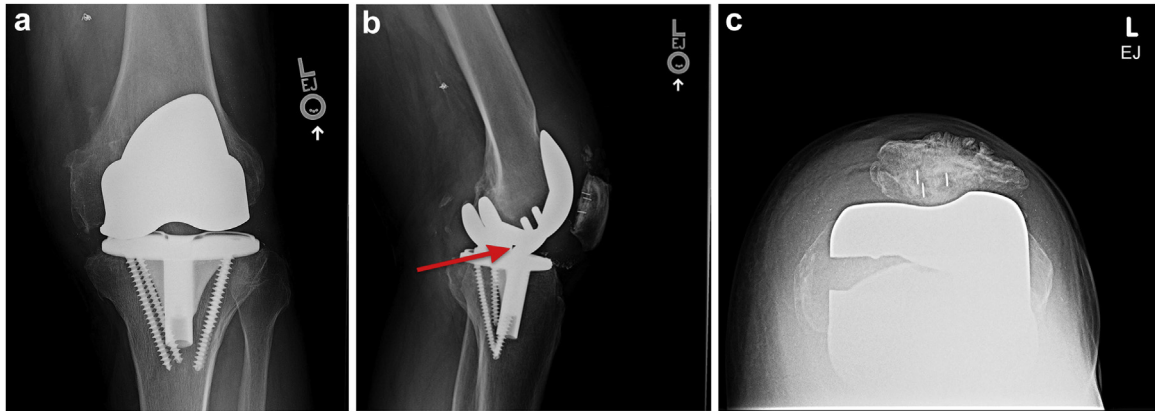
Figure 1. (a) Radiograph AP view of the left knee showing significant wear of the medial polyethylene insert with contact between the medial femoral and tibial components. (b) Radiograph lateral view of the left knee demonstrating fracture of the medial condyle of the Advance Medial-Pivot Knee System prosthesis (indicated with the red arrow). (c) Radiograph sunrise view of the left knee demonstrates a complete fracture of the medial condyle of the Advance Medial-Pivot Knee System prosthesis.

Radiographs taken that day displayed significant wear to the medial compartment of the polyethylene liner (Fig. 1) as well as possible metal fragments anterior to the tibial component on the lateral projections (Fig. 1b). The sunrise view revealed the medial condyle of the femoral component to be fractured (Fig. 1c). Given the patients’ radiographs and physical examination, a left knee CT scan with 3D reconstruction was ordered to confirm and further characterize fracture on the femoral component (Fig. 2). Given the abnormal radiographs suggestive of component fracture with no other hardware loosening, systemic signs of infection, or global inflammatory process, infectious and inflammatory diagnostics were foregone, and revision of the left knee was recommended. The patient agreed and provided a fully informed written consent to proceed with the operation. About 4 weeks after initially presenting to the author’s clinic, the patient underwent a revision of the TKA in September 2020.

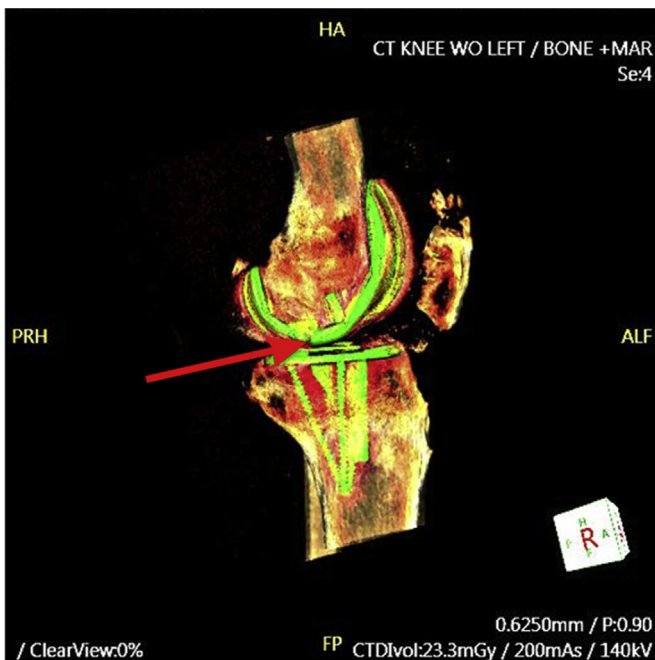
Figure 2. CT scan with MAR and 3D reconstruction demonstrates a medial condyle fracture of the Advance Medial-Pivot Knee System prosthesis (indicated with the red arrow).

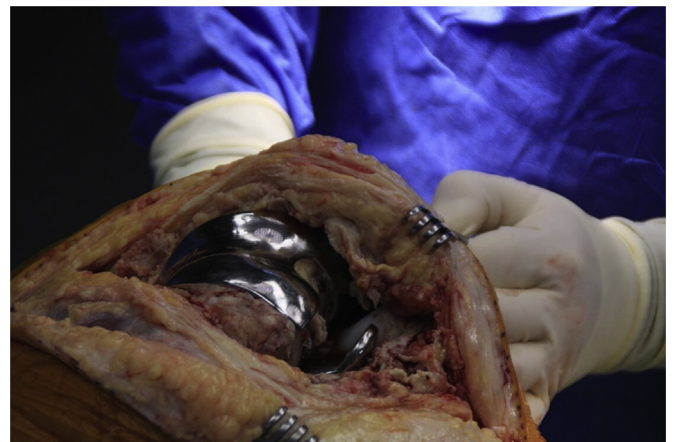
Figure 3. Intraoperative photograph displaying the fractured medial component of the Advance Medial-Pivot Knee System. In particular, this photo shows that loose medial component flipped 180 degrees.

The previous midline incision was used. Gross examination of the knee prosthesis was pursued, and the fracture of the medial femoral condyle was confirmed (Figs. 3 and 4). However, not only was the component fractured, the free-floating fractured component had flipped 180 degrees (Fig. 3). We theorize that the patient's sense of instability was likely due to the fractured medial compartment component moving freely within the joint. In addition to the component fracture, Figure 5 also demonstrates the severe wear of the polyethylene insert, particularly in the medial compartment. The knee was revised with a cemented Triathlon Total Stabilizer (Stryker Orthopedics, Kalamazoo, MI) without any immediate complications. Radiographs taken 2 weeks after the revision TKA demonstrate excellent positioning of total knee prosthesis with no evidence of lysis, loosening, or fracture (Fig. 6a and b). All evaluations through the 6-month post-operative period have been uneventful.

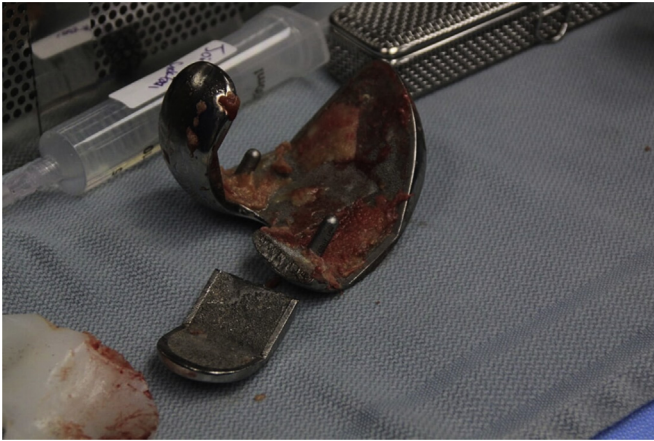
Figure 4. Intraoperative photograph displaying the fractured medial component of the Medial-Pivot Knee System once the prosthesis was fully extracted.

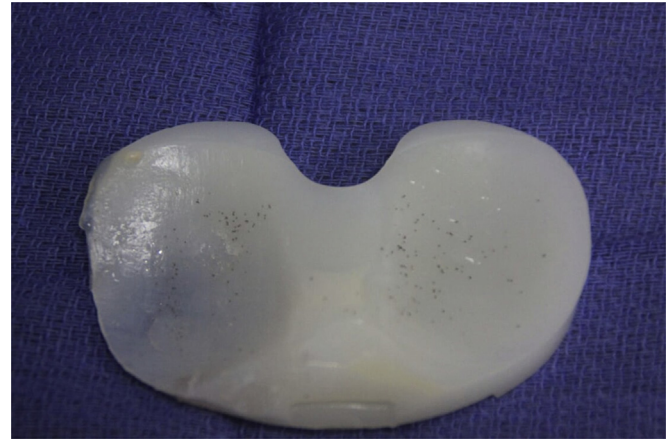
Figure 5. Intraoperative photograph displaying the severe medial polyethylene wear.

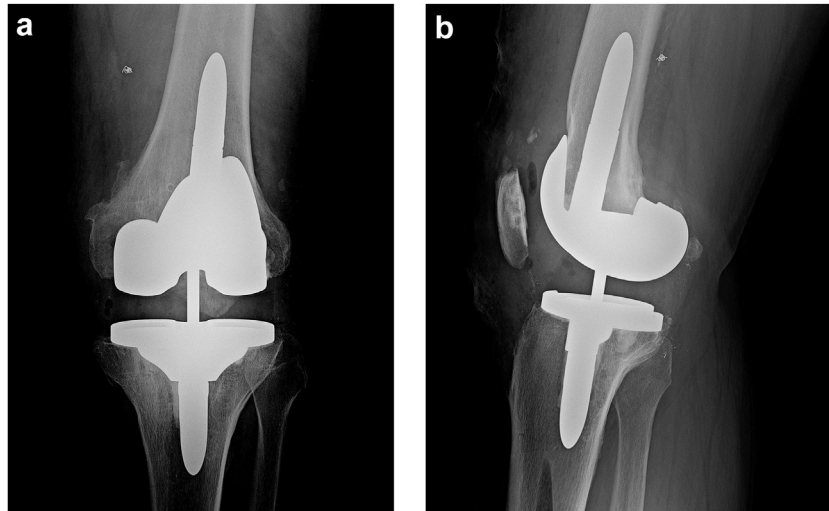
Figure 6. (a) Postoperative radiograph AP view displaying the new Triathlon Total Stabilizer (Stryker Orthopedics, Kalamazoo, MI) implant. (b) Postoperative radiograph lateral view displaying the new Triathlon Total Stabilizer (Stryker Orthopedics, Kalamazoo, MI) implant.
