Article

Mapping of Agricultural Subsurface Drainage Systems Using Unmanned Aerial Vehicle Imagery and Ground Penetrating Radar [†]

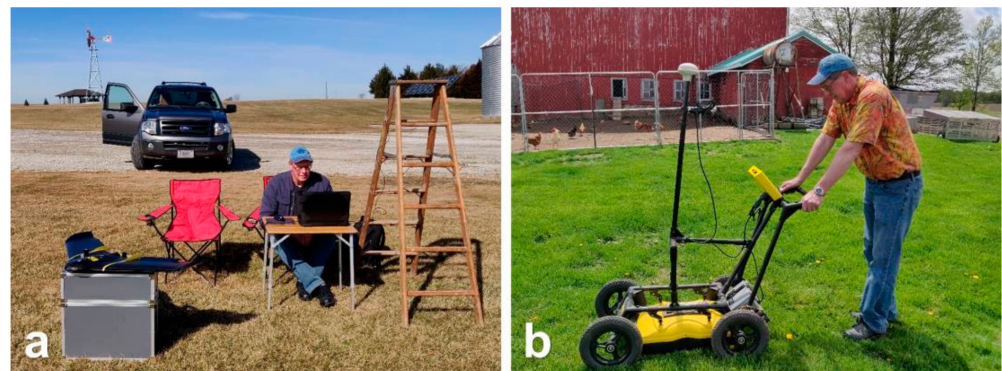
Figure 4. Equipment used in the investigation: (a) fixed-wing UAV, ladder with ground modem antenna, and computer, (b) SmartCart Noggin GPR system (250 MHz antennas).

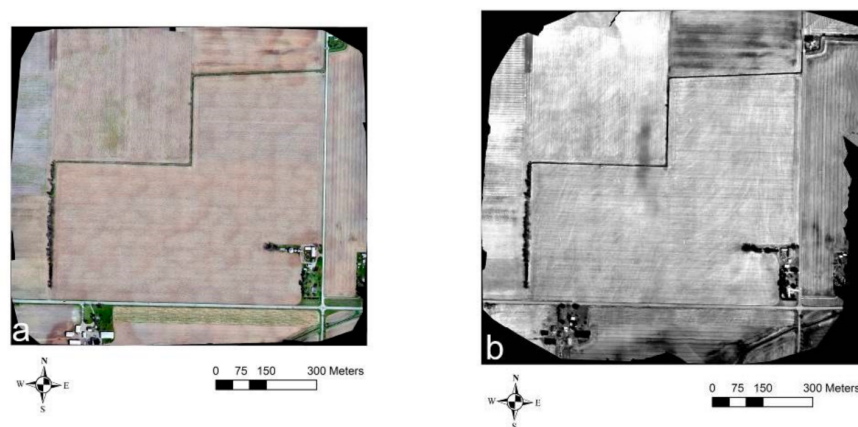
Figure 9. Site-3 UAV survey results from 7 May 2018: (a) VIS-C and (b) TIR orthomosaic imagery.

At Site-3 (Figure 15c), prior to the recent UAV flights with an established soybean crop, none of the UAV imagery captured on bare soil (Figure 9) or the historical Google Earth imagery (Figure 13c) was able to detect the drainage pipe signature or provide any hints that the field is potentially drained. Only the more recent UAV flights performed on an established soybean crop showed subtle signatures of drainage pipes as differences in crop development (Figure 8). Again, a few regions of interest were pointed out. Here, the use of parallel (Region-1), spiral, and serpentine (Regions-2 and -3) transects was helpful to validate that the field is drained and to determine the location and orientation of the drainage pipes. As an example, Figure 14c shows a GPR profile from Region-2 where closely spaced hyperbolic patterns were observed due to the serpentine transects employed. Here, as well, the hyperbolic responses were caused due to crossing the same drainage pipe multiple times. Moreover, the use of parallel transects also provided a general idea of the drainage network pattern and orientation at this specific site. Hence, at Site-3, based on the UAV imagery on bare soil (Figure 9) only, a possible misinterpretation could lead to the conclusion that this field is potentially undrained. Employing GPR in combination was helpful to both locate and validate the presence of the drainage pipes and retrieve their depth information, and, additionally, here, it provided an estimation of the drainage network pattern.

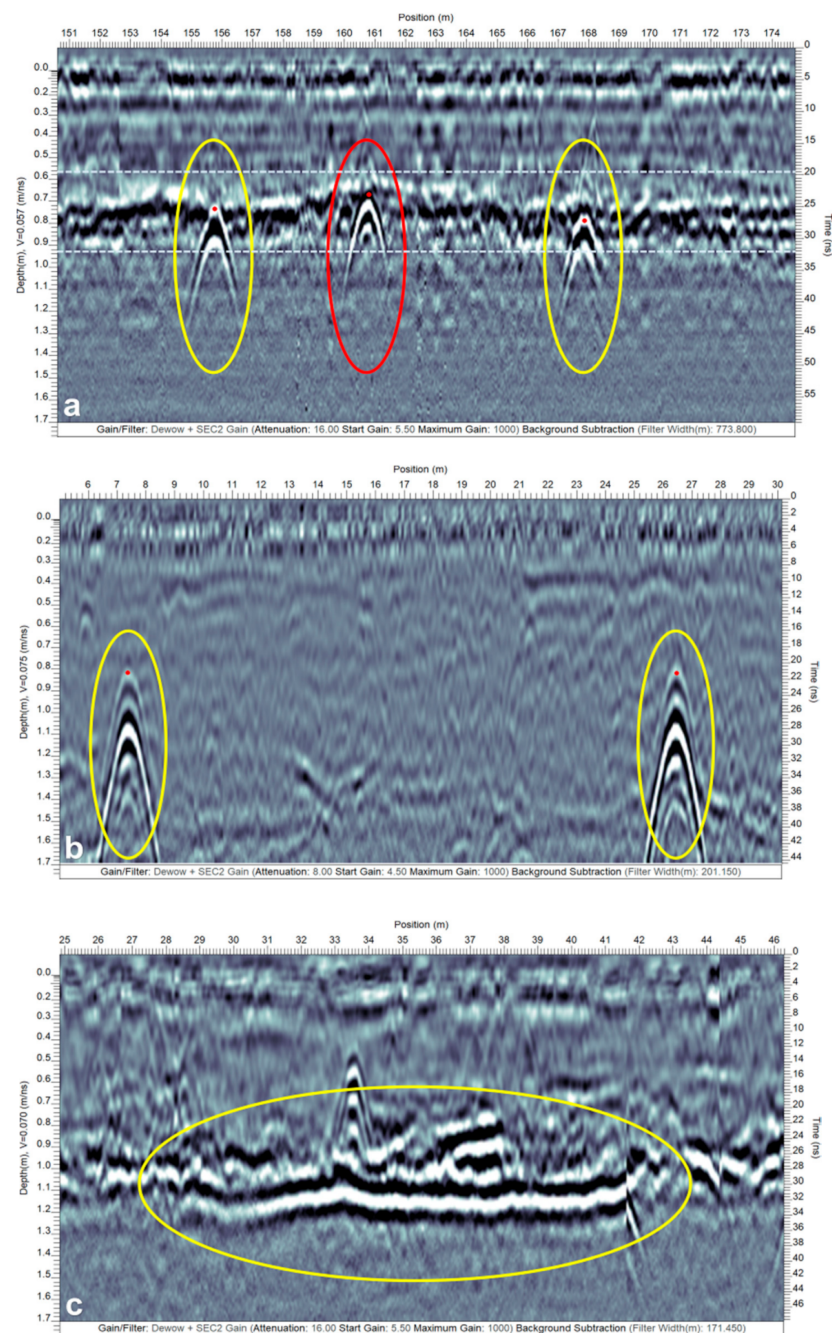
Figure 11. Drainage pipe response on the GPR profiles: (a,b) single (yellow and red) and dual (yellow) reflection hyperbolas result when the GPR traverse is perpendicular to the drainage pipe orientation (from Sites-1 and -3, respectively), and (c) banded linear feature (yellow) results when the GPR traverse is over the top and along the trend of the drainage pipe (from Site-2). In (a), the strong reflections from the water table due to a high RDP contrast are highlighted within the light blue dashed lines. Note that the red dots correspond to the actual location or top of the drain lines.

In relation to the drainage pipes, the hyperbolas are horizontally compressed when the angle is closer to 90° and become horizontally spread out as the angle deviates from 90° and is closer to 15° [26]. Moreover, a single hyperbolic response is observed when the drainage pipe is filled with air or only partially filled with water (Figure 11a), whereas a dual hyperbolic response results from an undrained drainage pipe completely filled with water as the GPR wave travels nine times slower (Figure 11b) [16,50]. In case the latter response is observed, it is possible to estimate the drainage pipe diameter, and the bottom hyperbolic response is usually stronger than the top (see Figure 11b). This is because less energy is reflected from the soil–water interface when the GPR wave interferes with the top of the drainage pipe compared to the water–soil interface when the wave exits from the bottom of the drainage pipe [16]. Technically speaking, the response from dual to single hyperbolas is gradational as the drainage pipe transitions from being completely water-filled to air-filled. Yet, this gradation is often impossible to track for the typical drainage pipe diameters (i.e., 50–100 mm for the laterals) both due to weaker reflections from the top of the pipe and constructive interference between the reflections from the top and bottom of the pipe given an insufficient time gap. This reasoning causes partially water-filled drainage pipes to often generate a single hyperbolic response.

Nevertheless, it is still possible to differentiate between the drainage pipes filled with air and those partially filled with water as a polarity flip is observed in the single hyperbolic responses caused by them. In Figure 11a, the hyperbolic response surrounded by a red ellipse is typically expected in case the drainage pipe is filled with air. Contrarily, a reverse polarity (yellow ellipses) is expected when the pipe is partially filled with water. Here, the water table also caused strongly pronounced reflections, as depicted within the interval highlighted by the light blue lines. Furthermore, care should be administered while interpreting the response caused by partially water-filled drainage pipes as a similar response is expected (i.e., the polarity of the EM wave is preserved) in case the pipes are metallic such as the underground utility installations (e.g., power lines). However, since the RDP of metals is infinite, the GPR wave ceases to propagate and results in noise beyond the pipe depth in the GPR vertical profile, thereby providing a means to differentiate them.

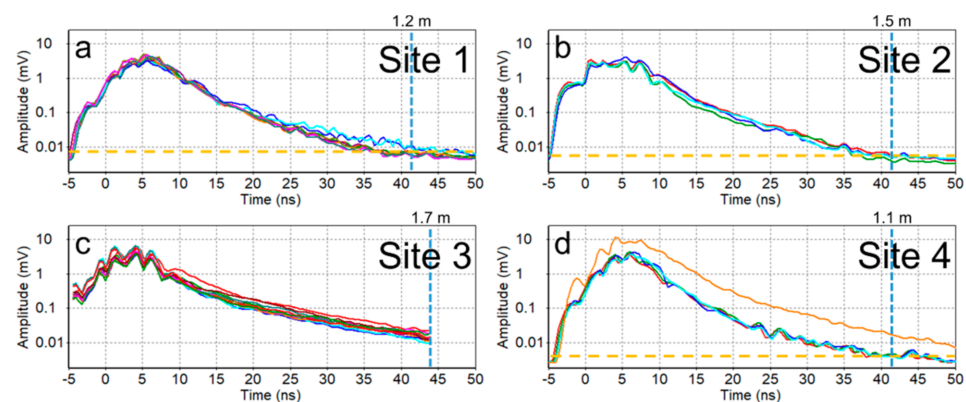
Figure 12. Average trace amplitude plots marked (in blue dashed lines) with approximate GPR signal penetration depths (PDs): (a) Site-1, (b) Site-2, (c) Site-3 (from the recent survey conducted on 10 December 2019), and (d) Site-4. Yellow dashed lines mark the approximate threshold voltage representing the radio frequency noise floor. Note that the PDs expressed in the distance (m) are marked on the top of each sub-figure.

To further explore the GPR PD at different sites, Figure 12 shows the ATA plots derived from the acquired GPR data. Except for Site-3, at the rest of the sites, the ambient radio frequency signal (commonly regarded as the “noise floor”) during the time of the surveys is depicted as yellow dashed lines. The two-way travel time (or depth) at which the GPR signal reaches this noise floor is considered as the PD, which is converted to depth expressed in distance based on the velocity estimates. The GPR PD was shallower (1.1 m) at Site-4 (Figure 12d) in comparison to Sites-1, -2, and -3 (Figure 12a–c). At Site-3, as the time window over which the GPR data were collected was narrower in the old and recent surveys, it was not possible to quantify the GPR PD. However, it can be reasonably assumed to be greater than 1.5 m, i.e., the maximum depth for typical drainage installations. As expected, the GPR PDs (Site-3 > Site-2 > Site-1 > Site-4) varied in the same order as the observed GPR wave velocities (Site-3 > Site-2 > Site-1 > Site-4) at the four sites. This can

be attributed to an increase in the soil EC (in turn, the GPR signal attenuation) with the water content (i.e., inversely proportional to the GPR wave velocity) as the soil texture and water content are the predominant factors that control the soil EC in non-saline soils [72,73]. Hence, based on the ATA plots alone, we can expect greater success in drain line mapping at Site-3 (Figure 12c) and the least success at Site-4 (Figure 12d). Moreover, as can be seen in Figure 12d, the orange average trace of a line of the lineset at Site-4 outliers the rest of the average traces. This was a line collected across the railway crossing (highlighted by the brown dashed line in Figure 10c). Hence, the data were noisy due to interference with the railway installations (see Supplementary Material Figure S1). This further illustrates the importance of ATA plots for a comprehensive understanding of the collected GPR data.

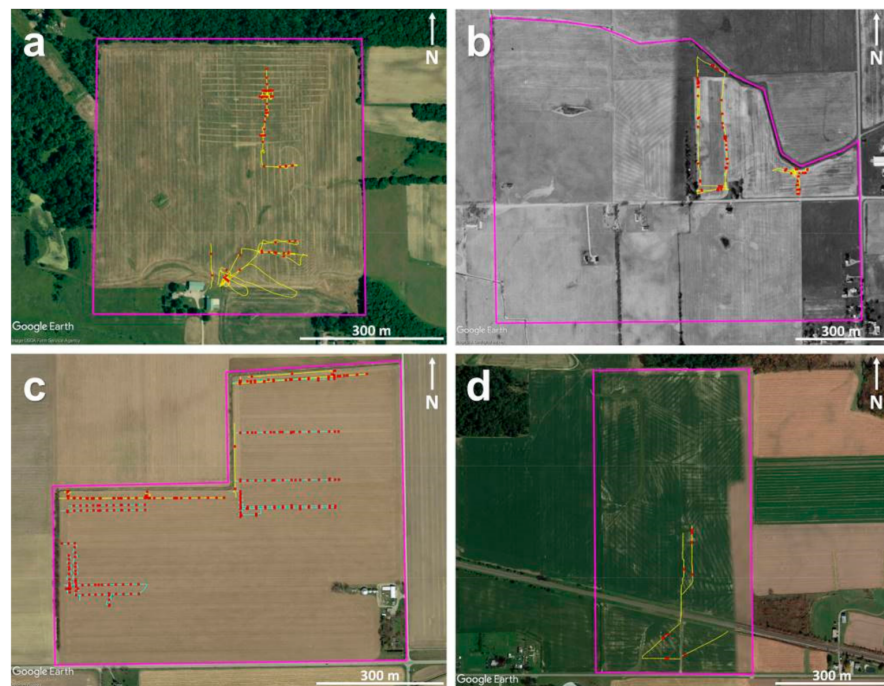
Figure 13. Potential drainage pipe locations marked (with red dots) on the GPR survey transects (yellow and cyan) overlaid on the Google Earth aerial images (same as in Figure 2): (a) Site-1, (b) Site-2, (c) Site-3, and (d) Site-4.

Figure 13 shows the potential drainage pipe locations (marked with red dots) on the GPR transects where hyperbolic signatures were detected at the four sites. A total of 81 locations were identified at Site-1 (Figure 13a), 104 locations at Site-2 (Figure 13b), 90 and 194 locations, respectively, in the preliminary and recent surveys at Site-3 (Figure 13c), and only 12 locations at Site-4 (Figure 13d). This was consistent with assumptions made earlier based on the ATA plots, more specifically, the observed PDs at the different sites. Although there were a few locations where the GPR traverse was exactly over the top and along the trend of the drain line by chance, these locations where corresponding banded linear features were observed in the GPR profiles were not marked in the figure. This is because it is fairly uncommon without any prior knowledge of drain line locations to traverse exactly on top and along the trend of a drain line while surveying large farm field areas.

Figure 13a shows that most of the potential drainage pipe locations marked on the GPR transects at Site-1 overlie exactly on the top of the drain line features visible in the Google Earth imagery. A slight offset was observed at a few locations and can be associated with the positional accuracy of the Google Earth imagery or the GNSS receiver used accompanying the GPR surveys. The marked points followed a line in the spiral, serpentine, and randomly fashioned transects used when the drainage pipe signature was ambiguous in the real-time GPR cross-section view on the DVL. The use of these transects clearly identified that the signature was actually caused due to a drainage pipe and, at the same time, assisted to determine its orientation. A few solitary locations were also identified as potential drainage pipe locations in the random transects to the southern part of the field. However, it was difficult to demarcate if this signature was caused by drainage pipes (or remnants) or other solitary objects in the soil. Moreover, GPR was also successful in finding the locations of drainage pipes to the southeastern part of the field that were

At Site-2 (Figure 13b), drainage pipe signatures were not visible on the Google Earth imagery where the GPR transects were measured. Therefore, it was difficult to ascertain if the marked locations represent actual drainage pipes. Nevertheless, similar to Site-1, there were locations where the marked points form a line on the spiral, serpentine, and randomly fashioned transects, showcasing the potential locations and the trend of the drainage pipes. Again, the locations where a solitary response was observed can either be due to a drainage pipe or any unknown object. However, based on the GPR data alone, it can be reasonably assumed that also this part of the field is subsurface drained.

At Site-3 (Figure 13c), the preliminary surveys conducted along the edge of the field revealed that this field might as well be subsurface drained. The recent surveys at this site focusing on measuring along parallel transects as well as using spiral and serpentine transects indeed confirmed this supposition, as many pipe-like responses were recorded by GPR. Similar to spiral and serpentine transects, parallel transects spaced few meters apart were also helpful to ascertain if the response was caused due to drainage pipes and to determine their orientation. Moreover, parallel transects spaced a few meters apart also allowed the determination of the drainage network pattern and orientation without the necessity of performing a dense GPR transect grid over the field. This was similar to the approach proposed by Allred et al. [26] while surveying large farm field areas. As can be seen in Figure 13c, the drain lines at Site-3 trend in a north–south orientation, and the drainage network pattern might as well be parallel (Figure 1a).

At Site-4 (Figure 13d), the few potential drainage pipe locations identified and marked on the GPR transects closely matched with the drainage pipe features visible on the Google Earth imagery. However, at some places, the marked locations were very close spatially and the hyperbolic responses were identified at different depths (Figure 14a), which can be due to co-existing drainage pipes overlying on one another that date back to two different installation periods.

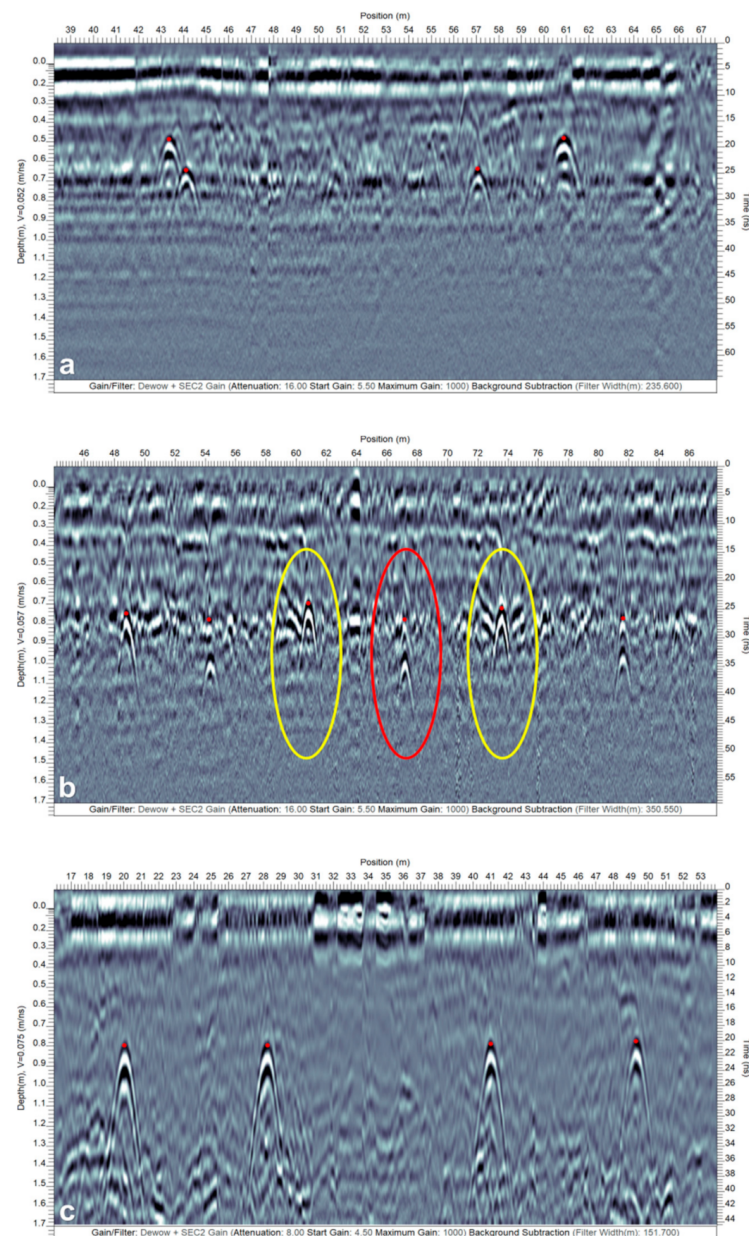
Figure 14. Drainage pipe response on the GPR vertical profile depicting closely spaced hyperbolic features from two different depths at: (a) Site-4 (from Region-2 of Figure 15d), potentially caused due to drainage pipes from different generations of installations, (b) Site-1 (from Region-1 of Figure 15a), caused due to the same drainage pipe probably with undrained water, but the first hyperbolic response being very weak in some instances obscures its visibility. Note that the latter profile can potentially be misinterpreted as a response caused due to two co-existing drainage pipes at different depths. (c) depicts the drainage pipe response from Site-3 (from Region-2 of Figure 15c). Here, the closely spaced hyperbolic features at a similar depth are caused due to the spiral and serpentine transects employed.

interesting regions marked. Regions-1 and -2 show examples of the spiral and random transects used to confirm if the linear features were related to buried drainage pipes as well as reaffirming their orientation. The GPR profile (Figure 14b) from Region-1 at Site-1 (Figure 15a) looked as if the signature was actually caused by two drainage pipes located at two different depths (i.e., at 0.75 and 1.0 m), which, if visible in the UAV imagery, might only produce a single linear feature. Again, this can happen when the drainage pipe systems from different generations are spatially overlaid on the top of one another or not too far apart. This might mislead to an indefinite conclusion based on the UAV imagery alone. However, here, a closer look into the GPR profile (Figure 14b) revealed that the signature was actually caused due to the same drainage pipe probably with undrained water; i.e., a dual hyperbolic response was observed at some locations. On the contrary to Region-1 at Site-1, a drainage pipe response at similar depths was observed on the GPR profile from Region-2 (Figure 15a). Here, as well, the hyperbolic responses were spatially not too far apart (similar to Figure 14c) and were generated due to crossing the same drainage pipe multiple times in a spiral fashion. Note that this should not be mistaken as a response caused due to several closely spaced drain lines. Region-3 at Site-1 (Figure 15a) was located to the southern part of the field where the drain line signature, though visible in the Google Earth imagery (Figure 13a) as well as the contractor's plan (Figure 3a), was faded off in the UAV imagery (Figure 5). Hence, at Site-1, based on the UAV imagery alone, only some of the known existing drainage pipes were mapped. Here, the GPR survey assisted both as a mapping and validation technique, providing the depth information of the drainage pipes.

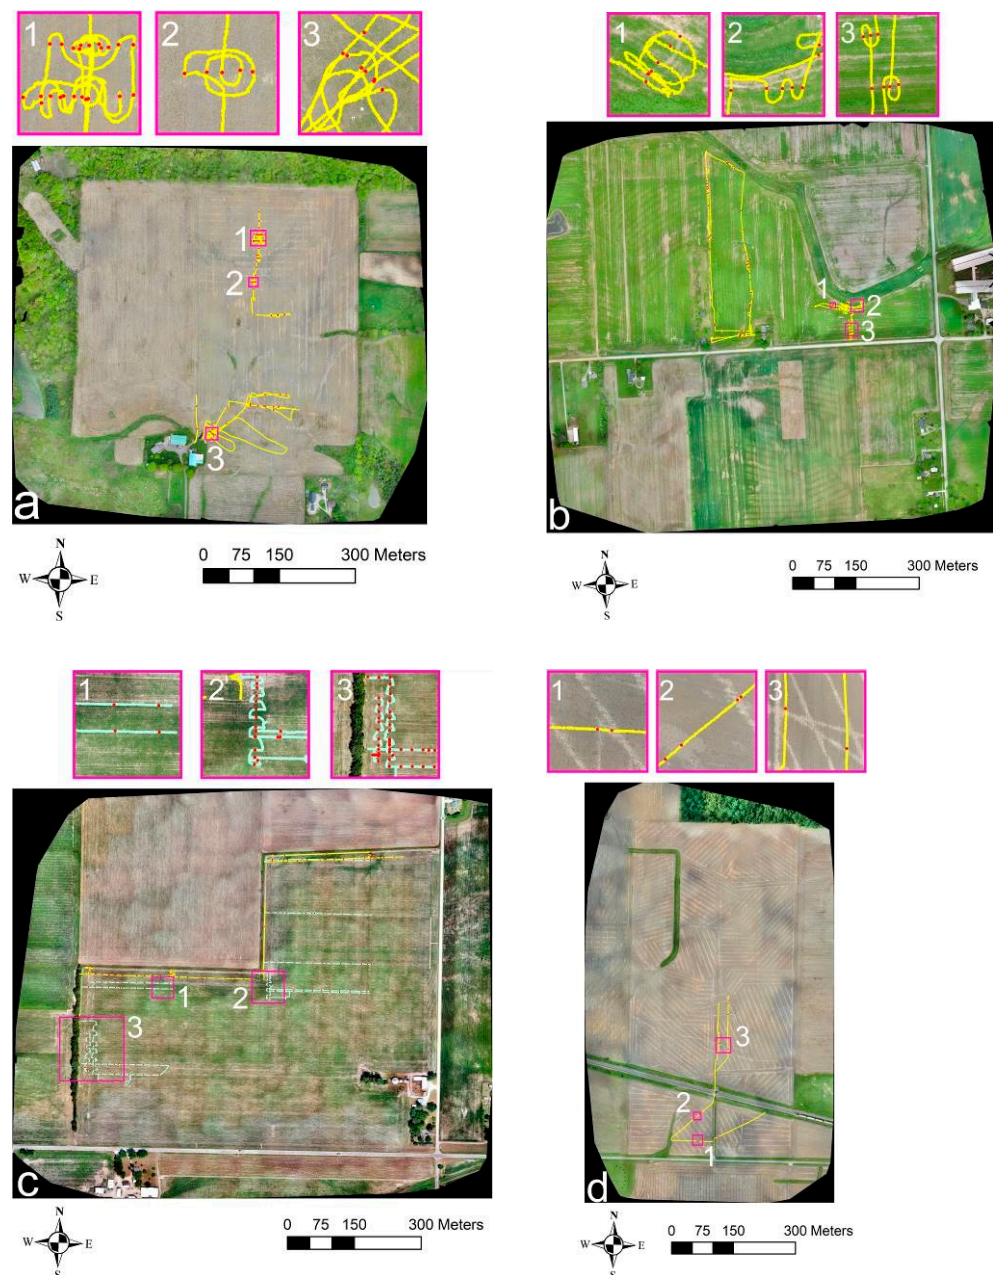
Figure 15. Potential drainage pipe locations marked (with red dots) on the GPR survey transects (yellow and cyan) overlaid on UAV VIS-C orthomosaic imagery: (a) Site-1, (b) Site-2, (c) Site-3, and (d) Site-4. The pink boundaries mark the regions of interest.

At Site-2 (Figure 15b), the GPR transects were overlaid on the recent UAV imagery and, again, a few interesting regions were pointed out. Regions-1, -2, and -3 were located to the eastern part of the field north of the road where the drainage pipes were not visible either in the historical Google Earth imagery (Figure 13b) or in both the UAV surveys (Figures 6 and 7) carried out at this site. Here, the use of spiral, serpentine, and random transects was helpful to delineate the drain line locations and to discern their orientation. Hence, at Site-2, GPR proved suitable as a mapping technique to the central and eastern parts of the field where the recently captured UAV imagery failed and additionally provided the depth information of the drainage pipes.

At Site-4 (Figure 15d), though the timing was crucial, the UAV imagery worked very well in discerning the drainage pipe locations, while GPR failed due to its limited PD. Here, performing a GPR survey on moderately dry soil might provide better results. Again, a few regions of interest were marked on the figure. While the locations marked on the GPR transects exactly overlies the drain lines' signature visible on the UAV imagery at Regions-1 and -3, interestingly, multiple closely spaced hyperbolic responses at two different depths (see Figure 14a) were observed from Region-2 (Figure 15d). As discussed earlier, this might be because of spatially co-existing drain lines from different generations of installation. Hence, at Site-4, the UAV imagery was mostly successful in finding the drain lines and only a few drainage pipe responses were recorded by GPR.
