# Failure behavior of nylon products for red phosphorus flame retardant electrical connectors

The failure behavior of red phosphorus flame retardant electrical connectors was investigated by their thermal degradation, changes of surface morphology and elements under an accelerating environmental experiment. The results showed that the nylon electrical connector degraded and cracks were generated on the surface. The temperature of maximum weight loss rate was advanced in the thermogravimetric analysis and the third weight loss peaks appeared after 28 days. The relative atomic content of O and P increased from 0 day to 28 days. The chemical environment of C changed. Partially, C–C bonds broke and became C–O bonds. The release of phosphine increased and this further oxidized to an acid with P=O and P–O groups in a warm and humid environment.

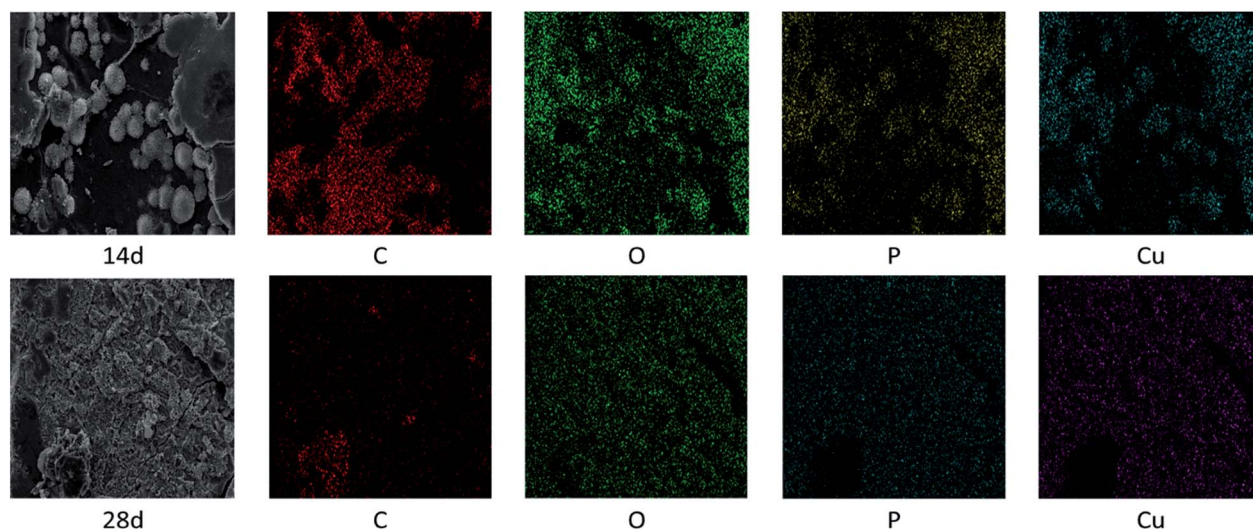
Fig. 6 and Table 2 exhibits the evolution of the elemental dispersion on the surface of connectors. As showed in Fig. 5, the spherical substance was mainly composed of P, O, and Cu elements. The elemental content given in Table 2 indicated that the substance was increasing over time. Phosphorus could not be detected on the surface at the beginning and after 7 days until the globular substance containing phosphorus was formed. With the time increase, the concentration gradient of phosphorus was produced from inside to surface. At the same time, the content of oxygen increased. It proved that phosphorus reacted with water and air to form phosphoric acid through these cracks in the high temperature and humidity environment and the phosphoric acid corroded the copper sheet attached to the connectors to form copper phosphate species on the surface.

Fig. 6 EDS images of connectors tested for 14 d and 28 d.

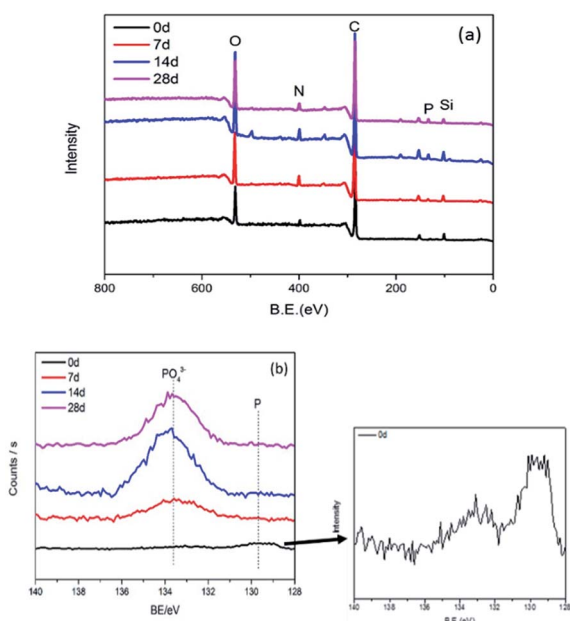
**X-ray photoelectron energy spectrum analysis.** XPS spectrum of survey scan for connectors is exhibited in Fig. 7 and elemental content of connectors tested for different days is showed in Table 3. The intensity of carbon and oxygen is very strong with traces of N and Si existing. Nevertheless, the signal intensity of phosphorus is very low.

The P 2p high-resolution spectra of connectors are exhibited in Fig. 7. There are two main peaks, 129.4 eV corresponding to red phosphorus; 133.4 eV corresponding to phosphate anion.<sup>24</sup> The presence of these peaks affirms that red phosphorus was

Fig. 7 Wide-scan (a) and P 2p high-resolution (b) XPS spectra for connectors.

oxidized to phosphate. The intensities of peaks increases gradually and reaches a stable state, confirming that phosphate concentration increased with test prolonging, especially in the first 14 days.

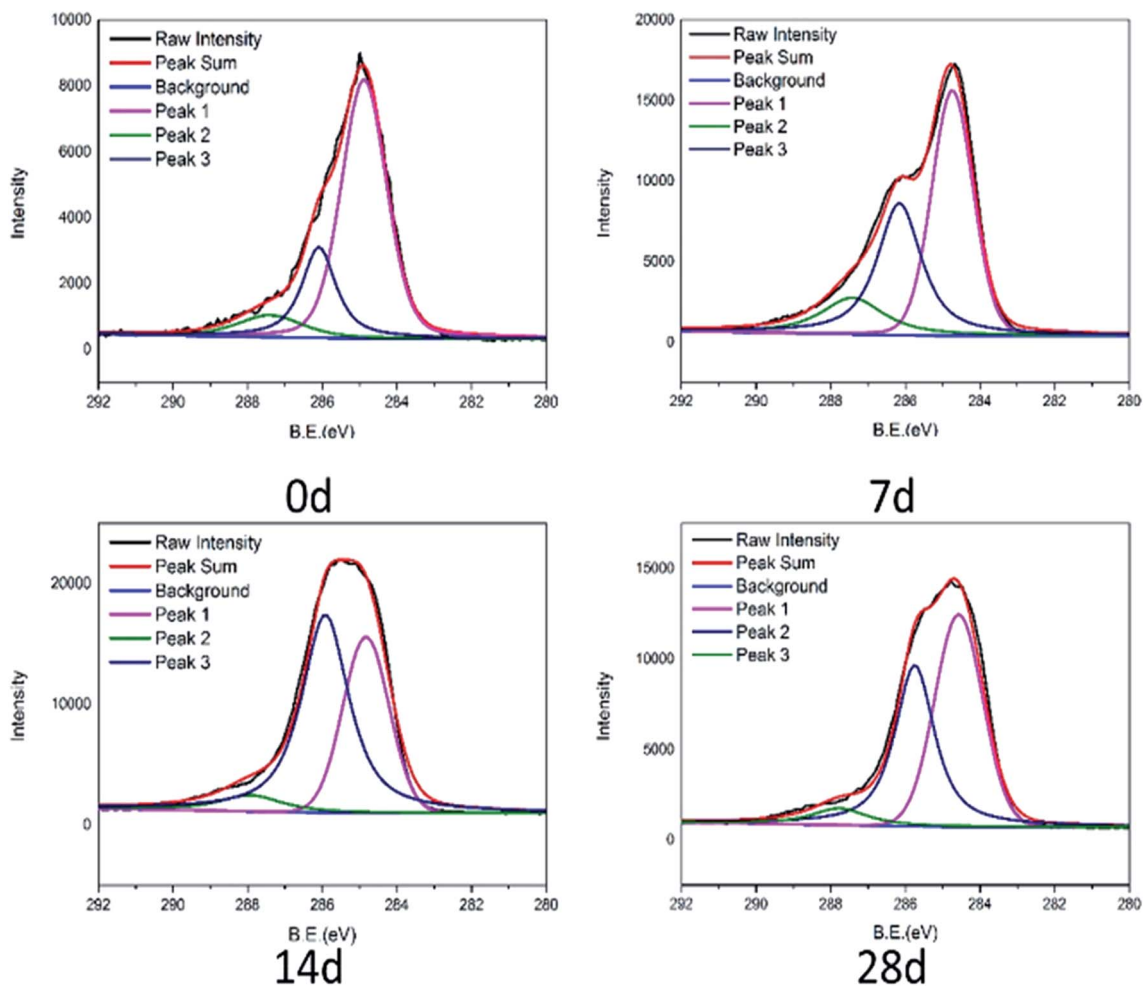
The C 1s spectra of tested connectors are fitted into three peaks to know the types of functional groups of PA66 from connectors in Fig. 8. The three peaks centered at 284.6 eV corresponding to C–C; 286.0–286.3 eV corresponding to C–O; 287.5–287.7 eV corresponding to C=O.<sup>25</sup> While compared with the C 1s of the initial product, the intensity of the carbon–oxygen bond significantly increased. It is expected that PA66 was degraded and carbon–carbon bonds partially were broken,

Fig. 8 C 1s high-resolution XPS element spectra of connectors.

oxidized to carbon–oxygen bonds. The degradation of PA66 is a complicated process, mainly involving not only the hydrolysis of amide bonds, but also the breakage of molecular chains, accompanied by the formation of various small molecular compounds. The carbon–carbon bond is broken further, accelerating oxidization to cause the rise of the carbon–oxygen bond. This would generate cracks and further reduce the thermal stability of the connector, making it flammability.<sup>26</sup>
