# Potential tree species for use in urban areas in temperate and oceanic climates

Miklas Scholz<sup>a,b,\*</sup>, Vincent C. Uzomah<sup>b</sup>, Furat A.M. Al-Faraj<sup>b</sup>

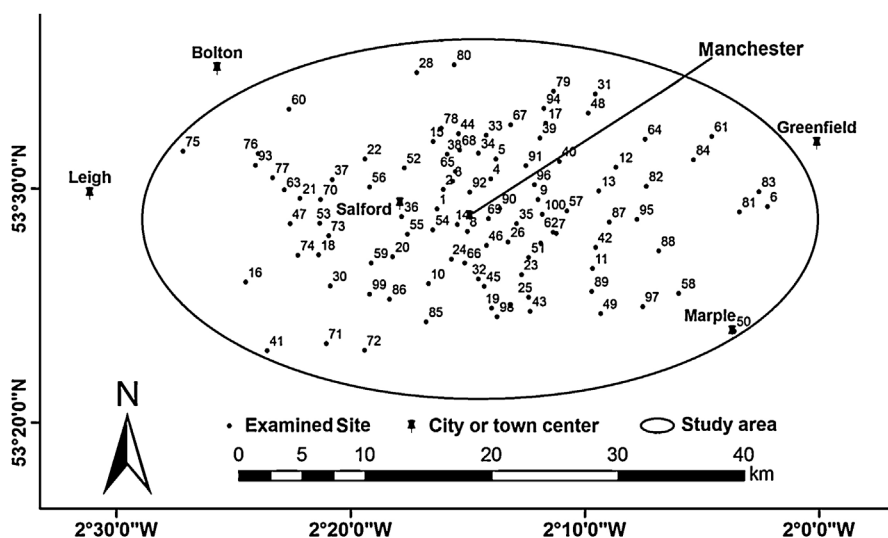
Fig. 1. Overview of the assessed case study sites located in the Greater Manchester area.

*Acer platanoides* occurred the most frequently (17%) among other trees that were found in this survey (Fig. 1). Furthermore, *A. platanoides* caused the most severe damage to structures (Table 2 and Table 3). The damage done to structures by *A. platanoides* did not follow any particular pattern. In this survey, 38 out of 73 (52%) *A. platanoides* caused damage to various structures (Table 2). About 35% of all *A. platanoides* planted close to permeable pavements with an average DBH of 56 cm and an average distance of 0.75 m from the permeable pavements caused severe to moderate damage to the pavement structures. This average DBH represents maturing *A. platanoides*.

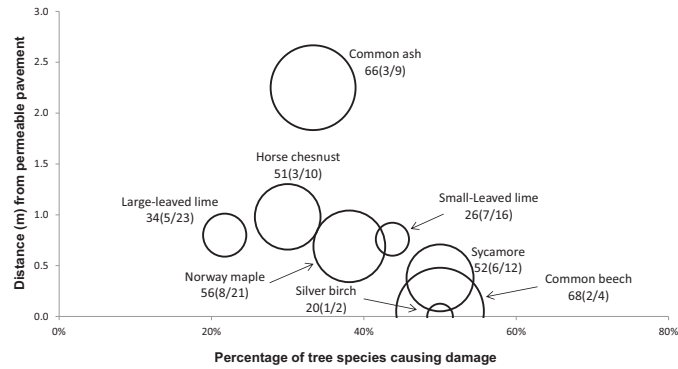
**Fig. 2.** Relationships of tree diameters at breast height (DBH (cm); represented by circles), average distances of trees away from permeable pavements, and the proportion of trees within 10 m to these structures subjected to moderate to severe damage. Note:  $x(y/z)$ , where  $x$  represents DBH and  $z$  indicates the number of the tree species out of which  $y$  trees caused damage.

Fig. 2, Fig. 3, Fig. 4, Fig. 5, Fig. 6, Fig. 7, Fig. 8 show the relationship of tree DBH, average distance of trees away from the structures, and the proportion of trees close to structures that caused moderate to severe damage. Note that only moderate and severe damage was considered, considering that the reason for light damage is often unclear. Apart from tree-related damage, other reasons for damage might be as important but only further destructive tests on site might reveal the main reason(s) for damage.

For  $x(y/z)$ , where  $x$  represents the DBH (cm), which is also signified by the relative size (diameter) of the circle. The diameters expressed by circles give a visual indication of the maturity of the average tree species, which makes visual comparisons between trees easier. The entry  $z$  indicates the number of the tree species within 10 m of the structure, out of which  $y$  trees caused moderate to severe damage.

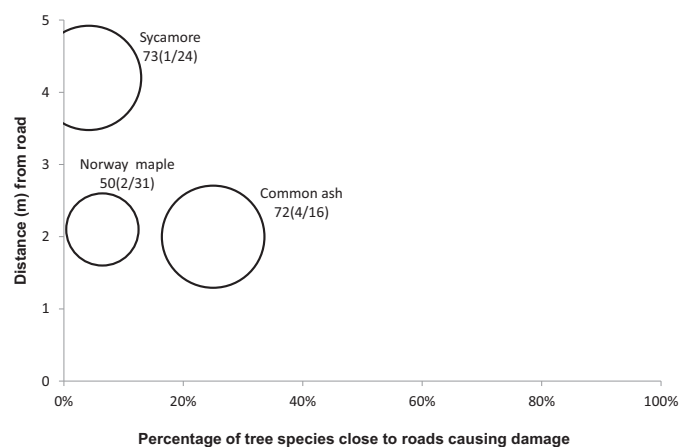
**Fig. 5.** Relationships of tree diameters at breast height (DBH (cm); represented by circles), average distances of trees away from roads, and the proportion of trees within 10 m to these structures subjected to moderate to severe damage. Note:  $x(y/z)$ , where  $x$  represents DBH and  $z$  indicates the number of the tree species out of which  $y$  trees caused damage.

The percentages of damage to roads and retaining walls were 3% each. Only three trees (*F. excelsior*, *A. platanoides* and *A. pseudoplatanus*) caused moderate to severe damage to roads (Fig. 5). Trees that caused damage to roads were located within an average distance of 2–5 m away from roads, indicating that the majority of them were planted close to the pavements.

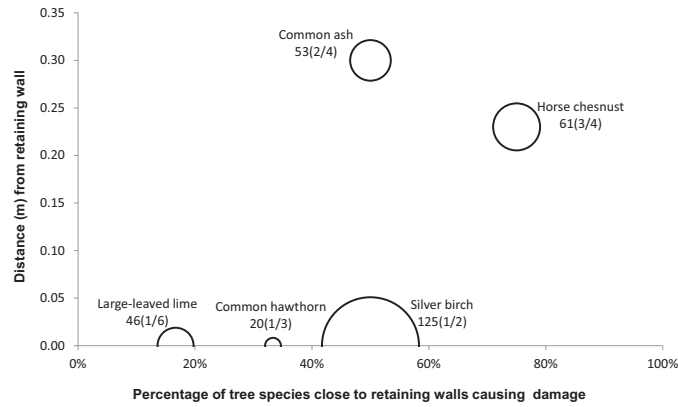
**Fig. 6.** Relationships of tree diameters at breast height (DBH (cm)); represented by circles), average distances of trees away from retaining walls, and the proportion of trees within 10 m to these structures subjected to moderate to severe damage. Note: x(y/z), where x represents DBH and z indicates the number of the tree species out of which y trees caused damage.

Not many trees were found close to retaining walls. For *B. pendula* with a DBH of 125 cm and planted at an average distance to structures of close to 0 m, only 1 out of 2 trees caused moderate to severe damage (Fig. 6). *Aesculus hippocastanum*

caused the most damage to retaining walls. Three out of four *A. hippocastanum* with an average DBH of 61 cm and located at a mean distance of 0.25 m away caused moderate to severe damage to retaining walls (Fig. 6).

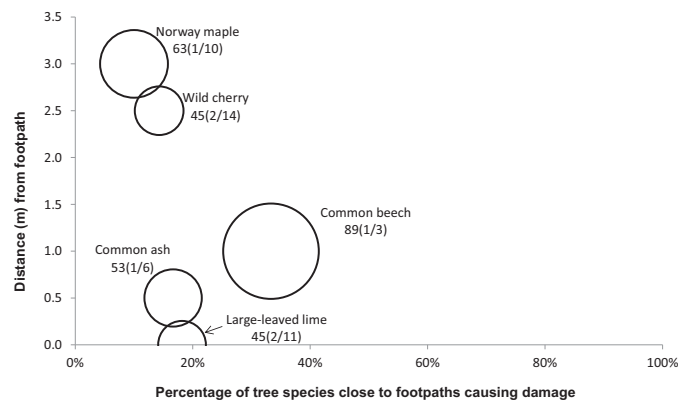
**Fig. 7.** Relationships of tree diameters at breast height (DBH (cm)); represented by circles), average distances of trees away from footpaths, and the proportion of trees within 10 m to these structures subjected to moderate to severe damage. Note: x(y/z), where x represents DBH and z indicates the number of the tree species out of which y trees caused damage.

Concerning *T. platyphyllos*, most trees that caused damage to urban structures (for example, impermeable pavements, retaining walls and footpaths) were very closely located to these structures compared to other trees (Fig. 4, Fig. 6, Fig. 7). Based on the survey, there was no record of severe to moderate damage by *T. platyphyllos* to some structures such as roads and walls. About 20% of the *T. platyphyllos* planted close to permeable pavements caused severe and moderate damage to permeable pavements from an average distance of 0.7 m. The average DBH of *T. platyphyllos* that caused damage were 34 cm. *Tilia platyphyllos* of this diameter were considered as still being in their growing stage (Table 1). The older these trees become, the more severe the damage would be.
