Urology Case Reports

Low power HOLEP after failed urolift: A case report using 50 Watt laser

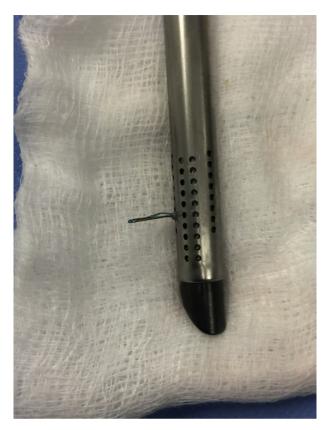
Fig. 1. Urolift implant caught in the irrigation holes of the outer sheath of the resectoscope.

Enucleation time was 80 minutes, with a respectable rate of enucleation of 0.875 g/min in comparison to standard reported of 1 g/min, and morcellation rate was 4.1 g/min in comparison to standard 5.7 g/min.⁴ We feel this lower rate may have been due to several problems encountered during morcellation, in this case. Firstly, metal implants caused difficulties with retrieval, resulting in recurrent "jamming" of morcellator blades. This problem was overcome by morcellating the adenoma in short bursts resulting in small prostate fragments with implants. Secondly, one small piece of tissue embedded with an implant was unable to be engaged in the morcellator (beach ball effect). To retrieve this expeditiously, and to retrieve isolated implants, we used the Cook NGage® Nitinol Stone Extractor, which conveniently fits down the 5Fr working channel of the Olympus morcellator scope, with excellent vision. Finally, one of the Urolift implants was noted to be caught in edge holes of the resectoscope sheath. This was only identified when the scope was removed at the end of the procedure. A subsequent cystoscopy, immediately afterwards, revealed no urethral injury. As the urethral end piece and capsular tab of the implant is only 8mm, we postulated that the implications of a potential urethral injury would be akin to performing an Otis urethrotomy.⁵

Low power HOLEP using 50 W Auriga XL can be performed safely and effectively in post-urolift patients. However, morcellation of the adenoma tissue may be complicated by the metallic implants. There are some strategies which can be used to try and improve efficiency of morcellation in such cases.
