## Billowing Of Endologix Powerlink Stent Mimicking Endoleaks

**Case Presentation:** A 65-year-old woman who had endovascular aortic repair (EVAR) of an abdominal aortic aneurysm with Endologix Powerlink system developed marked new circumferential cauliflower-like bulging of contrast-filled sacs at mid-stent-graft with enlargement of the excluded aneurysm at 3-year follow-up.

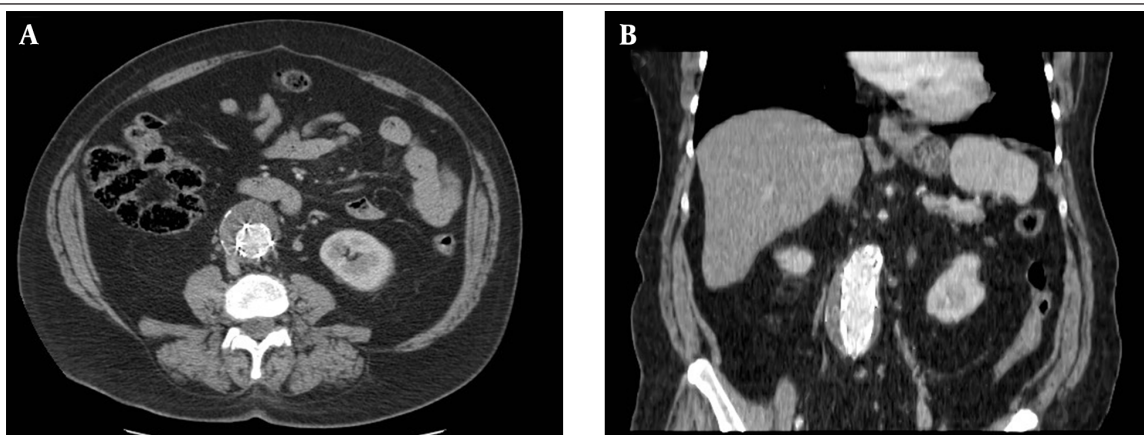
**Figure 1.** A, Axial and B, coronal slices of CTA of the abdomen with contrast at the level of the infrarenal aorta during the immediate post-operative period demonstrate stable and normal appearance of an aortic stentgraft; no evidence of endoleaks, kink or fracture.

An asymptomatic 65-year-old woman with atherosclerosis and an infrarenal AAA extending just superior to the bifurcation with a maximal transverse diameter of  $4.7 \times 4.6$  cm had increased to  $5.1 \times 4.7$  cm at 3-month follow up. The aneurysm neck length was 32 mm and the neck diameter was 23 mm with an angulation of  $56^\circ$ . She had undergone endovascular repair with Powerlink system. The procedure itself was uneventful. The immediate post-operative follow up CTA of the abdomen and pelvis demonstrated a normal appearance of an infrarenal aortoiliac stentgraft (Figure 1) with maximal diameters of  $5.1 \times 4.8$  cm. There was no evidence of endoleak, kinking or fracturing of the graft.

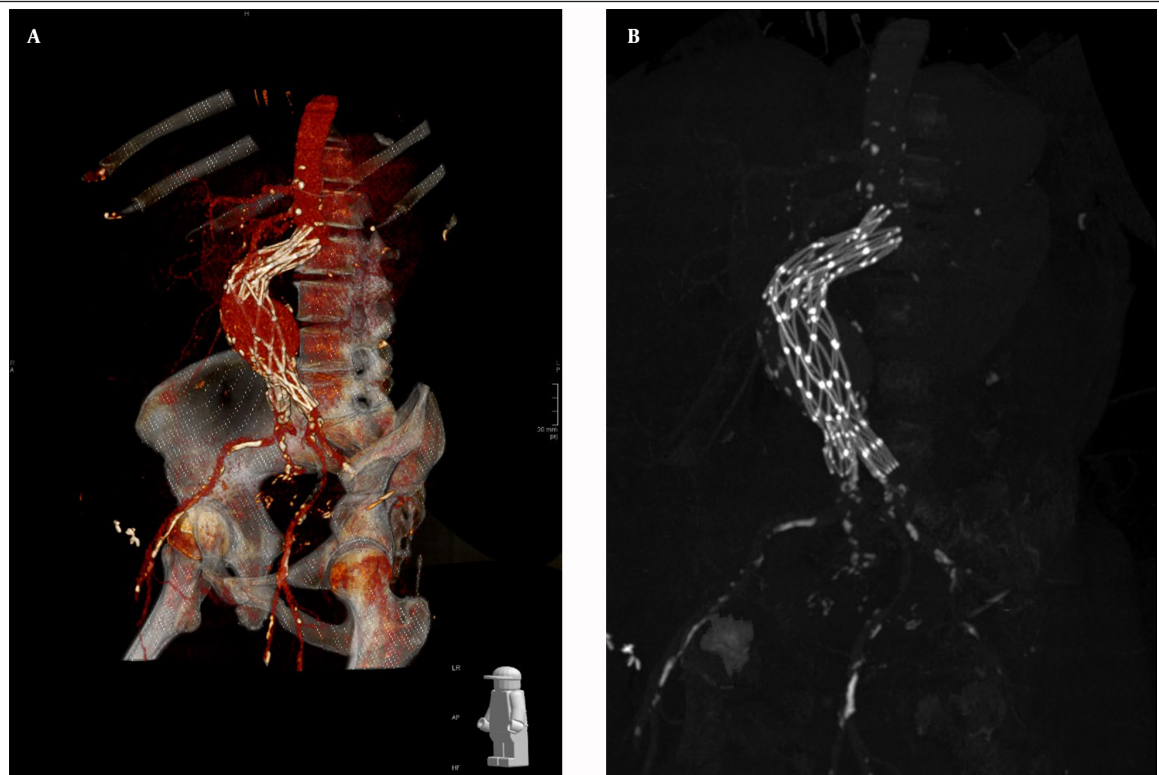
**Figure 3.** A, 3D rendering and B, maximal intensity projection of the Powerlink aortic stentgraft in situ reconstructed from the CTA demonstrate contrast filled sacs about the mid segment of the stentgraft.

struts at mid to distal stentgraft mimicking that of a Type III endoleak (Figure 3). While the outer margins of these bulging sacs extended to the wall of the excluded aneurysm, the bulging sacs were not interconnected. There was no extra stent contrast filling between the sacs. This suggested confined contrast materials within the outer fabric material of the stentgraft with interval increase in size of the excluded aneurysm sac. The patient was asymptomatic and was treated similar to that of an endoleak with endovascular insertion of an overlying stent.
