Entrapped central venous catheter guide wire

DOI: 10.4103/0019-5049.68378

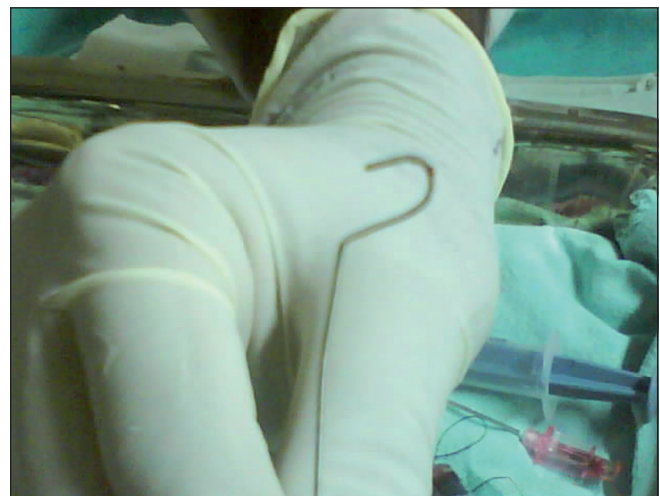
traction the introducer needle slipped and only the guide wire was left in place. We got a portable Chest X-ray done, which revealed that only J-tip of guide wire was stuck. Thus, after excluding guide wire knotting removal of guide wire was attempted again and it came out with gentle traction [Figure 1]. After removal of guide wire local pressure was applied. USG was done to reveal any injury or local haematoma. Gradually, patient improved and was shifted to ward.

Figure 1: Tip of the CVC guide wire after removal

applied. In our case the needle was withdrawn and guide wire pulled thereafter. Probably, the J-tip of guide wire got stuck just underneath the skin. Luckily, in this case guide wire could be easily removed in few attempts of gentle traction; otherwise it would have required surgical exploration.

Here we want to emphasize that even though central venous catheter placement is common, execution of details is imperative. We should be aware of potential entrapment of guide wire during central venous catheterisation. CVCs often are placed by personnel who are in training; closer supervision by more senior person may help identify and prevent similar complications. It is also important that force should never be used to withdraw a guide wire when unexpected resistance is encountered, as this may result in fracture of the wire and damage to the internal structures.
