# MRI for an Acute Secondary Site Complication in Post-arthroplasty Management: Narrative Review of Safety Concerns for an Implanted Hip and Knee Joint

Lavindra Tomar<sup>1</sup>, Gaurav Govil<sup>1</sup>, Pawan Dhawan<sup>1</sup>

Tomar L, Govil G, Dhawan P (February 17, 2022) MRI for an Acute Secondary Site Complication in Post-arthroplasty Management: Narrative Review of Safety Concerns for an Implanted Hip and Knee Joint. Cureus 14(2): e22319. DOI 10.7759/cureus.22319

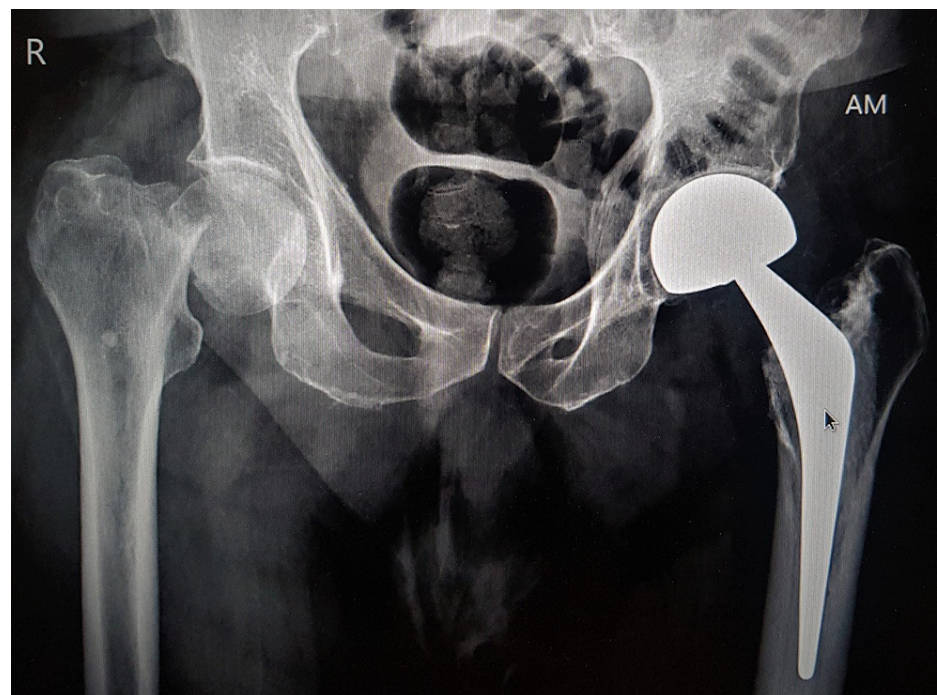
**FIGURE 1: Pelvis radiograph with a right hip fracture of the neck femur and left hip bipolar prosthesis in situ**

An elderly male presented with a slip and fall at home, with an injury to the right hip region. The injury was radiologically confirmed as a displaced fracture neck femur right hip (Figure 1). There was a past history of left hip cemented bipolar arthroplasty eight years ago.

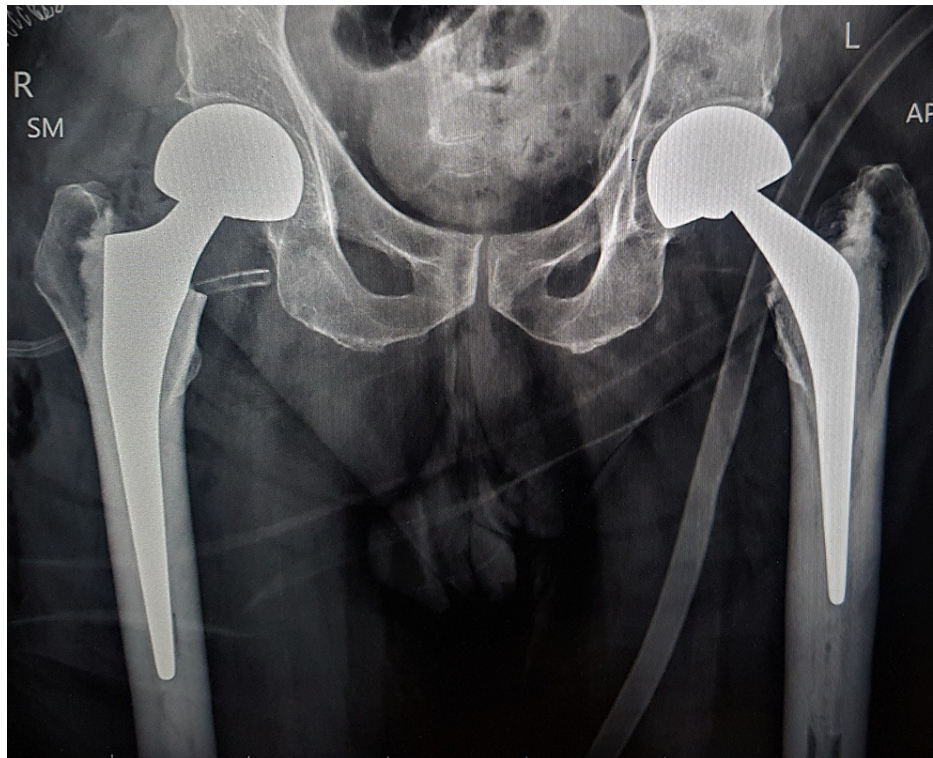
**FIGURE 2: Pelvis radiograph with both hips' bipolar prosthesis in situ**

There was a history of cerebrovascular episodes one year ago, which had recovered and allowed him to ambulate without any support. He underwent neurological assessment by a neurologist in the preoperative assessment. The carotid Doppler was essentially normal. The cardiac evaluation was done by dobutamine stress echocardiography, which was negative for inducible ischemia. Prophylactic thrombo-prophylaxis and the use of compression mechanical devices were initiated in the preoperative period for the prevention of deep vein thrombosis. Right hip cemented modular bipolar hemiarthroplasty was done under regional anesthesia on the third day of the injury (Figure 2).

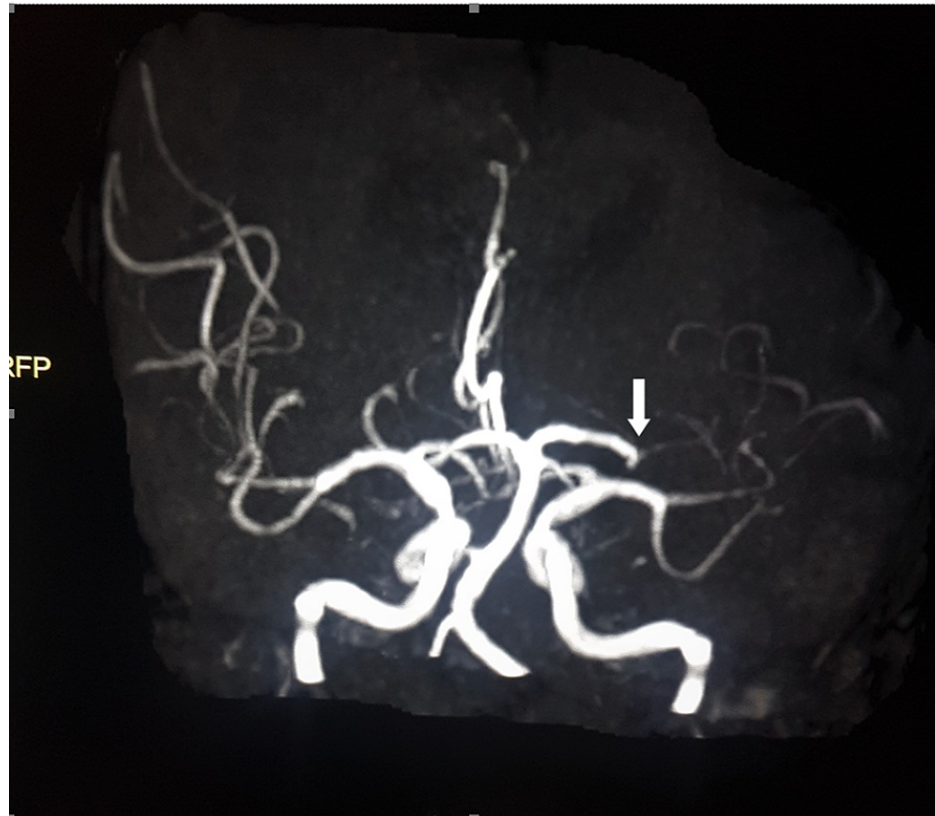
**FIGURE 3: MRI angiogram of the circle of Willis showed occlusion of the left middle cerebral artery (white arrow)**

The dilemma was how to proceed for MRI? We presumed that heating, dislodgement of skin staples, or loosening of the recently implanted hip would be a safety hazard for an MRI. A lead apron was placed along the pelvic area and operated wound site strapped. Post MRI, the local site was re-inspected to assess the displacement of sutures, abnormal wound protuberance, or abnormal skin change locally. Passive range of hip movements was assessed for any deformity, limb length discrepancy, or restriction. No local-site complications were observed. MRI brain revealed an acute left insular infarct. Angiography revealed occlusion with the absence of flow-related enhancement in the left middle cerebral artery territory (Figure 3).

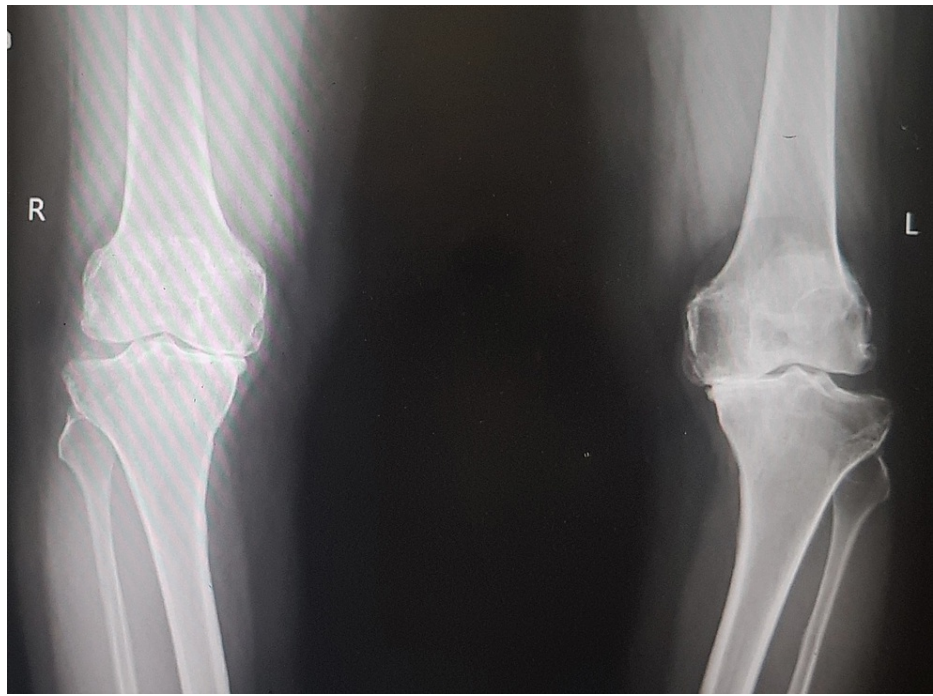
**FIGURE 4: Bilateral knee radiographs (anteroposterior standing view) shows severe osteoarthritis changes**

A 60-year-old female suffering from bilateral osteoarthritis of knees (Figure 4) with a history of associated type 2 diabetes underwent a planned simultaneous total knee arthroplasty under regional anesthesia with combined spinal-epidural medication.

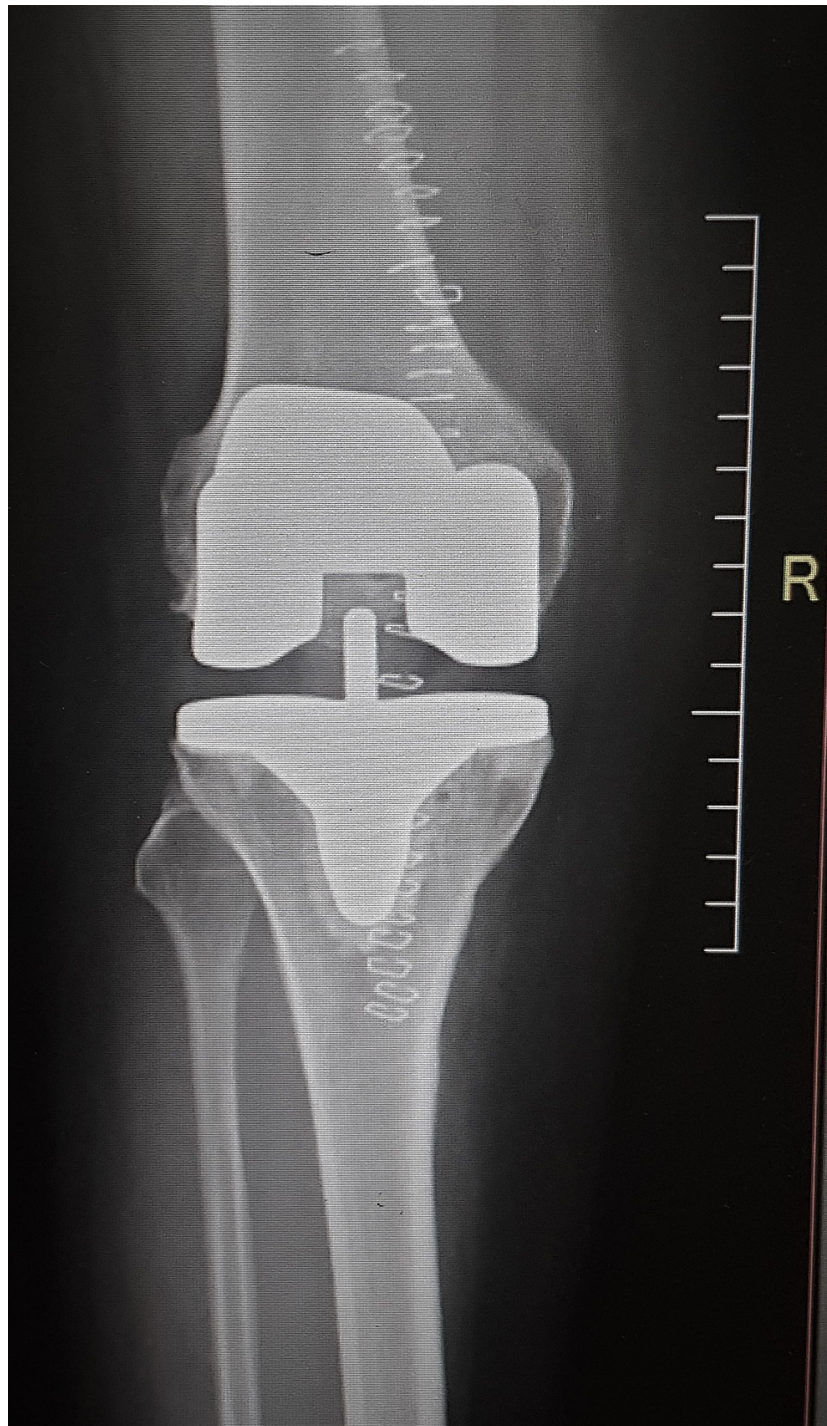
**FIGURE 5: Radiograph of the right knee (anteroposterior view) with a stable implant in the immediate postoperative period**

The immediate postoperative radiographs of the knee showed well-aligned joints (Figures 5-6).

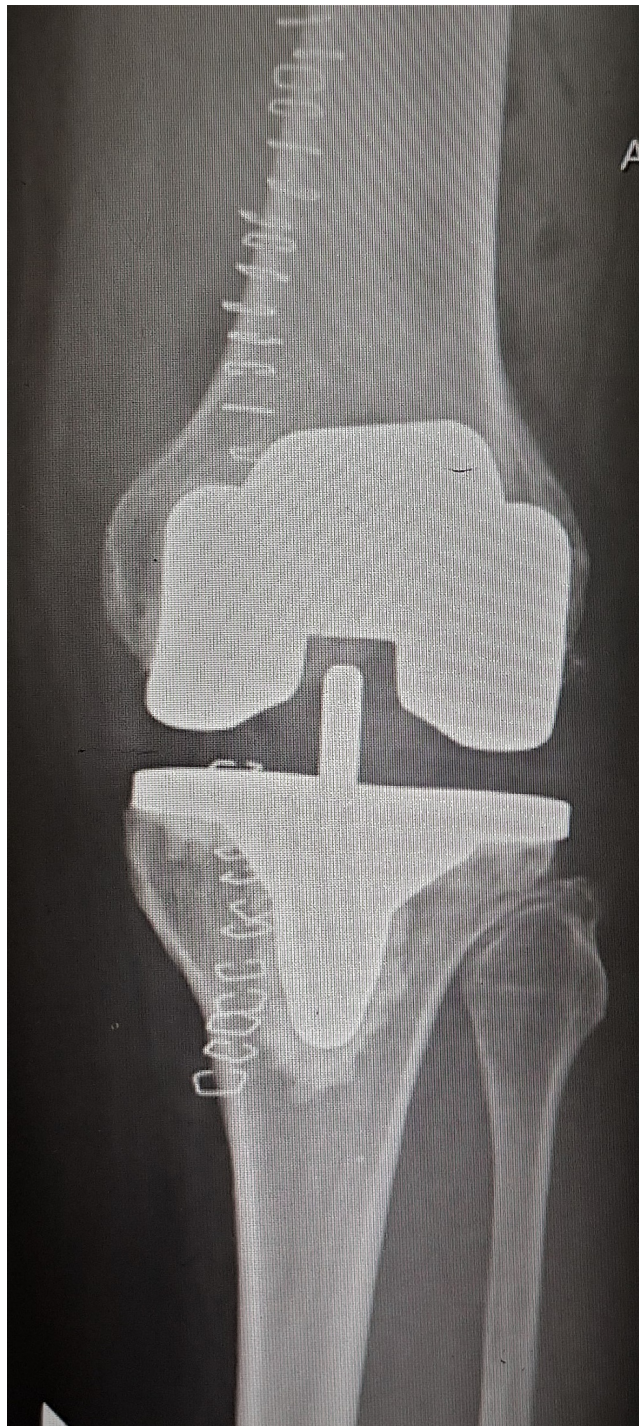
**FIGURE 6: Radiograph of the left knee (anteroposterior view) with a stable implant in the immediate postoperative period**

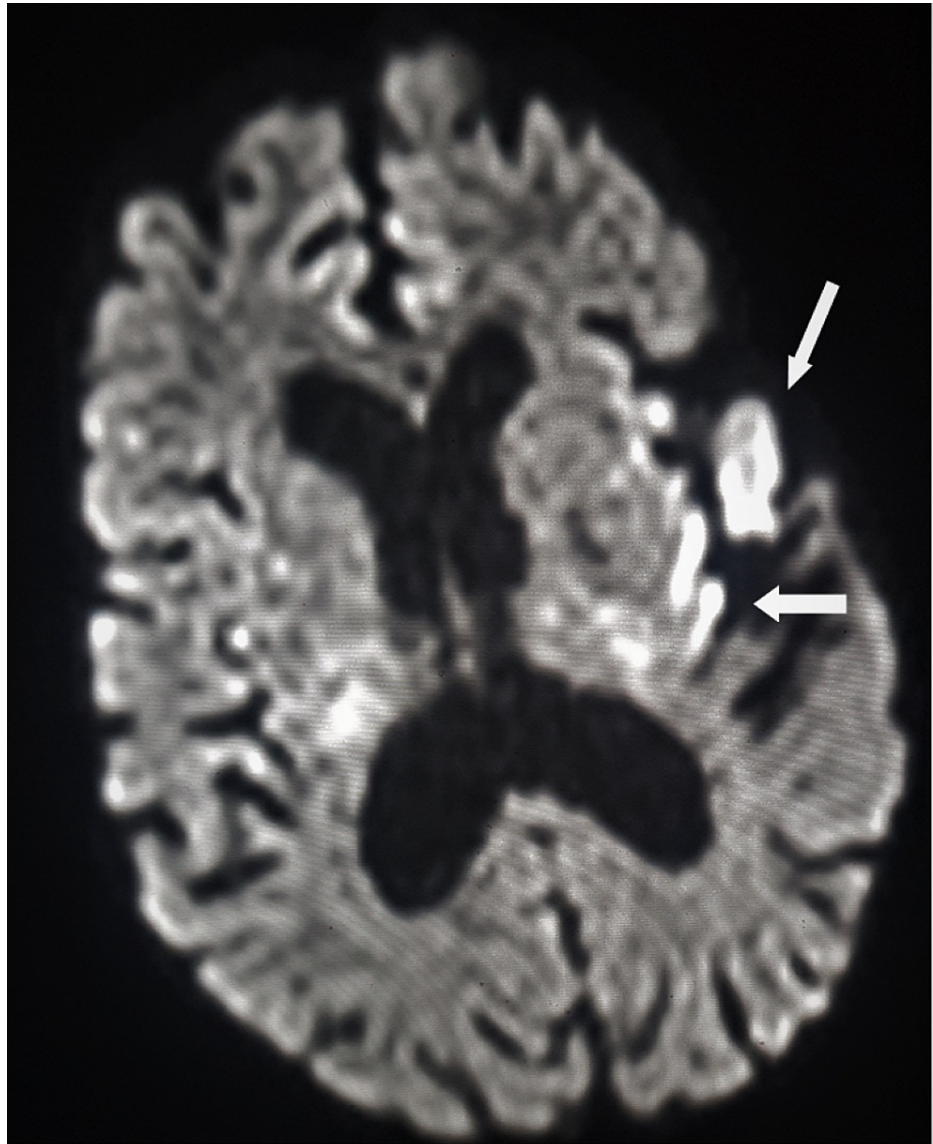
**FIGURE 7: MRI brain with focal areas of hyperintense signal on DWI with signal drop seen in the left frontal periventricular region and left insular cortex, suggesting acute infarct (white arrow)**

DWI: diffusion-weighted imaging

In the immediate postoperative period on the second day of surgery, weakness of the right lower limb was noted. Discontinuation of epidural medication, however, showed no signs of improvement. The persisting weakness required close observation along with a neurological assessment by the neurologist. The neurologist required an MRI brain evaluation to identify and ascertain the relevant pathology. The presence of skin staples and recently implanted knees posed significant challenges for the management team. The risk-benefit ratio was evaluated based on the literature and safety guidelines from the manufacturer manual. Written informed consent from the patient was taken. An MRI imaging of the brain was done with a lead apron along the pelvic and knee area with the operated wound site strapped. Post MRI, an assessment and review of the local site for the displacement of sutures or abnormal protuberance or skin change locally was done. The passive range of movement of both knee joints was assessed to be within routine ranges of knee motion. No local-site complication was noted. MRI brain revealed an acute infarct of the left frontal

periventricular region (Figure 7).
