Article

# The Influence of Non-Engineered Municipal Landfills on Groundwater Chemistry and Quality in Bloemfontein, South Africa

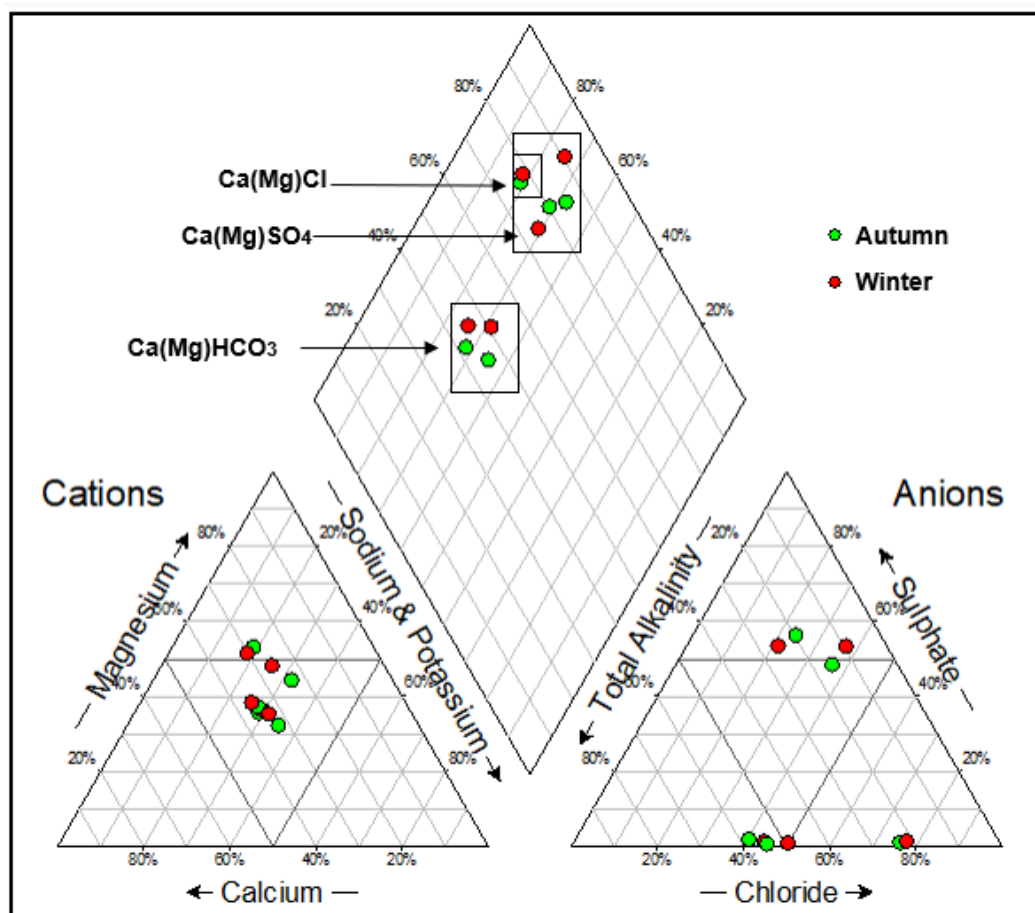
**Figure 3.** Piper diagram for the groundwater samples in the northern landfill site for the two seasons.

Piper plots were constructed to illustrate the hydrogeochemical facies for the groundwater samples, and four main water types were identified (Figures 3 and 4). Expanded Durov diagrams were plotted to further illustrate the eight chemical variables, as well as classify the water (Figures 5 and 6).

The water samples from the two landfill sites showed variation in the overall major ion chemistry, as well as similarities. Boreholes NB06A and NB06B had similar chemistry and plotted in the  $\text{Ca}(\text{Mg})\text{HCO}_3$  vicinity over both seasons. Boreholes SB08A and SB08B in the southern landfill site also plotted in the  $\text{Ca}(\text{Mg})\text{HCO}_3$  vicinity over both seasons. These water samples are indicative of dominance in alkalinity and no dominant cation. Boreholes NB03A and NB03B also had similar chemistry and plotted in the  $\text{Ca}(\text{Mg})\text{SO}_4$  vicinity in the two seasons. Borehole SB04 showed variation in the overall major ion chemistry over the two seasons. The borehole plotted in the mixed type vicinity in the autumn season and the  $\text{Ca}(\text{Mg})\text{Cl}$  vicinity in the winter season. Borehole NB07 plotted in the  $\text{Ca}(\text{Mg})\text{Cl}$  vicinity in the two seasons which indicated a dominance in the chloride anion and no dominant cation.

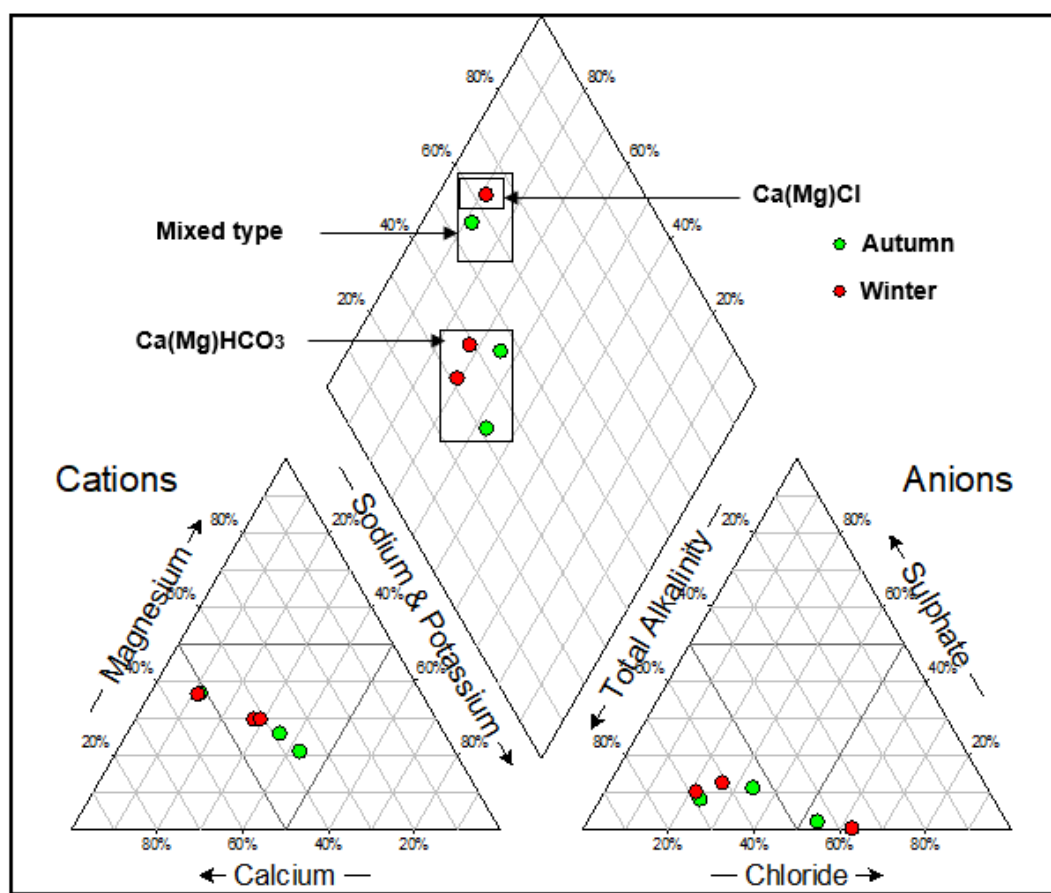
Figure 4. Piper diagram for the groundwater samples in the southern landfill site for the two seasons.

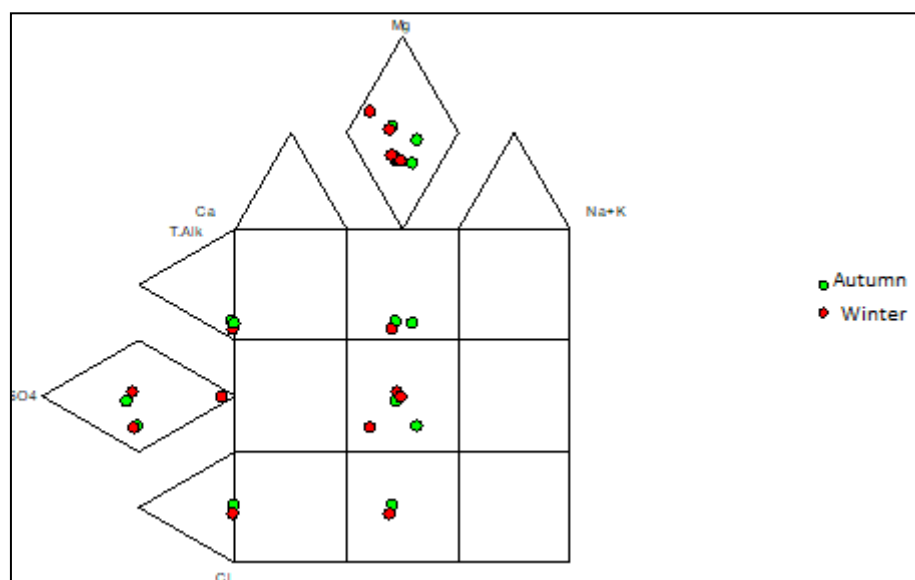
Figure 5. Expanded Durov diagram for groundwater samples in the northern landfill site for the two seasons.

Results from the expanded Durovs shows the water samples from the northern landfill site plotted on the seldom found section, as well as the unpolluted water types based on minimum requirements suggested by the Department of Water Affairs requirements for water monitoring at waste management facilities. From a hydrogeochemical perspective, these water types are represented of water undergoing continuous changes in chemistry. Sodium Adsorption Ratio diagrams were constructed to illustrate the salinity hazard of the different groundwater samples based on their electrical conductivities (Figures 7 and 8). The SAR diagram is plotted to illustrate the aquifers irrigation water quality within the vicinity of the landfill. In the northern landfill site, boreholes NB07 and NB03B had a very high salinity in both seasons. Borehole SB04 had a high salinity hazard over both seasons in the southern landfill site.

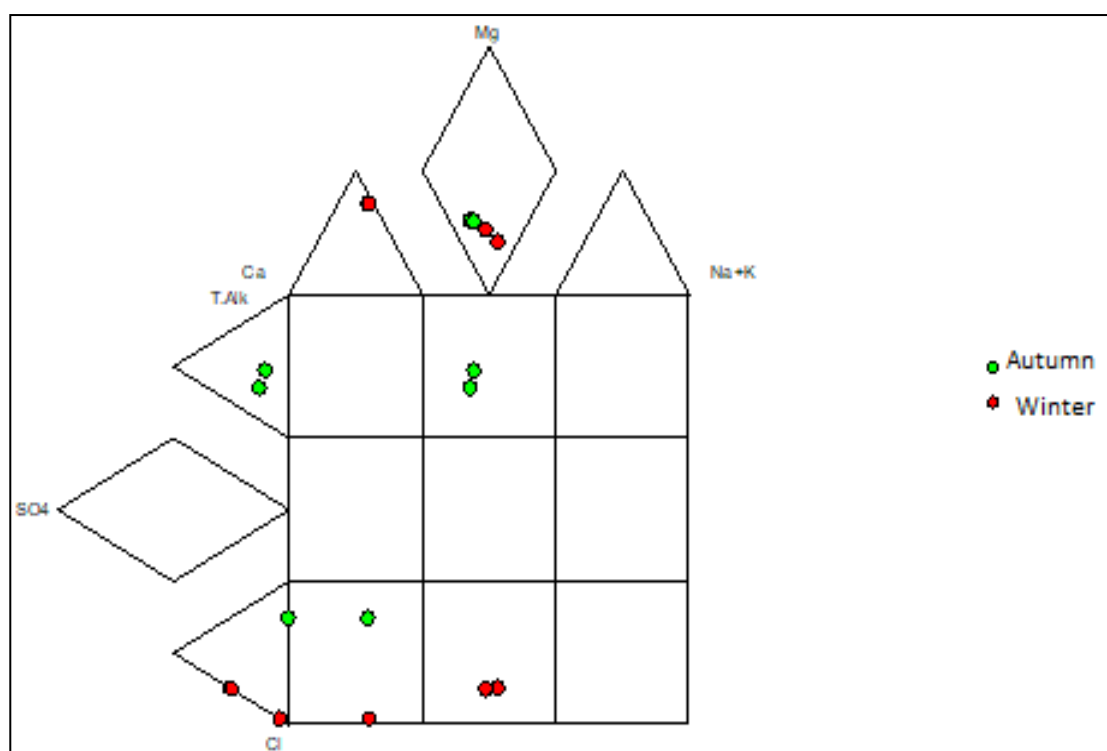
**Figure 6.** Expanded Durov diagram for groundwater samples in the southern landfill site for the two seasons.

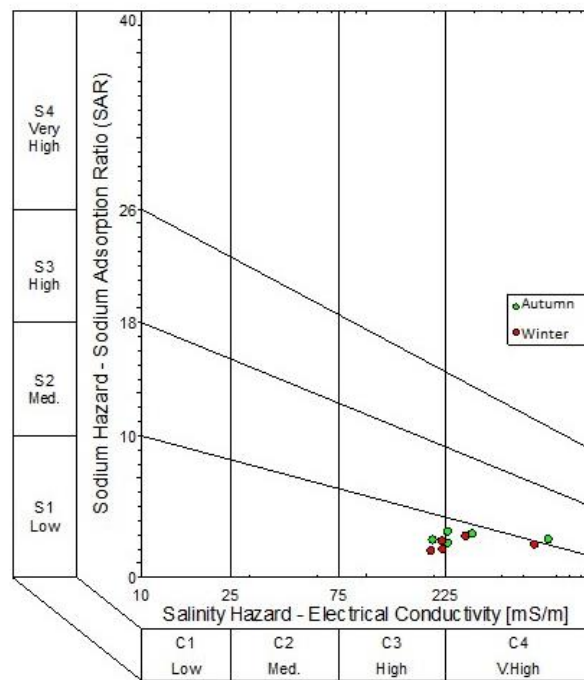
Figure 7. Salinity hazard (SAR) diagram for the boreholes in the northern landfill site.

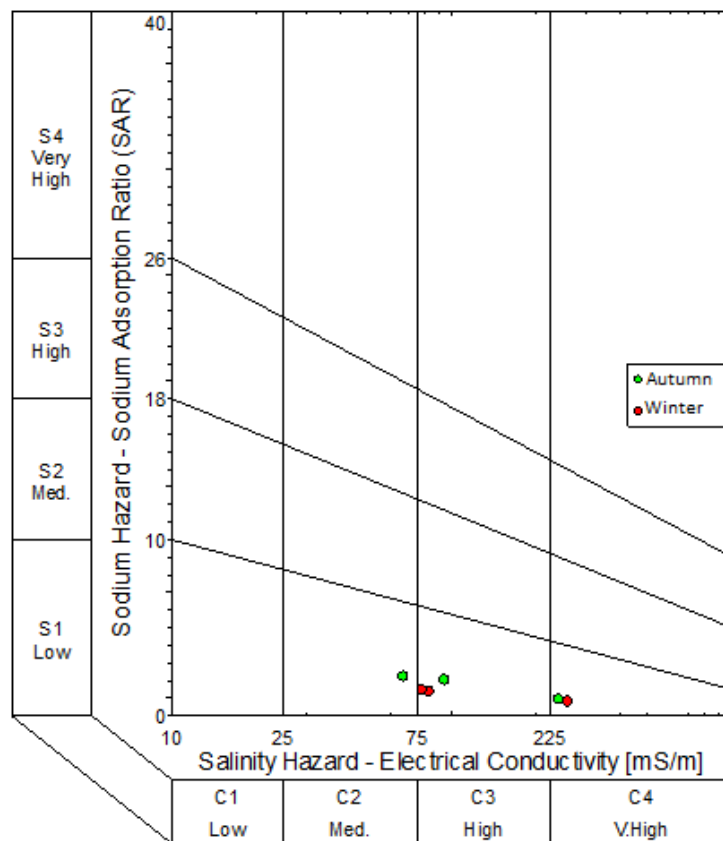
Figure 8. SAR diagram for the boreholes in the southern landfill site.

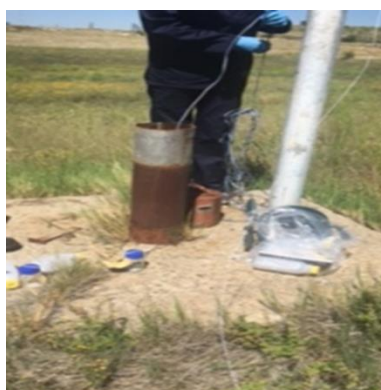
**Figure 9.** Well-constructed borehole in the northern landfill site.

Elisante and Muzuka [29], stipulate that groundwater is prone to microbial contamination, due to human activities, such as soil fertility remediation, indiscriminate refuse and waste disposal, and the use of on-site sanitation facilities. All the boreholes in the northern landfill site had zero *E. coli* concentrations over both seasons and were, therefore, within the recommended drinking water limits as stipulated by SANS 241 [22] and WHO [21]. All the boreholes in the southern landfill site had notable *E. coli* concentrations, with borehole SB04 having the highest *E. coli* concentrations over both seasons. Findings by Elisante and Muzuka [29] concluded that differences in microbial contamination in boreholes can be attributed to the quality of borehole construction, as boreholes that were well constructed had low microbial contamination in comparison to those whose mouths were set at the ground surface. Figure 9 is a representation of the status of the boreholes in the northern landfill site with Figure 10 representing the borehole in the southern landfill site, whereby significant *E. coli* counts were noted. The poor state of the borehole in the southern landfill site might have resulted in the borehole being prone to microbial contamination.

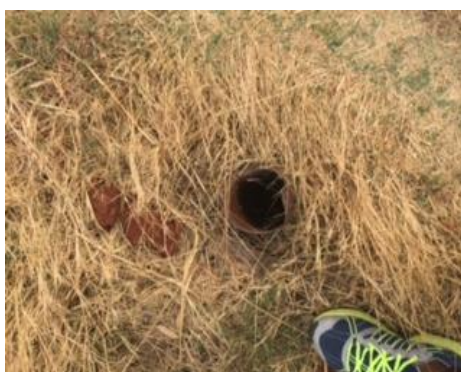
**Figure 10.** Poorly constructed borehole in the southern landfill site.

This study highlights that geology plays a significant role in the distribution of contaminants into groundwater systems. The presence of underlying dolerite in the northern landfill site resulted in the northern landfill site having a poorer water quality in comparison to the southern landfill site with respect to physicochemical parameters, while the poor state of the southern landfill boreholes made them more disposed to microbial contamination.
