First-in-Human Experience With Integration of a Hydrocephalus Shunt Device Within a Customized Cranial Implant

Operative Neurosurgery 17:608–615, 2019

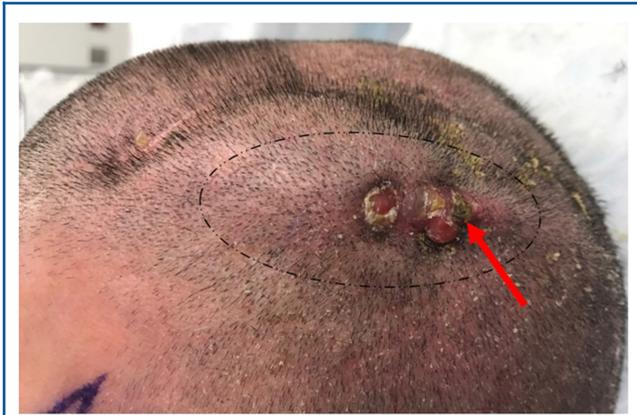
FIGURE 1. Preoperative photograph of inaugural patient presenting to neuroplastic surgery clinic with, left-sided scalp wound and extruding shunt valve. One can appreciate the high-profile shunt's visible deformity (represented by dotted black line), as well as the exposed valve (red arrow).

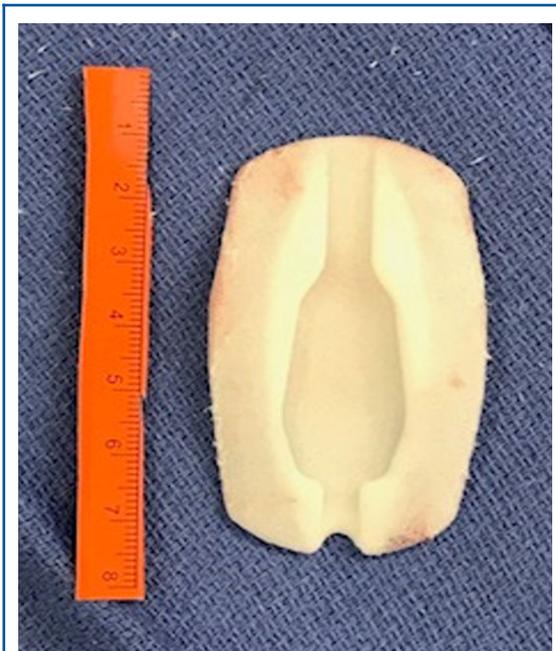
FIGURE 2. Intraoperative photograph of customized cranial implant made of high-density polyethylene. In particular, there is an exact fit design incorporated within the customized implant to accommodate the specific shunt valve system being selected by the neurosurgeon.

During this time, a customized cranial implant (InvisiShunt, Longeviti Neuro Solutions, Hunt Valley, Maryland) was designed specifically to house the exact shunt valve type planned for future implantation by neurosurgery (M.L.). Computer-assisted design/manufacturing (CAD/CAM) was performed in virtual fashion to allow the multidisciplinary team to coordinate exact locations with respect to contralateral shunt placement, planned craniectomy boundaries, and incisional/scalp flap exposure. Of note, the cranial implant was requested to be made out of high-density polyethylene, so that its mechanical properties would allow for intraoperative modification and flexibility as needed to better accommodate the convex curvature of the cranium—as opposed to a more rigid alloplastic material like poly-ether-ether-ketone or polymethyl-methacrylate. Of note, the upfront cost for this specific implant was institutional-dependent based on prenegotiated terms with the manufacturer. Furthermore, the cost of the implant is a fraction of the cost of a redo shunt and hospitalization.

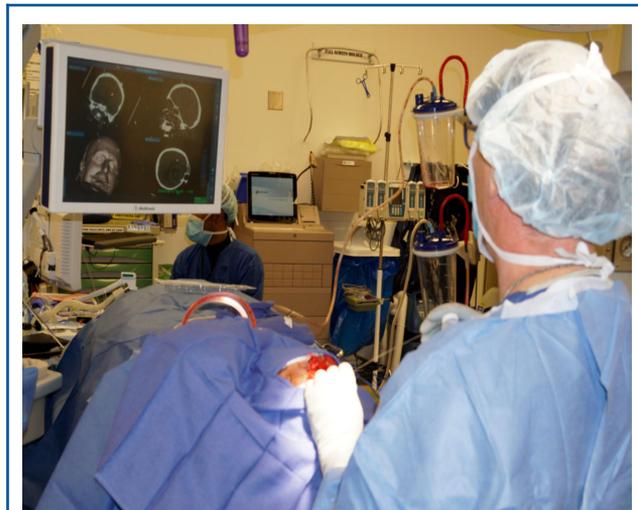
FIGURE 4. Intraoperative photograph of proximal catheter being placed via navigational guidance.

were determined based on length and width of the device. The proximal catheter was placed uneventfully in the lateral ventricle using intraoperative guidance (Figure 4). The distal catheter was placed in the peritoneal cavity using standard technique. Once both catheters were in proper position, the customized cranial implant was inset within the limited craniectomy defect and fixated with titanium screws along the periphery (Figure 5). The high-profile shunt device was then integrated within the implant, and the proximal catheter was passed through and connected. The distal catheter was connected and positioned within a customized groove at an angle less than 90 degrees. Following integration, the shunt valve was measured before inset to be 8 mm tall. Following implantation within the customized cranial implant, its relative height was reduced to just 1 mm, which left its edges just high enough to palpate

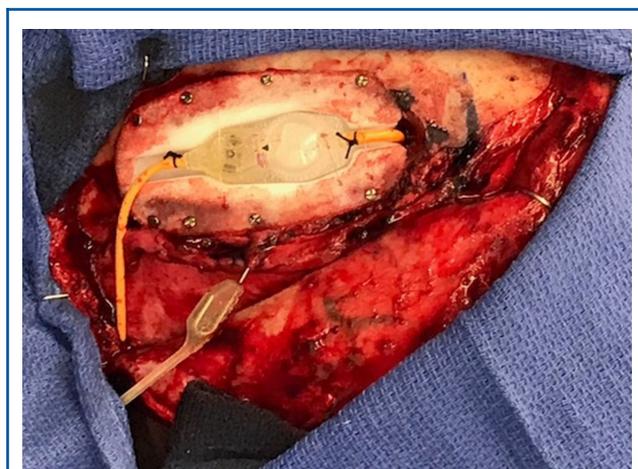
FIGURE 5. Intraoperative photograph of high-profile shunt valve implanted within customized cranial implant along right-sided temporoparietal location. Titanium screws fixate the cranial implant along the periphery.

its 3-dimensional shape. Furthermore, a partial-thickness defect may have only reduced the overall thickness by 1 to 2 mm.¹² As such, following a prolonged discussion with the patient in regard to the novelty of this approach, we decided to use a low-profile customized implant to reduce the valve's height by 87%, and at the same time, eliminate all concern for shunt migration by providing a "key-and-lock" type fit (Figure 5).

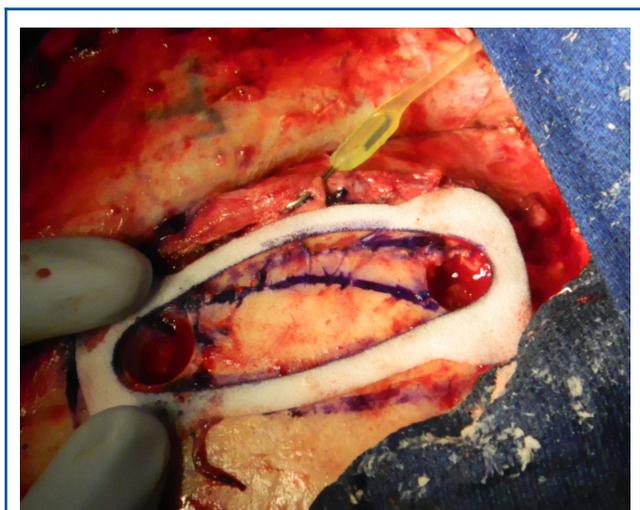
FIGURE 3. Intraoperative photograph of marking template being used to identify exact burr hole locations on either end. Next, a craniotome is used to complete the limited craniectomy.

At 2 wk, the second-stage surgery was performed on the contralateral side since the patient had communicating hydrocephalus, and in an effort to avoid the previously contaminated field/scarred scalp (**Video, Supplemental Digital Content**). The borders of the limited craniectomy were hand-drawn using a marking pen and template, as shown in Figure 2. Of note, the size of the limited craniectomy was oval-shaped and measured approximately 3.5 × 6.5 cm (Figure 3). The size limits of the craniectomy

In this particular instance, the main precipitating factor was the high-profile, rigid shunt device and its pressure on the overlying scalp. Therefore, to address this, we performed a small-sized craniectomy using a burr and craniotome (by way of a pre-designed marking template supplied by the manufacturer). Attempting to drill a partial-thickness cranial defect to mirror the necessary shunt device would have been quite challenging given

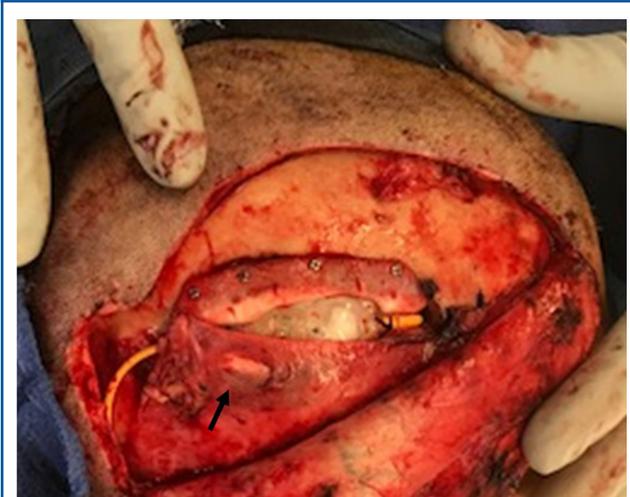
FIGURE 6. Intraoperative photograph showing the re-draping and inset of a pericranial-temporalis muscle flap over the inferior shunt valve/cranial implant in preparation for final scalp closure.

subcutaneously with one's fingers. Proper function and shunt flow were confirmed prior to flap inset, multilayered scalp closure, and closed suction drain insertion (Figures 6 and 7).

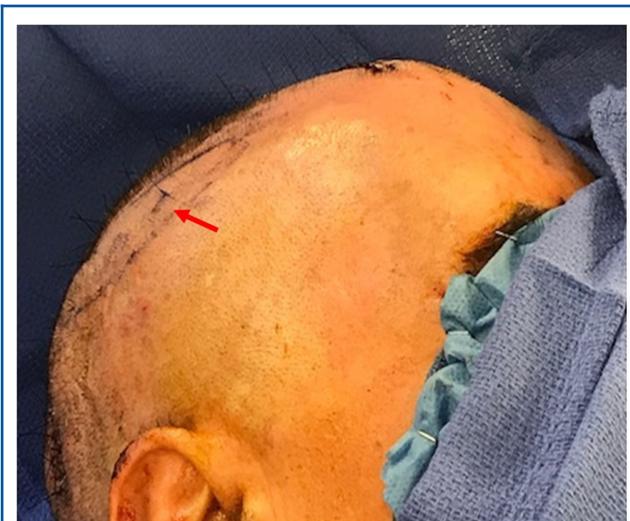
FIGURE 7. Right-sided intraoperative photograph of the final cranial contour following multilayered scalp closure. Of note, a single suture (red arrow) was placed above the low-profile shunt valve for this inaugural case to assist with postoperative device identification.

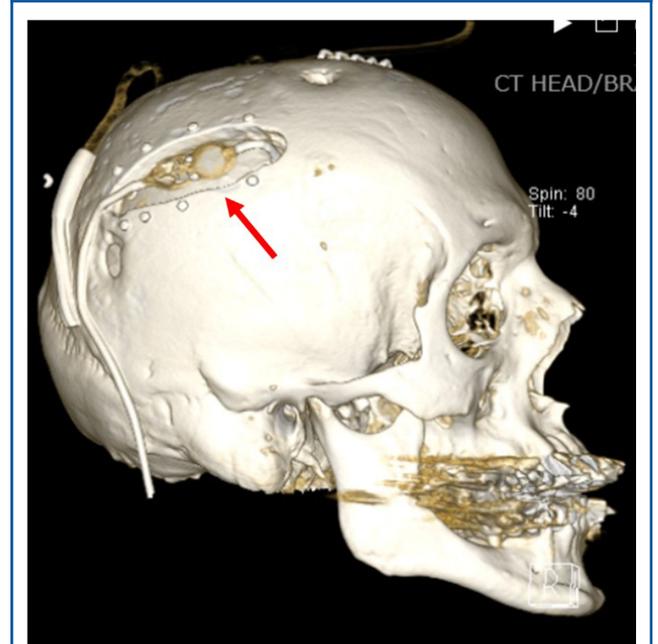
FIGURE 8. Postoperative CT scan with 3-dimensional reconstruction showing right-sided hydrocephalus shunt valve implantation within a customized cranial implant. In particular, the high-density polyethylene cranial implant is radiolucent and cannot be seen within the craniectomy site.

cranial implant has not interfered with any shunt programming or valve localization. To date, his hydrocephalus has remained well controlled. In particular, the overall height of his shunt valve device was decreased by 87%, as compared to its previous placement height which led to eventual extrusion (Figure 8). Overall, there is a significant difference in shunt valve prominence as compared to its previous placement, as shown in Figure 9.

Unquestionably, shunt-related complications are devastating to all patients regardless of age, ranging from simple adjustment to definitive removal. Although these complications are complex and multifactorial, the scalp-related variables play a major factor in cases of extrusion/failure and therefore, with this advance, could be prevented by way of a low-profile inset. As such, the ability to securely house shunt valves within the confines of a craniectomy defect (ie, intercranial space) by taking advantage of underutilized space within a cranial implant provides many newfound advantages (Figure 11).¹⁴⁻¹⁶ This includes offering our patients an option for an improved appearance with enhanced contour, while concurrently decreasing detrimental pressure and relative ischemia onto their overlying scalp (Figures 8 and 9).

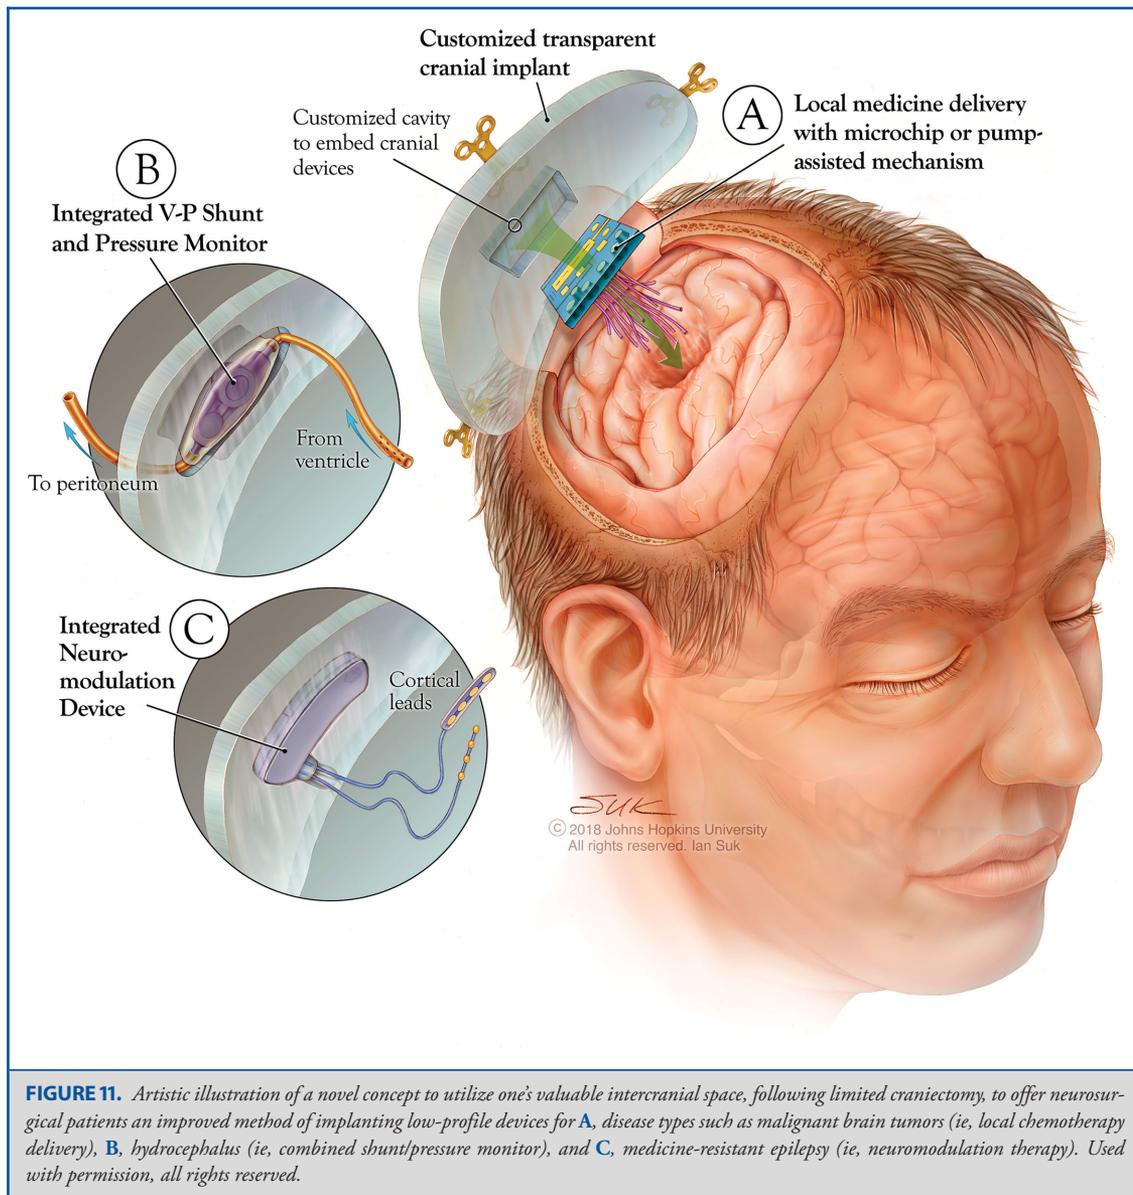
FIGURE 11. Artistic illustration of a novel concept to utilize one's valuable intercranial space, following limited craniectomy, to offer neurosurgical patients an improved method of implanting low-profile devices for **A**, disease types such as malignant brain tumors (ie, local chemotherapy delivery), **B**, hydrocephalus (ie, combined shunt/pressure monitor), and **C**, medicine-resistant epilepsy (ie, neuromodulation therapy). Used with permission, all rights reserved.

In parallel, there are several important advantages and disadvantages with this first-in-human experience. First, the advantages of integrating hardware within a customized cranial implant is an advance and may serve as a platform for all hydrocephalus-related neurotechnologies, including flow meters to detect shunt malfunction and/or pressure monitors, to diagnose elevated intracranial pressures. Of course, as this research progresses, one could envision implanting some of these technologies all
