Metallosis Presenting as Knee Pain 26 years after Primary Total Knee Arthroplasty

This case presents a catastrophic failure of a TKA due to severe metallic wear debris. This case emphasizes the importance of periodical follow up, which has the potential to identify such cases early in the course and prevent significant tissue and bony erosions and damage.

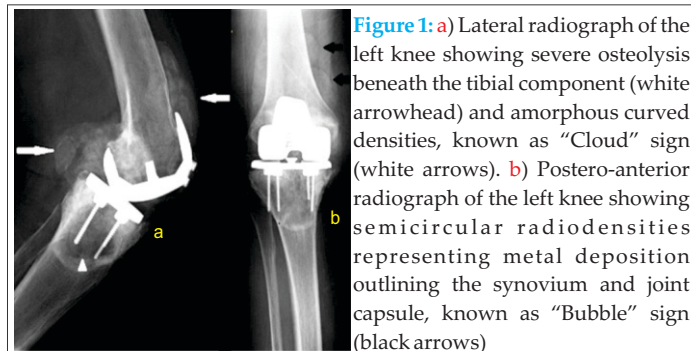
Figure 1: a) Lateral radiograph of the left knee showing severe osteolysis beneath the tibial component (white arrowhead) and amorphous curved densities, known as "Cloud" sign (white arrows). b) Postero-anterior radiograph of the left knee showing semicircular radiodensities representing metal deposition outlining the synovium and joint capsule, known as "Bubble" sign (black arrows)

Metallosis can be suspected pre-operatively with radiographic signs such as the "cloud sign," "bubble sign" and the "metal-line signs", with our patient displaying the former two on lateral and PA radiograph images. The "cloud" sign is the most commonly cited radiographic indication of possible metallosis and is described as amorphous, fluffy densities in periprosthetic soft tissues, most commonly found posterior to the knee implant [1, 2, 5] Additionally, bubbly appearing radiodensities representing metal deposition outlining the synovium are known as the "bubble" sign. Finally, the "metal-line" sign is a thin linear radiodense line that outlines part of the joint capsule (most commonly in the suprapatellar pouch) and is fairly specific for metal-induced synovitis. Evidence of these signs on imaging should prompt a close evaluation for metallosis. Serology and arthrocentesis also need to be performed to rule out infectious etiology. In general, a peripheral WBC count is not useful diagnostic measure since it is generally normal in TKA infections while persistent elevation of ESR, with abnormal levels defined as > 30 mm/hr three months to one year after TKA, is often indicative of infection (specificity of 87%) [9]. Similarly, elevated CRP levels defined as > 10 pg/ml at least 14-21 days after TKA also point to an infectious etiology (specificity 83%) [9]. Regarding synovial fluid leukocyte count and differential, the numbers to consider a possible infection, include > 1100 WBC/ml with a PMN percentage > 64% (88% and 94%

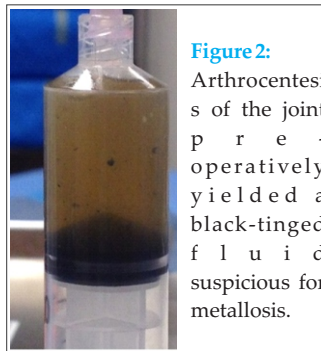
Figure 2: Arthrocentesis of the joint pre-operatively yielded a black-tinged fluid suspicious for metallosis.

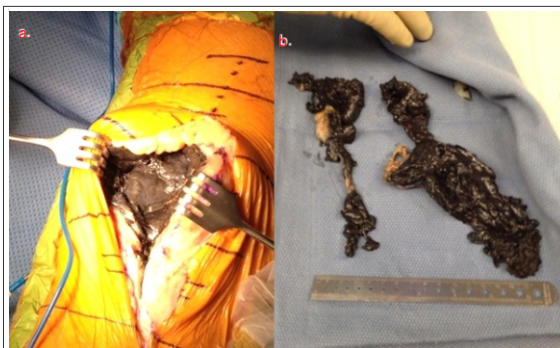
Figure 3: a) Black necrotic metallic debris material noted in the joint space. b) resected synovium with extensive black metallic debris material noted throughout

degrees. The knee was unstable on varus and valgus testing, in extension, mid flexion, and 90 degrees of flexion. There was slight joint line tenderness medially and laterally as well as palpable crepitus and grinding when ranging the knee. Knee radiographs revealed amorphous densities in the posterior capsule and the suprapatellar recess consistent with the "cloud sign" (Fig 1a) and curved radiodensities around the distal femur and joint capsule both medially and laterally, consistent with the "bubble sign" (Fig 1b). There was severe osteolysis with loosening of both the femoral implant and tibial base plate. A knee arthrocentesis was done in clinic, with significant amounts of black-tinged fluid aspirated (Fig 2). Infection was ruled out with joint fluid analysis resulting in a WBC count of 406 and PMN % of 6. Bloodwork was obtained, with CRP and ESR levels within normal range. Given the severe pain, evidence of implant aseptic loosening and high clinical suspicion for metallosis, the recommendation was made for the patient to undergo left revision total knee arthroplasty. During the operation, there was extensive necrotic black material overlying the entire knee joint after arthrotomy (Fig 3a). A complete synovectomy was performed at the medial and lateral

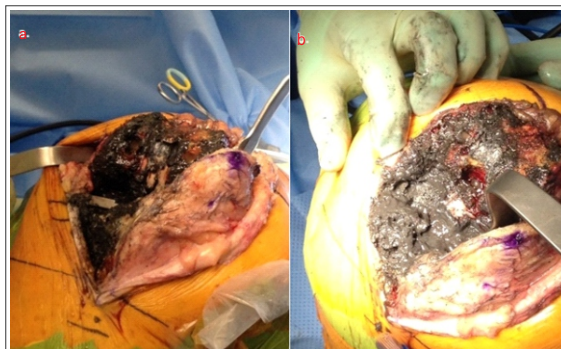
Figure 4: a) Extensive black metallic debris material noted over the distal femur and femoral canal upon removal of the femoral component, b) Extensive black metal debris material noted over the tibia following removal of the tibial component.

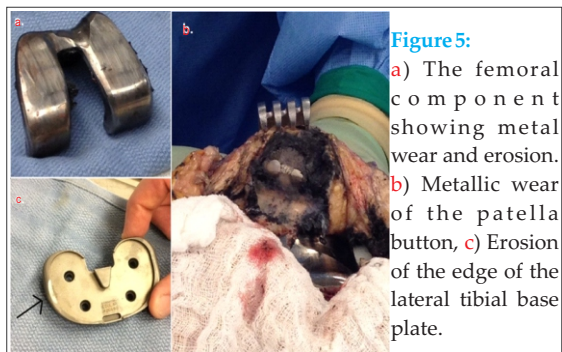
Figure 5:
a) The femoral component showing metal wear and erosion. b) Metallic wear of the patella button, c) Erosion of the edge of the lateral tibial base plate.

Close inspection of the implants revealed metallic wear secondary to grinding on both the femoral component (Fig 5a) and metal backed patella (Fig 5b), as well as along the lateral surface of the tibial plate (Fig 5c). After irrigation and debridement, most of the metal debris was removed. The revision implants included long press-fit diaphysis fitting stems in both the femur and tibia and a varus-valgus constrained component with tibial and femoral wedges used to reconstitute the bone loss and restore the anatomical joint line. An oxidized zirconium femoral component was used to prevent repeat metallic wear (Smith & Nephew, Memphis, TN). The patellar component was removed in its entirety and not replaced due to insufficient bone stock to support a new patella button (Figs 6a and 6b).

Most cases of metallosis after total knee replacement are due to wear of a metal-backed polyethylene patellar prosthesis [5], and this was the likely source of our patient's TKA aseptic failure based on the significant patellar destruction. Metal-backed patellar implants are no longer commonly used, but close evaluation should be kept on patients with these components and metallosis should be at the top of the differential if they present with complaints such as effusion, grinding and pain. In addition, the patient in our case also had

wear of the titanium tibial and femoral components with both components showing signs of erosion. A review of the current literature revealed that titanium components appear to have an increased association with metal wear leading to metallosis as compared to chromium-cobalt comprised implants [8]. Newer implants such as the one used in this case (Smith and Nephew's Oxinium) are composed of oxidized zirconium with the goal of reducing metal wear and should result in fewer incidences of metallosis in the future [12]. These components should preferentially be used during revision cases to limit any additional spread of metal debris.

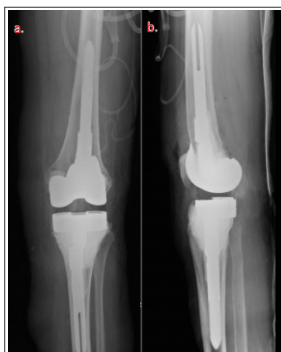
Figure 6:
a) Antero-posterior post-operative radiograph showing revision TKA b) lateral post-operative radiograph showing revision TKA

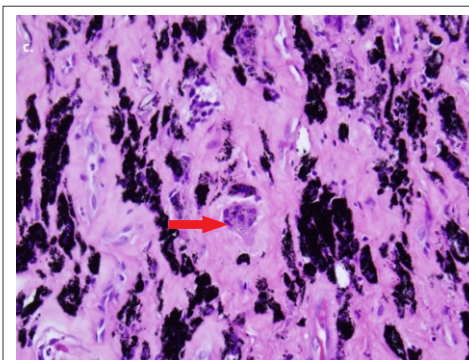
Intraoperative joint fluid analysis was again negative for infection, with WBC count 243 and PMN % of 10. Histologic examination of the periprosthetic tissues demonstrated extensive fibrosis (Fig 7a) with multiple histiocytes (Fig 7b) and multi-nucleated giant cells (Fig 8) consistent with the diagnosis of metallosis.

Figure 8:
Synovial microscopic histology showing a multinucleated giant cell (red arrow)
