A Rare Case Report of Spontaneous Disassembly of Bipolar Hip Prosthesis in Elderly Patient

Case Report: We, hereby, present a case of the spontaneous disassembly of the bipolar hip prosthesis, which was timely recognized and treated adequately in an elderly patient.

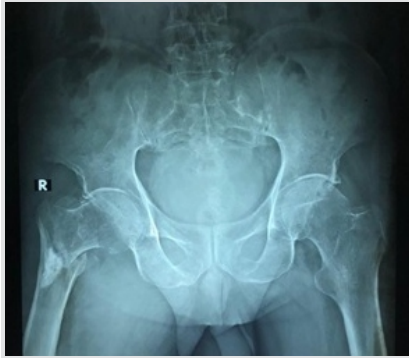
Figure 1: X-ray pelvis view showing right-sided neck of femur fracture.

back in the month of May 2018 before consulting to us. He underwent a clinical and radiological examination, in which he was diagnosed as a case of fractured neck of the femur of the right hip secondary to age-related osteoporosis, as shown in Fig. 1.

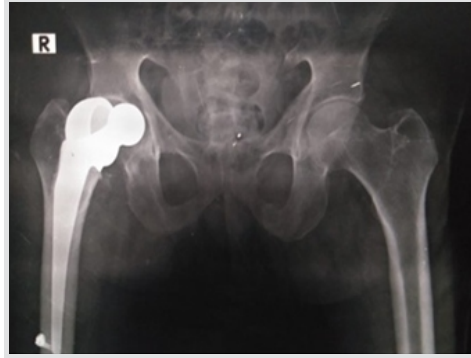
Figure 2: X-ray pelvis AP view showing disassembly of the bipolar prosthesis.

Considering the age of the patient, he was operated for hemiarthroplasty by posterior approach, for which cemented bipolar prosthesis was used. Postoperatively on the 5th day, the patient felt clicking in her right hip while walking and was unable to move her hip as usual. The patient came back to the hospital for the following complaints and was admitted again, after which he underwent clinical and radiological investigations. On examination, there was swelling in the hip region with no open wound, scar, or dilated veins. On palpation, there was tenderness over the right Scarpa's area with bitrochanteric compression test positive. There were no neurological signs or symptoms. The hip radiographs demonstrated dissociation of the components of the bipolar hemiarthroplasty at the femoral head and neck junction (Fig. 2).

In the present case, the most vital cause for disassembly is the weakened bond between the cement and the metal-based socket. The advantages of cemented prostheses are improved post-operative outcome and low rates of implant-related complications such as dislocation, disassembly, or periprosthetic femoral fracture. However, the modular design of the cemented bipolar prosthesis can very rarely lead to disassembly of the components, and Ito et al. [10] reported a disassembly rate of 4% in the study. With this case report, we, hereby, present such a complication.

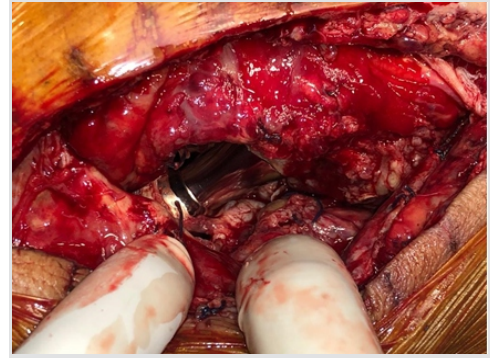
Figure 3: Intraoperative image showing disassembly of the bipolar implant.

Open reduction was performed through the old surgical scar using the posterior approach. The femoral head component was found intraoperatively in the acetabulum and was covered with a well-healed capsule. The tapered part at the inner head and stem neck did not show any scratch marks or defects. Fig. 3 shows intraoperative photos while removing dissociated bipolar hip prosthesis.

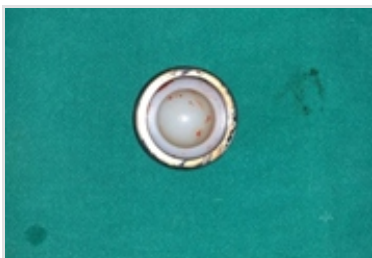
Figure 4: Demonstrates the removed portion of the prosthesis.

Fig. 4 shows the extracted bipolar prosthesis. After the revised surgery, the patient has been followed up for 1 year, and he is
