Trauma Case Reports

Broken guidewire retrieval from the hip joint: A case report

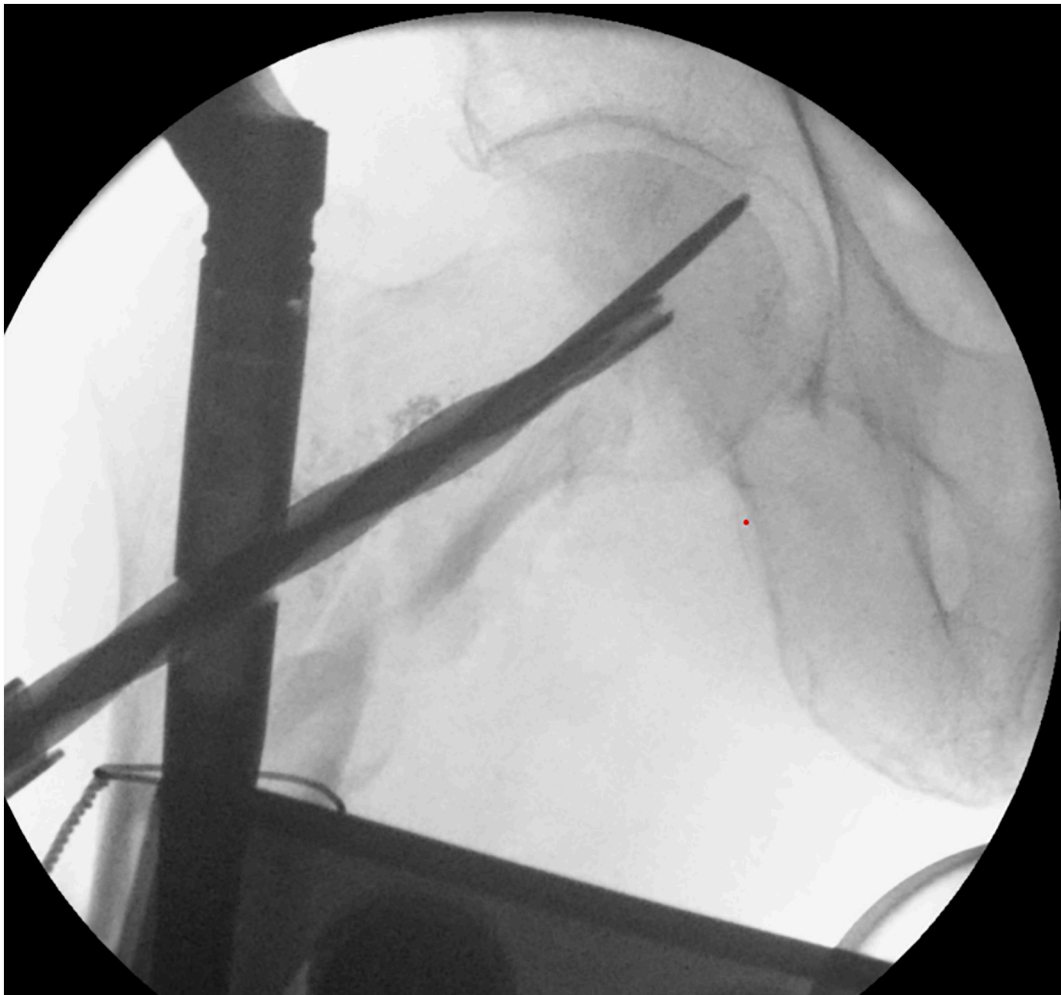
Fig. 1. Over-reaming around broken Guide wire tip.

trochanter. After reaming under fluoroscopy control to confirm maintenance of the reduction, a long proximal femoral nail was inserted. A threaded guidewire was then placed with the aid of the insertion device, to guide the insertion of the helical blade. However, during reaming over the cannulated guidewire, a sudden loss of resistance was unexpectedly encountered. On checking with fluoroscopy it was observed that the proximal end of the guidewire had sheared from the shaft with its tip lying within the subchondral area of the femoral head. Fortunately, the broken tip had not breached hip joint and entered the pelvis. The surgeon immediately consulted with his colleague and several options on how to retrieve the guidewire were discussed. It was decided to remove the nail and then attempt to reach the broken guide wire by careful over reaming the guide wire track with the same cannulated reamer to create a channel to retrieve the guide wire with either a long Kocher's forceps or a dissection forceps (Fig. 1). The incision was enlarged and the reaming track was exposed. Under direct vision & fluoroscopic control careful over reaming was performed over the guide wire and once the track was large enough a dissection forceps was passed through it and the distal end of the guide wire was firmly grasped with it (Fig. 2).

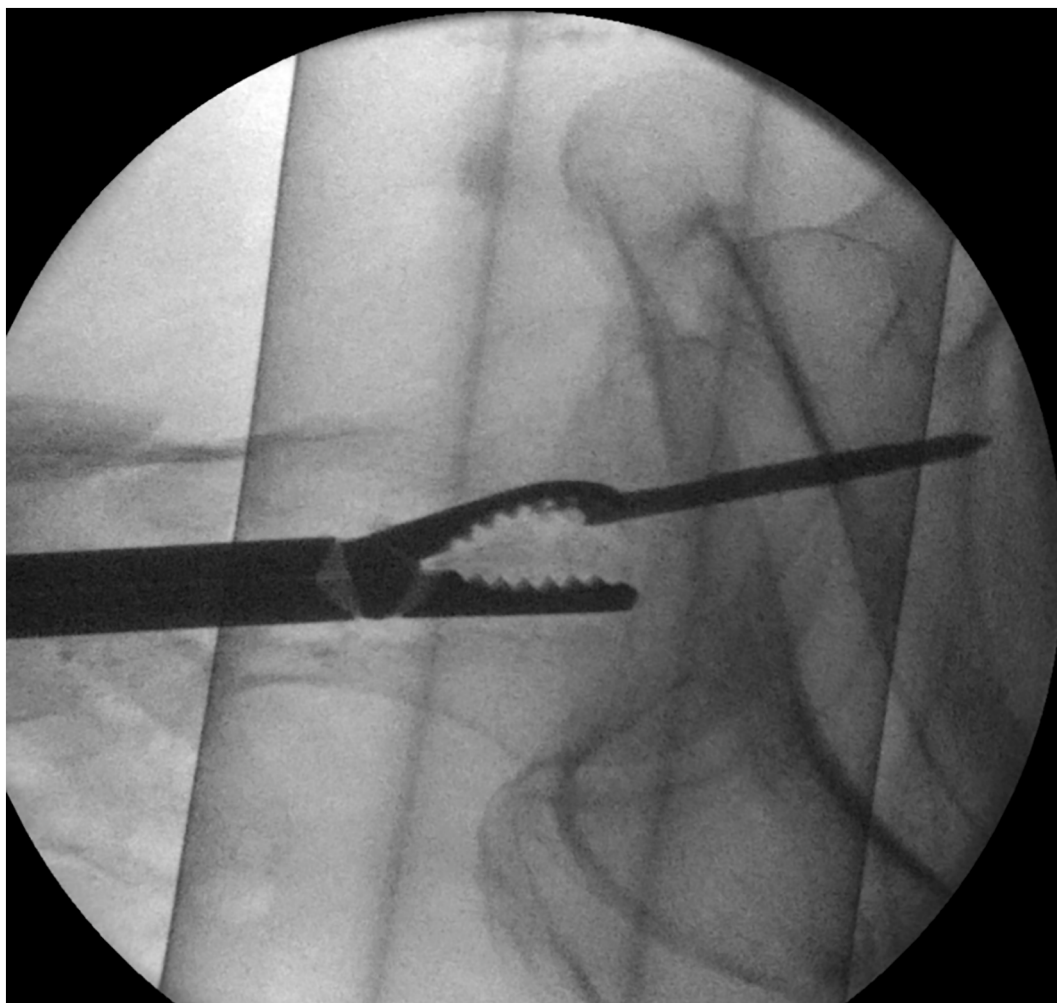
Fig. 2. Using a dissection forceps to grasp the broken tip of the wire.

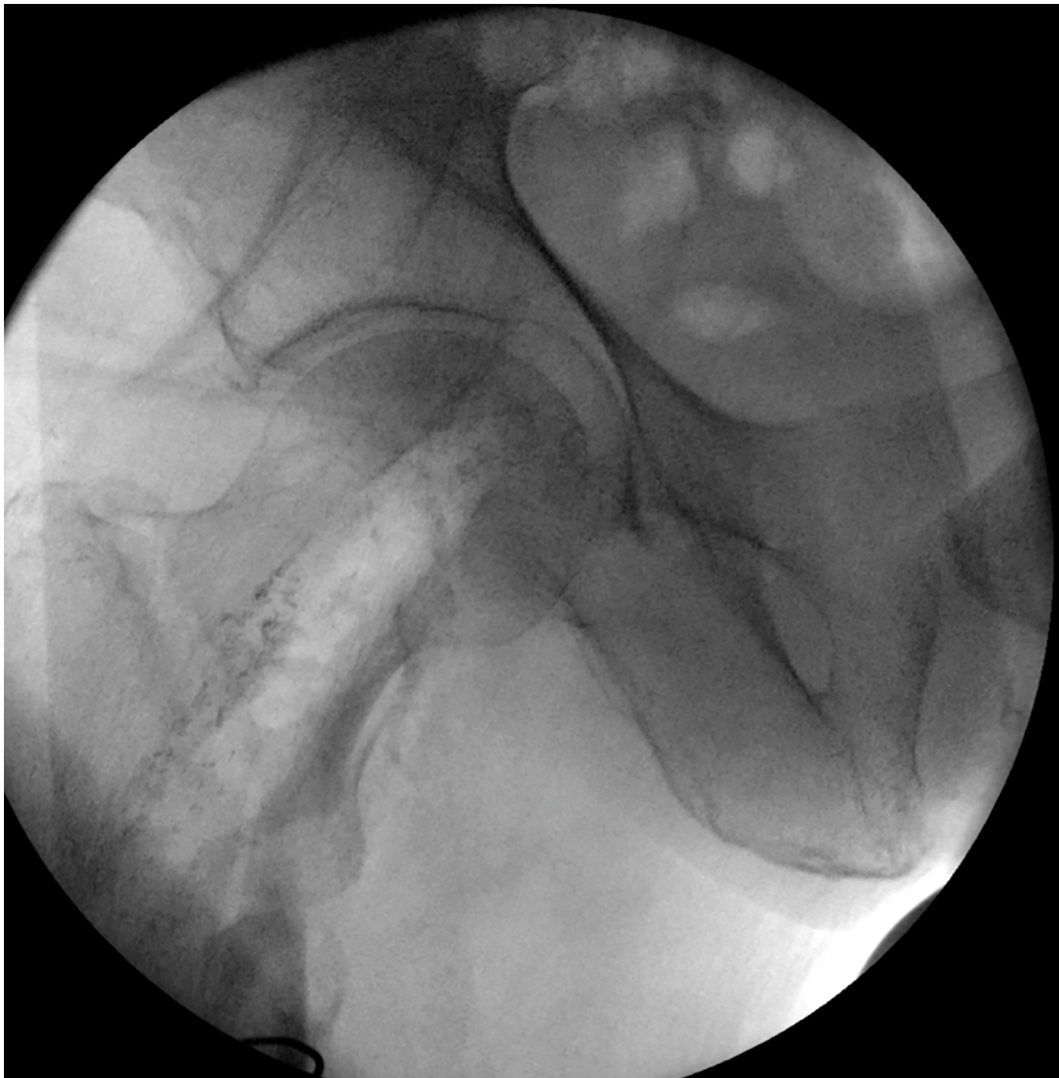
Fig. 3. Successful retrieval of broken tip of guide wire.

After confirming the hold of the forceps over the guidewire, the forceps was rotated by 180 degrees in the opposite direction of the reaming to dislodge the tip of the threaded guide wire from the cancellous bone and it was carefully pulled out of the reamed channel (Fig. 3).
