PMCT images of a motorcycle helmet-associated fracture

Christopher Bell¹ · Thomas R. A. Prickett² · Guy N. Ruttly²

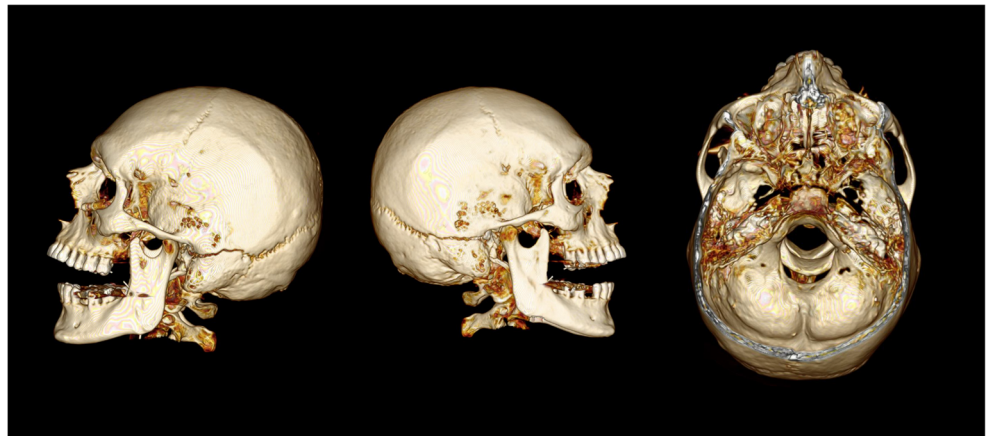
A 44 year-old male was involved in a head-on collision with a car which was overtaking another vehicle at the time. After being thrown from the motorcycle the deceased impacted to the car's nearside, then to the rear offside curtain of an oncoming lorry before coming to rest on the opposite verge of the road. He was declared dead at the scene. The full-face SHOEI brand helmet worn had a witness mark to the front center just above the visor edge. There were multiple areas of bruising and abrasion to the head but no lacerations. Blood was noted to issue from the left ear. Post-mortem computed tomography (PMCT) identified a fracture of the base of the skull centered at the pituitary fossa extending to both middle fossae. It extended to the temporal bone of the vault, and along the lambdoid suture. The fracture did not quite meet at the back of the head, preventing dissociation between two skull portions (Fig. 1).

Fig. 1 PMCT images of the deceased from case 1, showing views from the left, right, and top (windowed view). The fracture extends through the skull base and continues to the lambdoid sutures bilaterally but does not meet sagittally to completely dissociate the skull portions

The five cases presented here demonstrate the same fracture pattern: a circumferential fracture comprising of a linear fracture of the middle cranial fossa extending through the pituitary fossa, continuing to the temporal and occipital bones of the skull vault. They are presented in order of increasing severity. Case 1 was less severe without dissociation of the skull. In cases 2–5 the fracture was sufficiently severe to completely dissociate the skull into two parts. Case 3 had an additional

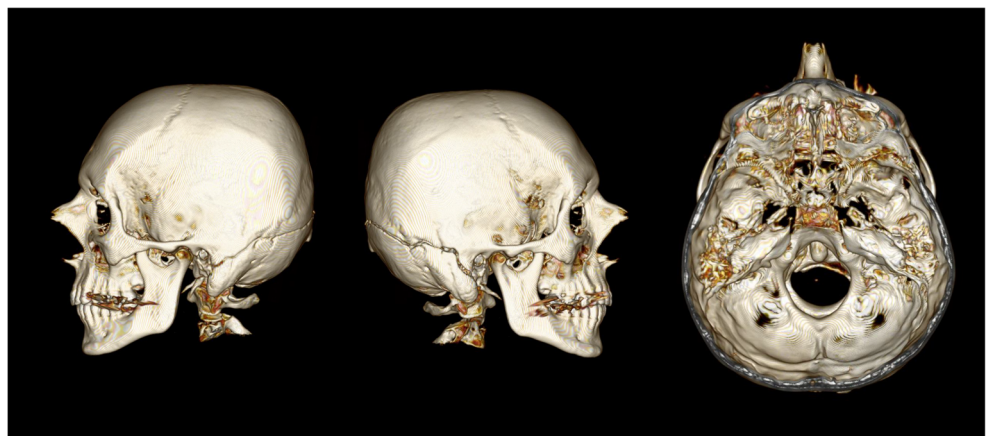
back and damage to the interior padding on the right. The visor was broken with only a small portion remaining attached to the helmet. On external examination there was blood emanating from both ears, bruising to the back of the right ear and a band of red bruising and abrasion to the left chin. PMCT identified a fracture of similar pattern to case 1, but rather than involve the lambdoid suture it extended across the posterior occipital bone to complete a full circumferential fracture and separate the two portions of the skull, with minimal displacement (Fig. 2).

Fig. 2 PMCT images of the deceased from case 2, showing views from the left, right, and top (windowed view). In this case the displacement is minimal but there is a clear separation between both portions of the skull

associated defect more akin to a classic incomplete ring fracture of the skull base. Cases 2, 4 and 5 show the fracture-type largely alone. Of note all of the deceased had witness marks on their helmet indicating an impact to the face, except for the individual in case 2, who clearly had an impact to the chin from the injuries noted on examination. All died at the scene due to their head injuries, although several had other injuries to the chest or abdomen which contributed equally to death.

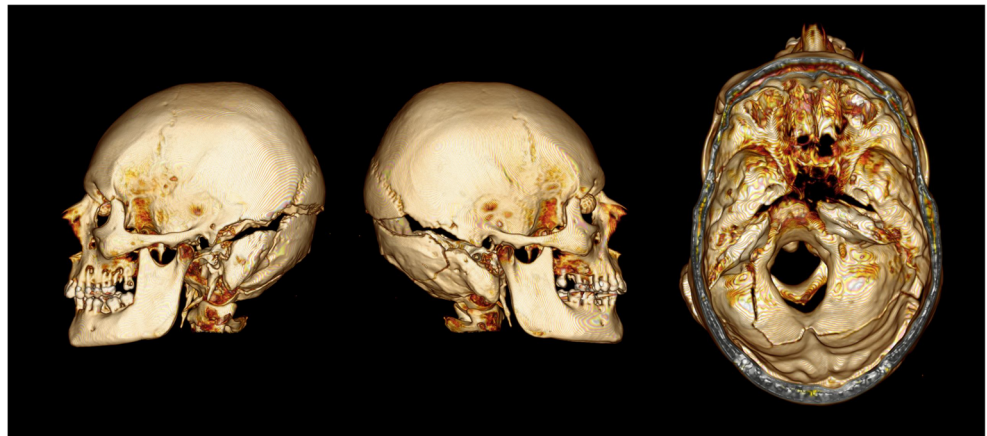
A 51 year-old male was riding his motorcycle at high speed when he collided with the offside passenger door area of a car entering from a side-road. He was thrown in the air somersaulting several times before landing 4–6 m from the car. He was declared dead at the scene. The full-face Shark brand helmet worn had a large vertical crack on the left side extending from the upper edge of the visor upwards. On external examination a closed fracture of the posterior skull was evident as well as bleeding from the right ear and a black eye. PMCT identified a skull fracture of a similar pattern to case 2 with more displacement, and an associated incomplete classic ring fracture of the base of the occiput (Fig. 3).

Fig. 3 PMCT images of the deceased from case 3, showing views from the left, right, and top (windowed view). There is complete dissociation between the two portions of the skull. An associated fracture line extends from the foramen magnum more akin to a traditional incomplete ring fracture. The deceased had a false right eye

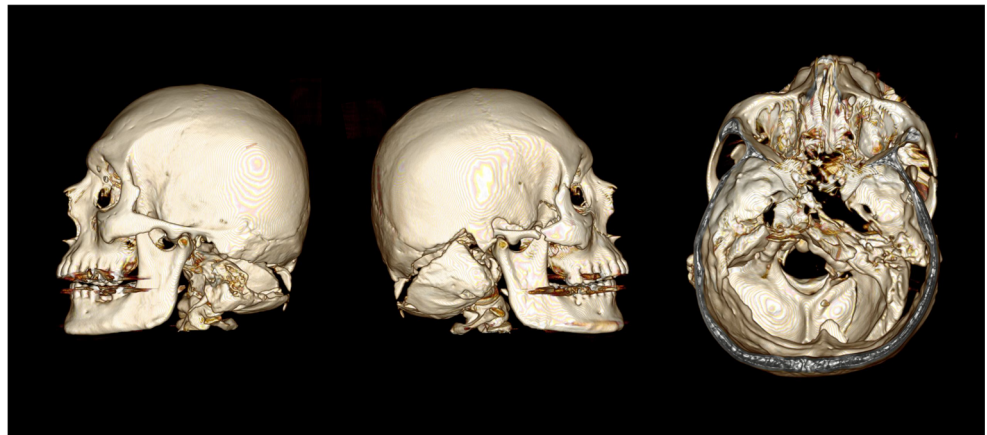
impact. The top vent and visor had been broken off. On external examination there was purple bruising and a 12×3 cm red abrasion on the underside of the chin, as well as several small areas of bruising and abrasion around the eyes and nose. To the left side of the back of the head was a linear partial thickness laceration measuring 2 cm in length. PMCT identified a fracture of similar pattern to case 2, and below this fracture line the remaining part of the occipital bone had fractured into several pieces (Fig. 4).

Fig. 4 PMCT images of the deceased from case 4, showing views from the left, right, and top (windowed view). There is complete dissociation between the two portions of the skull. In addition portion of the occipital bone below the fracture line is in several pieces

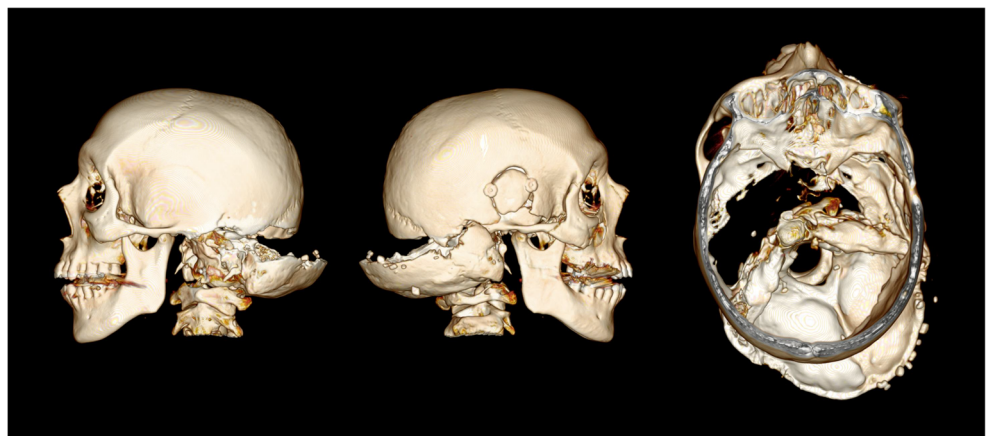
laceration extending across the occiput and left face. PMCT identified a fracture of similar pattern to case 2 with massive displacement of the skull parts (Fig. 5).

Fig. 5 PMCT images of the deceased from case 5, showing views from the left, right, and top (windowed view). There is complete dissociation of the two portions of the skull with significant displacement. Evidence of previous surgery to the right parietal area can be seen
