Application of Intensity-Based Coherent Optical Time Domain Reflectometry to Bridge Monitoring

Xin Lu ^{*}

Citation: Lu, X.; Chruscicki, S.; Schukar, M.; Münzenberger, S.; Krebber, K. Application of Intensity-Based Coherent Optical Time Domain Reflectometry to Bridge Monitoring. *Sensors* **2022**, *22*, 3434. <https://doi.org/10.3390/s22093434>

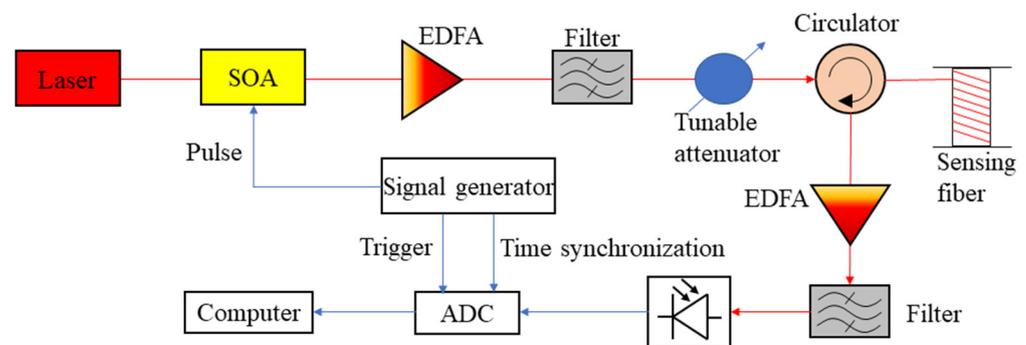
Figure 1. Configuration of the distributed acoustic sensor used for bridge destructive testing. The red line represents optical path and the blue line denotes the electrical connection.

The configuration of the sensing system used for bridge monitoring is depicted in Figure 1. A semiconductor laser (RIO ORION, Santa Clara, CA, USA) with a linewidth of 2.9 kHz was used as the light source. A signal generator provided rectangular pulses to a semiconductor optical amplifier (SOA) so that the continuous wave from the laser was modulated by the electrical pulse and converted into optical pulses with a high extinction ratio. Then, the generated pulses were boosted by an erbium-doped fiber amplifier (EDFA) and a narrowband filter was employed to filter out the amplified spontaneous emission (ASE) from the amplifier. The peak power of the pulse had to be adjusted by a tunable attenuator to avoid non-linear effects in the sensing fiber. The pulse entered the sensing fiber through a circulator and the Rayleigh backscattered light was directed to the receiving module by the same circulator. As the backscattered light is very weak, another EDFA was employed as a pre-amplifier. The amplified light passed through another narrow filter and arrived at a photodetector.

The pulse width was set as 10 ns during the measurement, corresponding to 1 m spatial resolution. The bandwidth of the photodetector was 125 MHz, which could guarantee the spatial resolution [23,24]. The pulse repetition rate was 40 kHz, so the frequency response of the system was up to 20 kHz. An A/D converter (ADC) synchronized with the signal generator was used to digitalize the output of the detector at a rate of 500 MS/s. The digitalized data was processed by a computer to retrieve the vibration information.

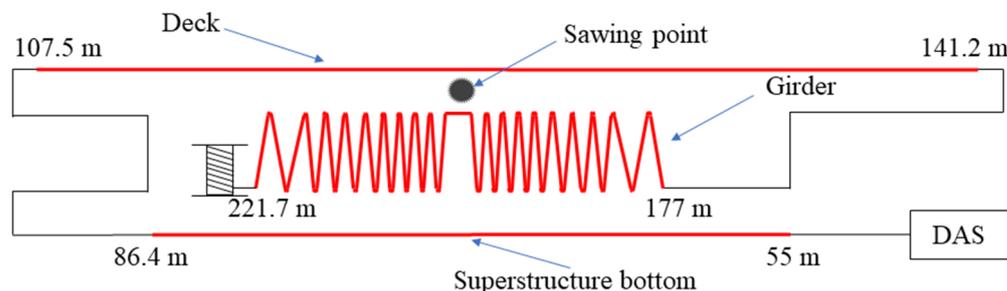
Figure 2. Optical fiber deployment in the bridge. The red line indicates the sensing sections.

The superstructure of the concrete bridge was ~37 m wide and over 150 m long. There were several box girders in the main beam with a height of ~1.5 m. Detailed information is provided in [19]. A standard single mode fiber with a 3 mm-diameter jacket was used for the measurement, and its length was in total ~245 m. The optical fiber was attached to the bridge as shown in Figure 2 for sensing. The whole fiber section from 55 m to 86.4 m was glued to the bottom of the superstructure. Another section from 107.5 m to 141.2 m was buried in a slot on the deck. In addition, a ~44.7 m-long fiber between 177 m and 221.7 m was totally glued in a zigzag shape on the inner wall of the girder. A rear handle saw was

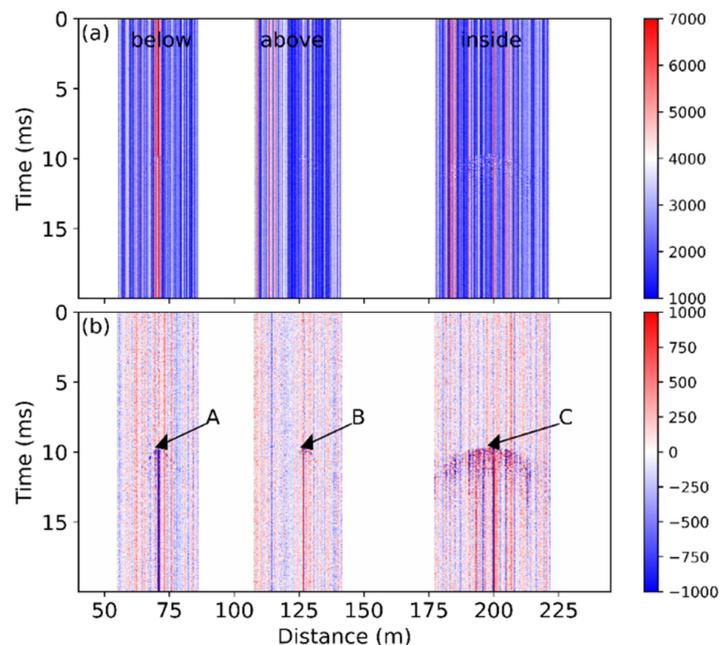
Figure 3. (a) Raw data and (b) data change compared with the first obtained trace during the sawing process. Points A, B, and C indicate the starting positions of the vibration.

The raw data presented in Figure 3a were also analyzed in the frequency domain by the short-time Fourier transform (STFT). The STFT is an effective tool for feature extraction of the obtained signal and has been applied to identify the threats to gas pipelines [25]. At each position, the frequency spectrum of a window of 128 temporal points was obtained, and this operation was repeated while the window slid in time domain. As a result, a group of spectra was obtained at each fiber position over the measurement time, and the STFT result $S(t, z, f)$ is actually a 3D matrix in time, distance, and frequency domain. Figure 4 shows the STFT results of the A, B, and C points, where the first signal variation was observed at each fiber section.

Although the measured frequency spectra vary from case to case, the last fiber section always experiences the most intense vibration, as demonstrated by Figures 3 and 4. This can be explained in two aspects. Firstly, the fiber in the girder is the closest to the sawing position, so it experiences the strongest and probably longer perturbation. The mechanical vibration becomes less intense during its propagation across the bridge, resulting in a weak influence on the fiber above and below the bridge. However, the fiber is glued on the vertical wall in the girder, whereas the other sensing sections are placed horizontally, as shown in Figure 2. The vibration may travel vertically, in parallel with the fiber in the girder, thus most of the fiber experiences large perturbation because the fiber is most sensitive to the axial strain. However, the working principle of the COTDR system is much less sensitive to the radial strain [26]; the signal obtained from the other fiber section therefore varies mildly.

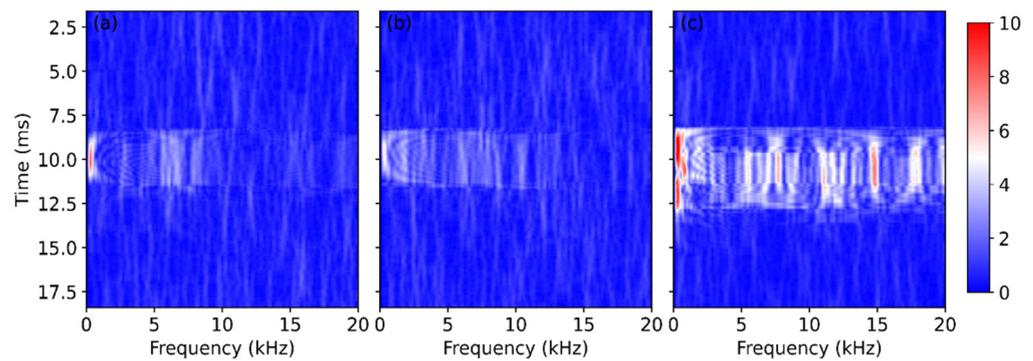
Figure 4. Temporal evolution of the frequency spectra at the first signal change points (a) at the bottom of the bridge; (b) above the deck; (c) inside the girder.

The figure exhibits significant signals at ~10 ms due to the sawing process. For the fibers installed below and above the bridge, most of the signal was below 10 kHz, as shown in Figure 4a,b, respectively. In comparison, the fiber attached inside the girder measured a signal over the whole frequency range up to 20 kHz, and the received signal was much stronger, as shown in Figure 4c.

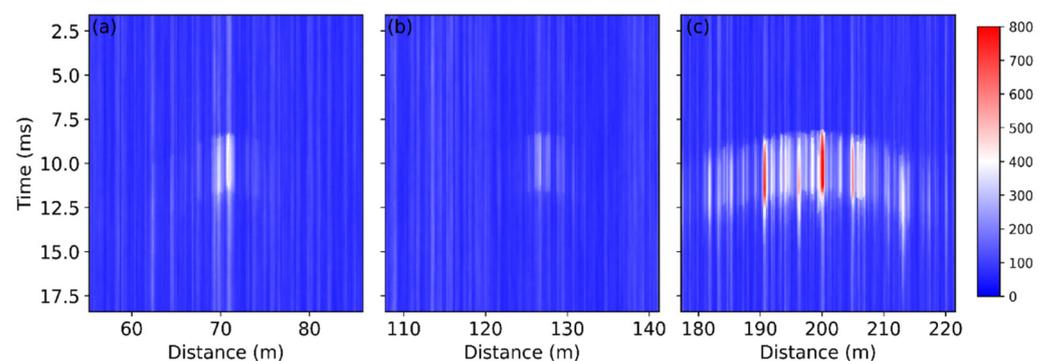
Figure 5. Temporal evolution of the frequency signal summed from 0 to 20 kHz (a) at the bottom of the bridge; (b) above the deck; (c) inside the girder.

The frequency analysis also helps identify the vibration events. The STFT results within the frequency range between 0 Hz and 20 kHz are summed up at each position and time point. The obtained results for each fiber section are plotted in Figure 5, respectively. The ratio between the peak value (~7000) and the standard deviation of the data (~1278) obtained inside the girder as shown in Figure 3a is about 5.5. On the contrary, the ratio is over 10 for Figure 5c. As a result, the vibration shown in Figure 5 is visually easier to identify than Figure 3, and the edges are more obvious. The frequency result might therefore be more helpful to analyze the vibration behavior, such as the wave propagation speed.

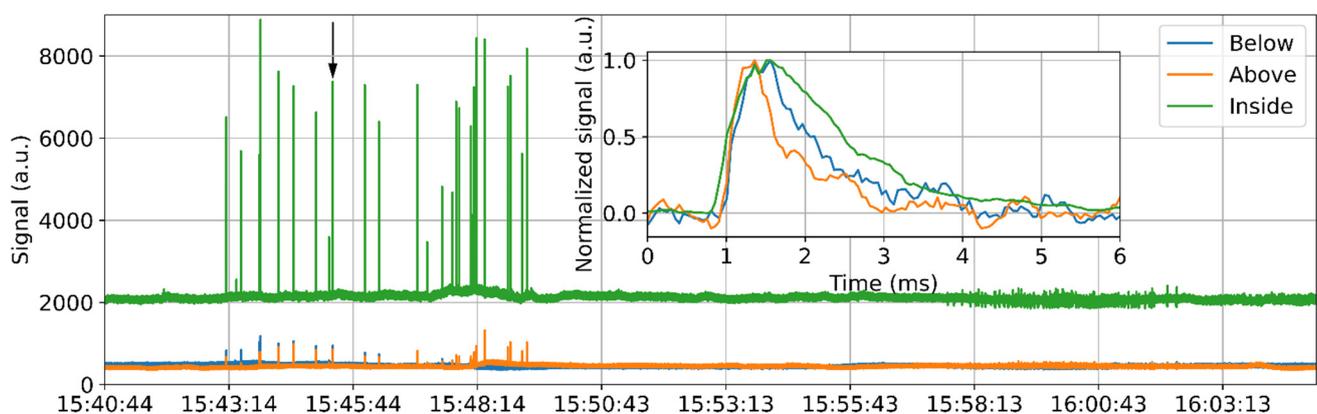
Figure 6. Temporal evolution of the summation result over the whole sensing section. Inset: zoom-in of one peak as indicated by the arrow; the DC level is removed and the peak is normalized to its maximum.

Another usage of the frequency result is to detect the effective sawing during the whole measurement. In this case, the STFT result over each sensing section and the whole frequency range is summed, so the obtained data changes only with time. The summation results for all three sensing sections are plotted in Figure 6 over a 20 min measurement time. Since the sensing fiber inside the girder is longer than other sections, the signal obtained from this part has a larger value, so the corresponding DC level is much higher than that of the other fiber sections. The sawing process started at about 15:43 and lasted about 6 min. Many peaks are shown during this time period in Figure 6, which are supposed to be caused by the interaction between the saw teeth and the rebar during the sawing process. Ideally, the peaks should have appeared at a fixed time interval as the saw blade rotated. However, the saw was held by hand and therefore moved during the sawing process, which caused the quasi-random occurrence of the peaks, as shown in Figure 6. The peak obtained inside the girder exhibits a very high value, as this fiber section is longer than the others and closest to the cutting point, as explained above.

The inset in Figure 6 shows the temporal evolution of one peak as indicated by the arrow; the DC is removed, and the peak is normalized to its maximum value for a better visualization. The green curve, representing the signal from the girder, starts to increase a bit earlier than other curves, as this fiber section is the closest to the sawing point. In addition, the corresponding signal decreases more gradually due to the long fiber section inside the girder. The occurrence time difference of different fiber sections may be very useful to locate the vibration source in practice. It is not likely that the actual vibration always occurs in proximity to the sensing fiber. By analyzing the time delay of the peaks detected by different fiber sections, the origin of the vibration can be located with a high accuracy. A similar method has been applied to determine the breakdown discharge position in a gas-insulated switchgear [27].

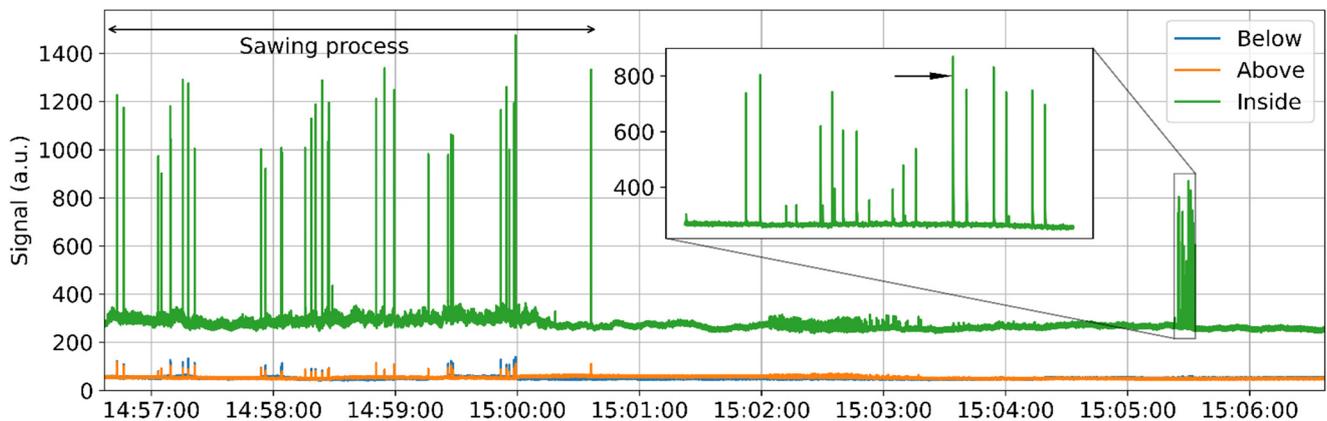
Figure 7. Temporal evolution of the summation result over the whole sensing section. The destructive testing process lasted ~4 min; then, an unexpected signal is detected, as shown in the inset.

The STFT result as shown in Figure 6 seems to be an effective tool to detect the occurrence of the sawing and was used to analyze all the data obtained during the three-day testing. Figure 7 shows another measurement over 10 min, and the sawing-induced signal peaks can also be clearly observed during the destructive testing process, which lasted ~4 min. Interestingly, the sensing fiber is vibrated ~1 min after the sawing, as the obtained signal varies slightly between 15:02 and 15:03, as shown in Figure 7. The fiber section is then perturbed significantly, as the inset clearly shows many peaks within a period of 10 s, which have lower amplitudes than the sawing-induced signal. This is totally unexpected, as the bridge was free from any external perturbation at that time. Hence,

this acoustic event could only have been triggered by some internal factor. A further and detailed analysis is necessary to determine the cause of this vibration.

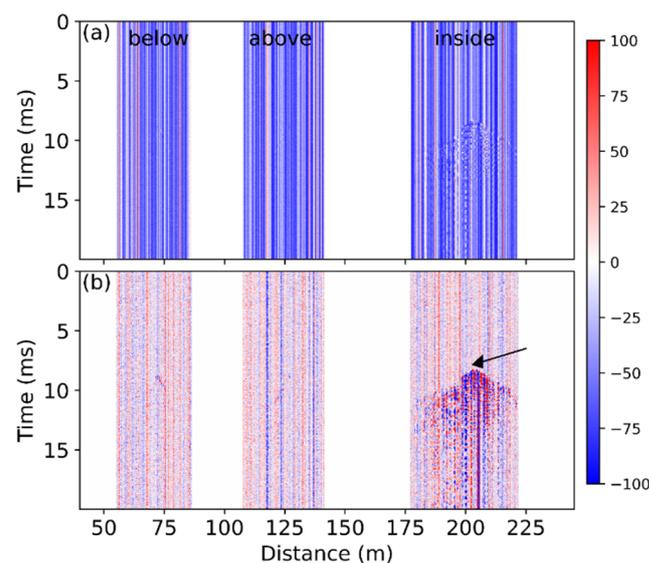
Figure 8. (a) Raw data of the unexpected signal and (b) data change compared with the first obtained trace. Arrow denotes the starting position of the vibration.

One of the unexpected acoustic events, as signified by the arrow in the inset, was thoroughly investigated. The raw data and the data change are plotted in Figure 8, and the vibration signal can only be observed clearly for the fiber section inside the girder. The arrow in Figure 8b indicates the starting point of the signal; it occurs at ~203.5 m, about 3.7 m away from the detected sawing position. However, the actual location of the vibration is closer to the sawing position as indicated by the zigzag shape; the location of this event is different from the sawing case. In addition, the spread of the vibration is different from the sawing-induced vibration. The boundary of the perturbed region as shown in Figure 8b is steeper than Figure 3b shows, indicating the propagation speed of this signal was much smaller than the sawing-induced signal. One possible explanation is the occurrence position of the vibration. The sawing-induced vibration mainly propagated along the reinforced steel; the speed of the sound in such a material is comparatively large. The unexpected vibration may occur inside the concrete, where the corresponding sound speed is smaller.

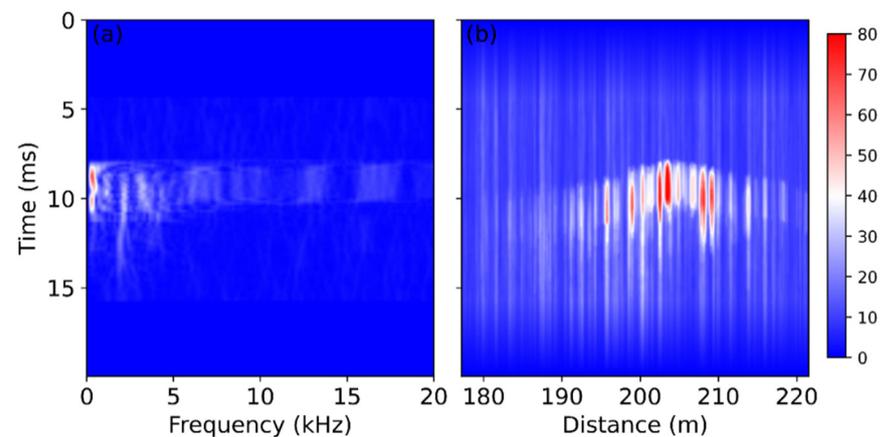
Figure 9. Temporal evolution of (a) the frequency spectra at 203.5 m and (b) the frequency result summed from 0 to 20 kHz over the whole sensing section.

The signal from the fiber section inside the girder was further analyzed in frequency domain. The STFT result of the signal at the starting point (203.5 m) is shown in Figure 9a. Most of the energy associated with this unexpected vibration is at a low frequency, below 1 kHz, unlike the sawing-induced perturbation, which exhibited several high-frequency components according to Figure 4c. The STFT result summed within the frequency range between 0 Hz and 20 kHz is shown in Figure 9b, and it exhibits large amplitudes at several positions. In comparison, the sawing-induced vibration shows a high amplitude only at the starting point, as presented in Figure 5c. The different behaviors may be dependent on the origin of the vibration. A very strong and large event may occur in the girder, so that the high amplitudes have been observed at many positions, as shown in Figure 9b. Further study on this signal might provide a concrete explanation.
