CASE REPORT

# Acute phosphine poisoning on board a bulk carrier: analysis of factors leading to a fatal case

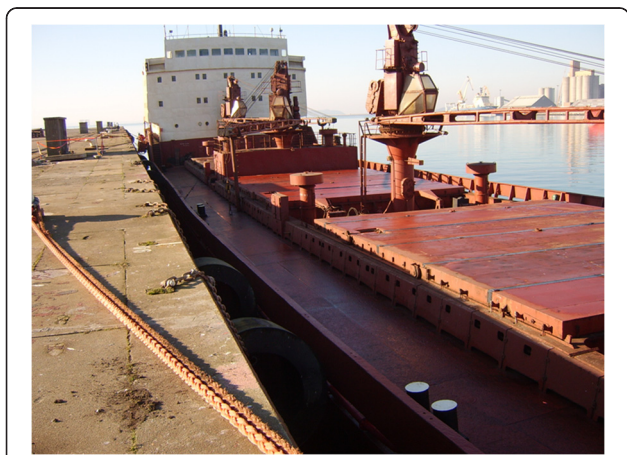
**Figure 1** Bulk carrier where the poisoning occurred.

Thirdly, gas had leaked had from the holds to the cabins. Several months after this incident, the expertise highlighted the causes of this leak. Moreover, Lloyds© found two main problems.

The first problem revealed holds which were no longer airtight due to rusting of certain partitions. The second related to the smoke detection system between the holds and the crew quarters (in particular the deceased seafarer's cabin). Initially shut off, the ducts were reopened because the crew wasn't aware of potential fumigation in the holds. This then meant that the gas could expand throughout these closed areas (firstly the holds, then the cabins). Therefore, the spreading of phosphine from the holds towards the quarters, located on the deck above could be explained by the fact that the ventilation ducts connecting the two areas of the vessel were not shut off.

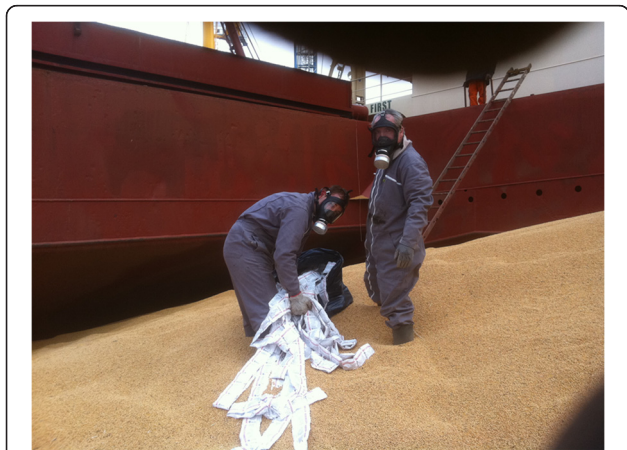
Phosphine is an expanding gas which spreads through the closed environment of holds reaching pesticide concentration (several hundred ppm). This concentration reaches its peak once all the aluminium phosphide pellets have reacted with the air or water in the holds then it decreases during the voyage, until hardly detectable after 3 weeks. Nevertheless, great care must be taken when handling the open pellet blisters after fumigation in order to control complete dissolution. Protective equipment must be worn in these cases (Figure 2).

**Figure 2** Operators handling blisters which contained aluminium phosphide pills.
