Article

# Microstructure and Properties of Heat Affected Zone in High-Carbon Steel after Welding with Fast Cooling in Water

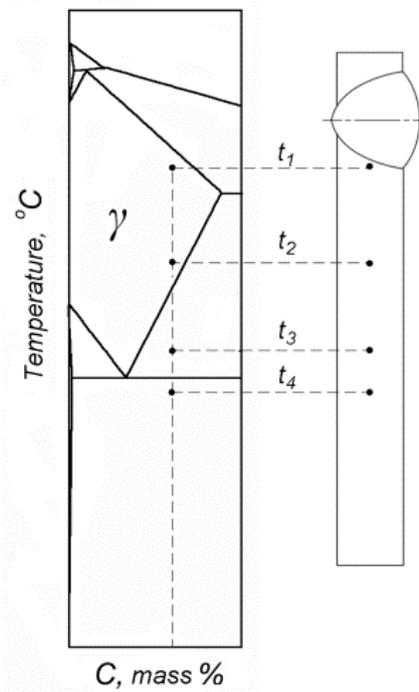
**Figure 1.** Schematic representation of different heating points in a heat affected zone (HAZ) during welding of 120Mn3Si2 steel in accordance with phase diagram adapted from [30].

The following considerations were taken into account for welding the quenched 120Mn3Si2 steel. The structure of material in a heat affected zone (HAZ) depends on the distance from the fusion line and on cooling rate. If fast cooling is used instead of slow cooling, then each HAZ layer heated above  $A_1$  critical temperature will be quenched.

A phase diagram for corresponding welded material may be used to predict the structure of HAZ. According to the phase diagram for 2.5% Mn alloy by Houdremont [30], steel with 2.5% Mn and 1.2% C (designated as 120Mn3Si2) can be quenched from single-phase  $\gamma$ -region in the near vicinity of the fusion line. This situation corresponds to temperatures from  $t_1$  to  $t_2$  on Figure 1. It is obvious that fast cooling from  $t_3$  will result in a predominantly martensitic structure formation; fast cooling from  $t_4$  will not result in phase transformation at all. Therefore, a sharp drop in hardness is expected between HAZ layers corresponding to  $t_3$  and  $t_4$ . The question remains, which structure would appear in HAZ between points corresponding to temperatures from  $t_1$  to  $t_2$ ?

According to the theory of heat treatment, the structure after quenching depends on the martensite start temperature ( $M_s$ ).  $M_s$ , in turn, depends on the chemical composition of austenite just before cooling. When 120Mn3Si2 steel is heated to a single-phase region, all carbon and alloy elements should dissolve in austenite. Therefore, the chemical composition of austenite will be the same as that for steel. This causes  $M_s$  to be at 30 °C and, therefore, leads the formation of an almost fully austenitic structure after quenching from single-phase region [28,29]. As a result, a hard martensitic layer in HAZ (quenching from  $t_3$ ) should be surrounded by two much softer layers: an austenitic layer from one side (quenching from  $t_1$  to  $t_2$ ) as well as a layer of highly tempered material (heating to  $t_4$ ).

The transformation of the structure and hardness in zones 1 to 6 is in accordance with the considerations outlined above (see Figure 1). The only difference is the sharp peak of hardness just at the fusion line. Figure 4a shows the microstructure that is observed along the width of the fusion line.

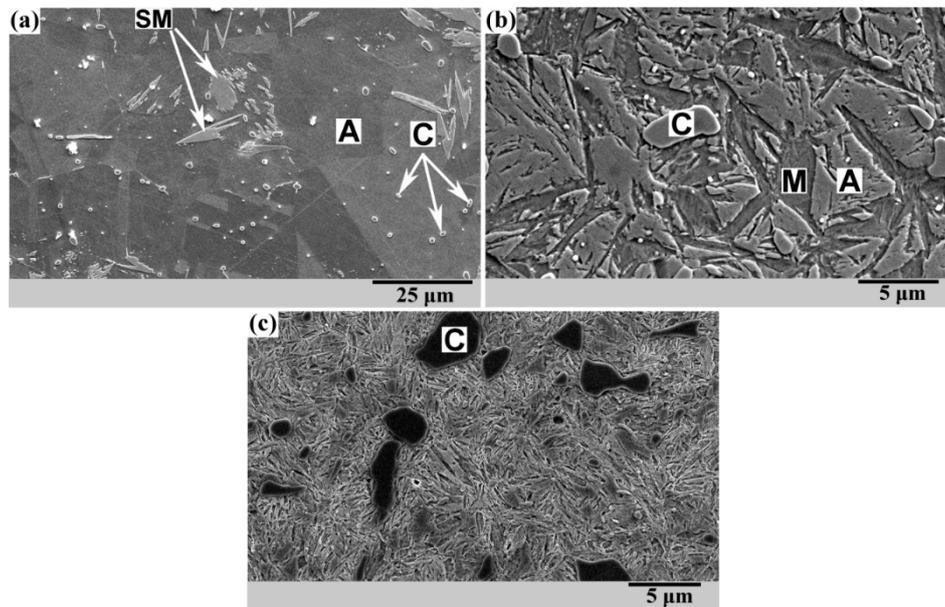
**Figure 2.** Microstructure of 120Mn3Si2 steel after quenching from different temperatures. Temperature of heating: (a) 1000 °C,  $\times 1000$ ; (b) 900 °C,  $\times 4000$ ; (c) 800 °C,  $\times 3700$ .

After quenching from 1000 °C, the structure was predominantly austenitic (A) containing a small amount of undissolved carbides (C) (Figure 2a). Due to the instability of the retained austenite, separate fields of surface martensite (SM) were observed. Surface martensite appears as thin plates during grinding/polishing in the process of sample preparation. The hardness of the material after quenching is 220–240 HV0.5.

Quenching from 900 °C provides a microstructure that differs significantly (Figure 2b). Undissolved carbides are much coarser. A significant amount of martensite is also present. This is due to  $M_s$  that is higher than that for quenching from 1000 °C. The rise of the  $M_s$  is caused by the lower carbon concentration in austenite at 900 °C than that at 1000 °C. The hardness of the material after quenching is 480–500 HV0.5.

A further decrease of quenching temperature down to 800 °C leads to a microstructure of hardened hypereutectoid steel (Figure 2c): a predominantly martensitic matrix with coarse undissolved carbides. The hardness of the material after quenching is 790–800 HV0.5.

The thermally unaffected structure depends on the preliminary thermal treatment of 120Mn3Si2 steel. Three different possible microstructures are shown in Figure 2. Quenching from 800 °C (see Figure 2c) results in a predominantly martensitic microstructure of high hardness and high brittleness, and

therefore it is unlikely to be used in practice. Quenching from 1000 °C and 900 °C (see Figure 2a,b) results in a less brittle microstructures which possess even higher abrasive wear resistance than the predominantly martensitic one [29]. Quenching from 900 °C is more favorable than quenching from 1000 °C because it provides slightly higher abrasive wear resistance [29] and accelerates bainite transformation at 250 °C [28]. The acceleration of bainite transformation is caused by pre-existing martensite [33–35] which is present in the microstructure after quenching from 900 °C (see Figure 2b).

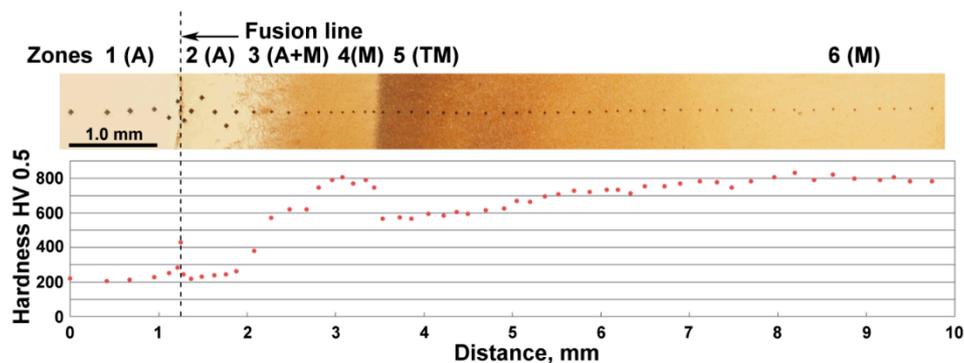
Figure 3 shows the change of macrostructure and hardness of welded 120Mn3Si2 steel from weld metal through HAZ to thermally unaffected material. Several zones may be distinguished here. Zone 1 (weld metal) should have austenitic structure (A) according to the chemical composition of the electrode. The hardness of this zone is about 200–220 HV0.5, which corresponds to that of austenite. Zone 2–6 represent welded 120Mn3Si2 steel. Zone 2 has austenitic (A) structure with the same hardness as well. This zone corresponds to quenching 120Mn3Si2 from temperatures between  $t_1$  to  $t_2$  (see Figure 1). Zone 3 comprises mixed austenite + martensite (A + M) structure and corresponds to quenching from temperatures between  $t_2$  and  $t_3$ . The hardness in zone 3 gradually increases with the distance from the fusion line. Hardness reaches its maximum about 800 HV0.5 at approximately 1.6 mm from the fusion line. Zone 4 with preliminary martensitic (M) structure begins here and is ~0.5 mm thick. This zone corresponds to quenching 120Mn3Si2 steel from  $t_3$ . At the end of zone 4 a sharp drop in hardness can be seen. This is due to the transfer from zone 4 (quenching during welding) to zone 5 where the structure consists of tempered martensite (TM). Zone 5 is about 3.5 mm wide and gradually transforms into zone 6 with the structure of martensite (M) which is not affected by the welding heat.

**Figure 3.** Microstructure and hardness of HAZ of 120Mn3Si2 steel after welding with fast cooling in water. A— austenite; M—martensite; TM—tempered martensite.

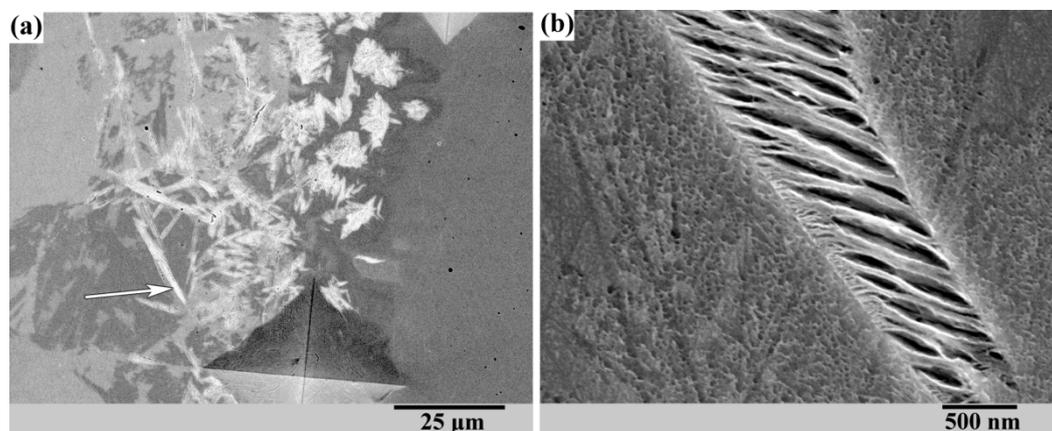
The microstructure suggests that a certain amount of martensite appears inside the fusion line. Figure 4b represents a closer view of one of the martensite plates (see arrow on Figure 4a). According to the microstructure shown in Figure 4b, the martensite is tempered obviously due to the welding heat. This may be the reason why no cracks are observed in and near the fusion line despite a decent amount of martensite and quite high hardness.

**Figure 4.** SEM micrographs of martensite inside fusion line in different magnification: (a)  $\times 1000$ ; (b)  $\times 33,000$ .

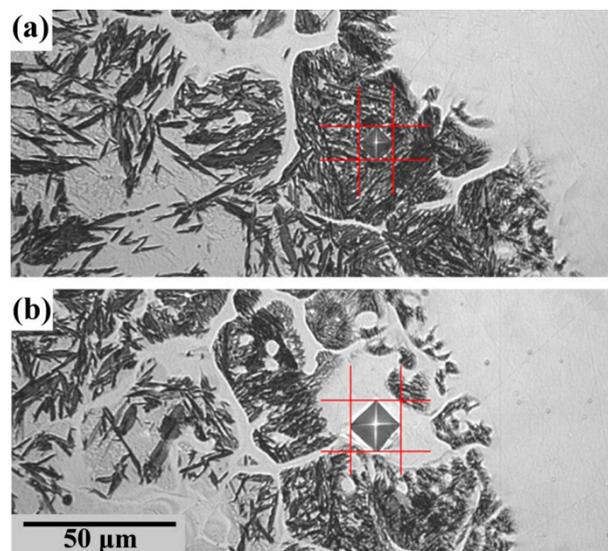
Figure 5 shows indents after microhardness measurement of unmelted grain (Figure 5a) and surrounding remelted metal (Figure 5b). Martensite (see indent on Figure 5a) seems to appear inside the unmelted parts of the grains. These unmelted parts cannot be diluted by electrode metal. Therefore, the reason for martensite’s appearance inside unmelted grains in the fusion line cannot be connected with the composition of the electrode.

**Figure 5.** Indents after microhardness measurement of unmelted grain (a) and remelted metal (b). Values of microhardness: (a) 740 HV0.05; (b) 329 HV0.05.

Another observation is that martensite inside the fusion line appears as isolated “grains” surrounded by austenitic bands (Figure 5). This corresponds with the fact that fusion line is consisted of partially melted grains of base material. These grains are surrounded by remelted metal which is a mixture of base and electrode materials.

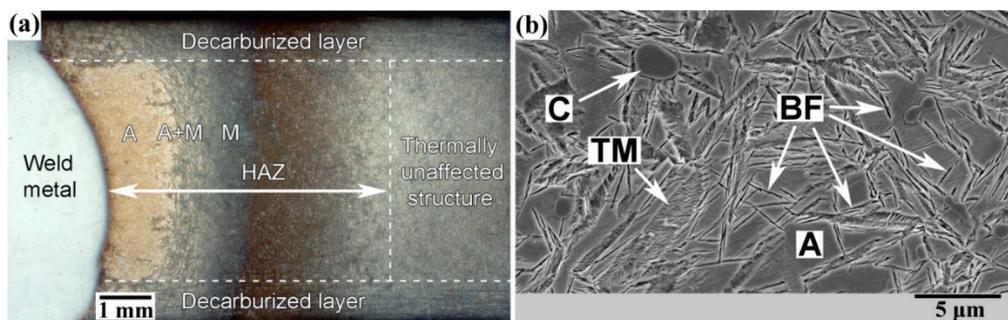
Figure 6a shows the typical macrostructure of a quenched 120Mn3Si2 steel sample welded with rapid cooling in water. A decarburized layer about 1 mm in depth is present on both sides of the welded sample. The microstructure here would be preliminary martensitic either in HAZ or in a thermally unaffected zone.

Figure 6b shows the typical microstructure of 120Mn3Si2 steel after quenching from 900 °C and isothermal treatment at 250 °C during 2 h. The microstructure contains austenite A, carbides C, tempered martensite TM, and thin plates of bainitic ferrite BF. This microstructure is significantly more ductile than that without isothermal holding (see Figure 2b) [28] and has abrasive wear resistance as high as untempered martensite after quenching from 800 °C [29]. Thus, a combination of quite high abrasive wear resistance (like untempered martensite) and significantly higher ductility of lower bainite [36–38] makes this microstructure the most favorable for application in abrasive wear conditions.

**Figure 6.** (a) Macrostructure of HAZ of 120Mn3Si2 steel after welding with rapid cooling in water; (b) One of the possible thermally unaffected structures—quenching from 900 °C and isothermal treatment at 250 °C during 2 h,  $\times 4000$ . A—austenite; C—carbides; TM—tempered martensite; BF—bainitic ferrite.

Three zones are presented in HAZ which are analogous to zones 2 to 4 from Figure 2. These zones are located in the core of 120Mn3Si2 sample between the decarburized layers and appear after welding independent of the previous thermal treatment of 120Mn3Si2 steel. The zones are austenite (A), austenite + martensite (A + M), and martensite (M).

In practice, a friction surface can work under any of two possible modes of mechanical wear or even under both of them. Therefore, it would be rational to provide both predominantly martensitic and predominantly austenitic structures inside the wear resistant element. This goal is precisely achieved in a 120Mn3Si2 steel plate with decarburized layers (see Figure 6a). The following is the rationale behind this statement.

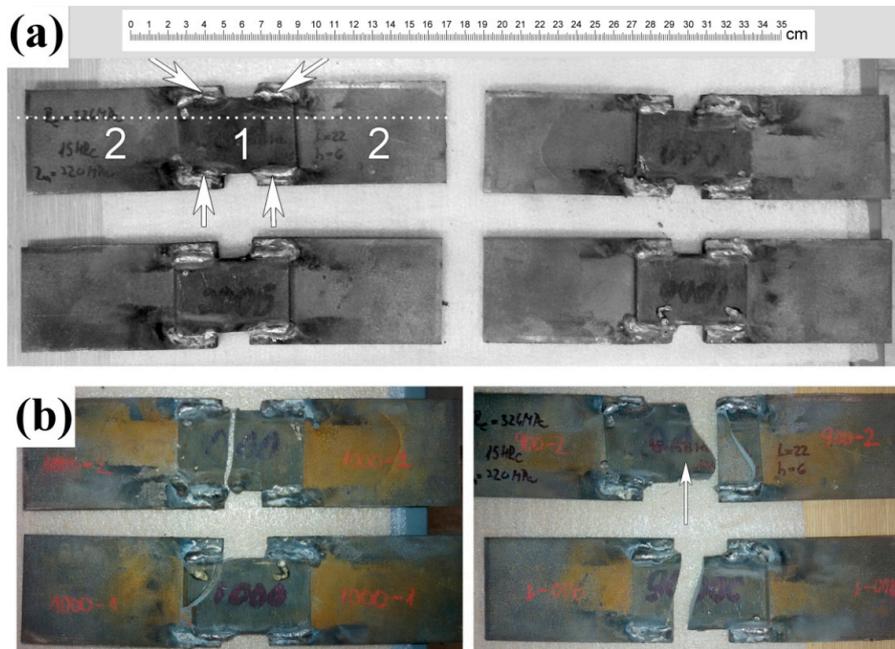
The samples appearance after tensile test is shown in Figure 7b. It should be noticed that all four samples were broken through 120Mn3Si2 quenched plate, not through welds.

Figure 7. Non-standard welded samples from 120Mn3Si2 steel (1) and 09Mn3Si2 steel (2) before (a) and after (b) testing.

The loading diagram for sample #4 (see Figure 7, arrow; Figure 8) confirms the assumptions given above. Arrow 1 on Figure 8 indicates a sharp drop in load because of initial crack. The crack stops at a certain depth and some plastic deformation of the core takes place (arrow 2). The horizontal site (arrow 3) corresponds to the interesting moment. The crack reaches the weld (arrow 1 on Figure 9) and the austenitic layer bears the load during a certain time with concomitant plastic deformation.

Since no one sample was broken in the weld metal (see Figure 7), ISO 4136 standard tests were performed in order to assess tensile strength of welding joints. The standard welded samples were 5 mm thick. One part of the sample was 120Mn3Si2 steel without heat treatment, the other one was 09Mn2Si steel. Eight samples were prepared. The samples were plunged into water by the 120Mn3Si2 side during welding.

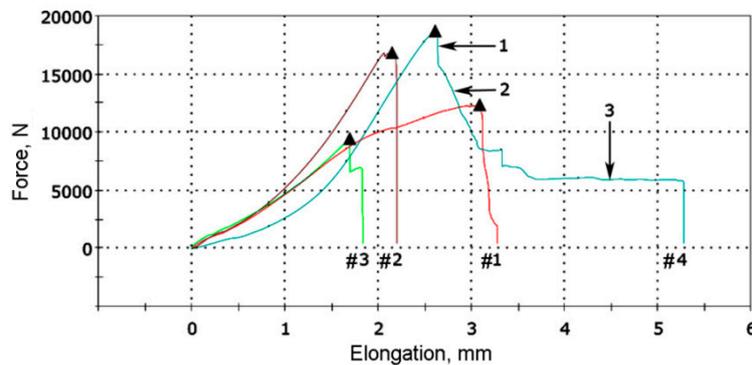
The loading diagrams for all four samples are shown in Figure 8. The plates of 120Mn3Si2 steel for samples #1 and #2 were quenched from 1000 °C. The plates for samples #3 and #4 were quenched from 900 °C. The minimal and maximal breaking loads recorded were 9488 N and 18,690 N for samples #3 and #4, respectively. In this way, no significant difference in breaking load was noticed between plates quenched from different temperatures. Another output was that the breaking load appeared an order of magnitude lower than expected. The cross-section of quenched 120Mn3Si2 plates was approximately 200 mm<sup>2</sup>. Therefore, nominal stresses in the base material at the moment of breakage were 47 MPa (9488 N load) and 93 MPa (18,690 N load).

Figure 8. Loading diagram for non-standard welded samples.

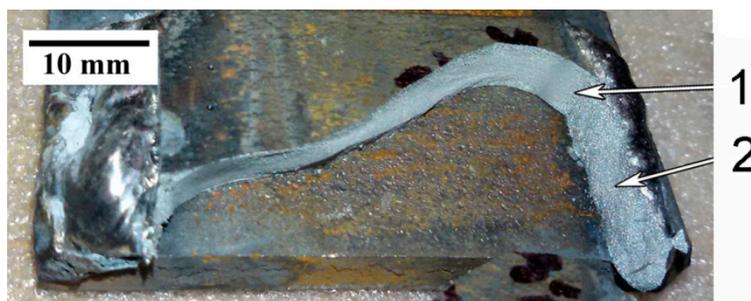
Figure 9. Broken sample #4: (1) core of broken 120Mn3Si2 plate; (2) weld that carried the load in the last stage of failure.

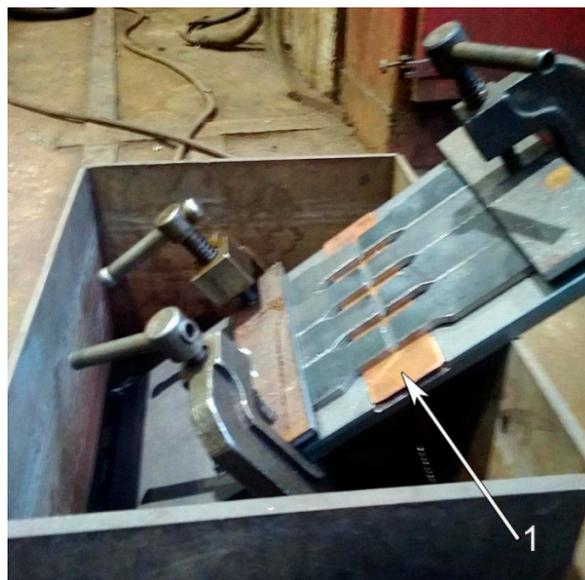
Figure 10 shows four clamped samples which are located in the reservoir ready for welding. A copper plate (arrow 1) was initially intended to facilitate cooling. It was found that that the water reached the welding arc via gap between the sample and copper plate because of surface tension. Therefore, the copper plate was not used in the further experiments.

Figure 10. Standard welded samples clamped before welding.
