# Elusive Differential of a Painful Unstable Total Knee Arthroplasty – Metal on Cement Disease

Jagadale V (August 26, 2019) Elusive Differential of a Painful Unstable Total Knee Arthroplasty – Metal on Cement Disease. Cureus 11(8): e5495. DOI 10.7759/cureus.5495

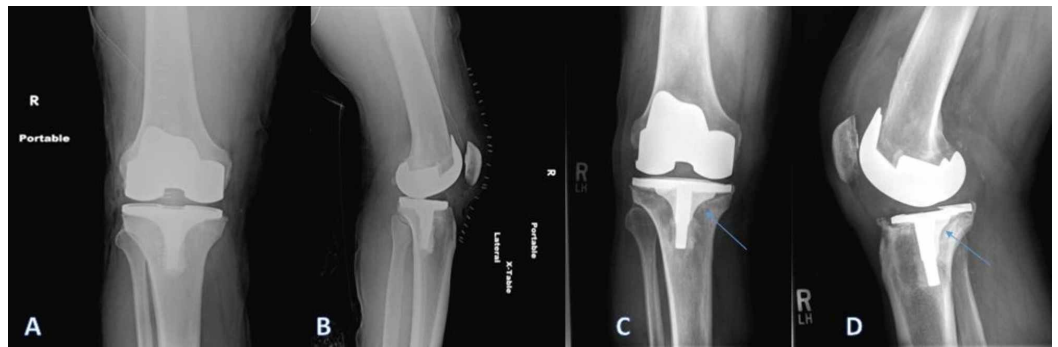
**FIGURE 1: Right knee anteroposterior (AP) and lateral (LAT) radiographs taken immediately after the initial surgery (A, B) in comparison with those taken just prior to the revision surgery (C, D) showing minimal periprosthetic osteolytic areas underneath the tibial base plate with well-fixed cement-bone interface on the rest of the implant but no signs of metal-cement de-bonding**

Routine radiographs of the knee joint (Figure 1), three-phase bone technetium scan (Figure 2), and computed tomography (CT) scans (Figure 3) were negative for any signs of component loosening, malalignment, component asymmetry, or maltracking and only showed moderate effusion.

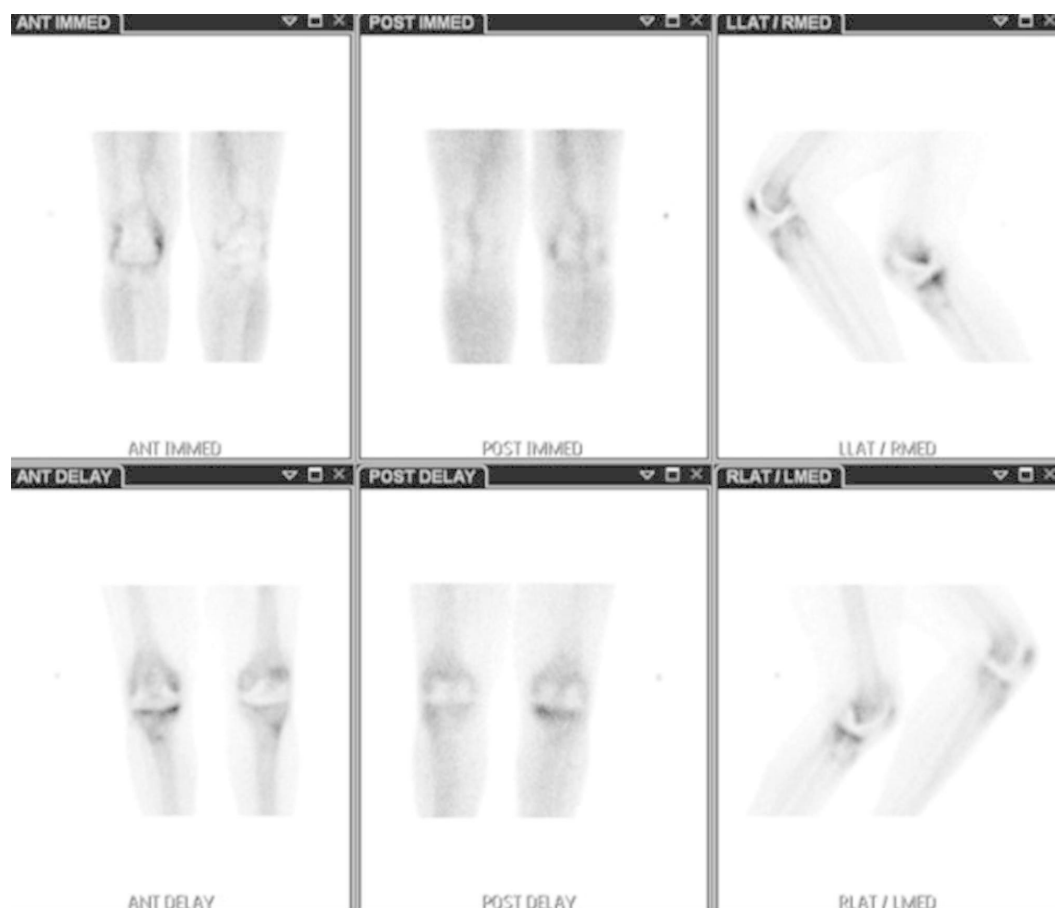
**FIGURE 2: Three-phase bone scan shows increased radiotracer uptake in the periprosthetic region of the right knee on the venous phase of the flow, blood pool, and delayed**

## series, which are consistent with periprosthetic osteolysis

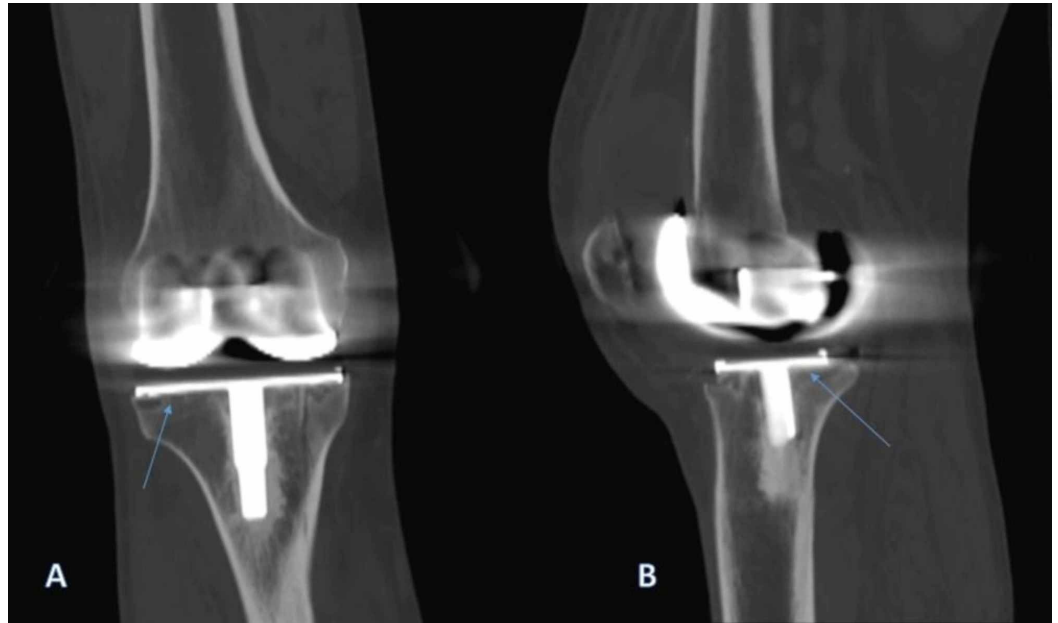
**FIGURE 3: Computed tomography (CT) scan of the right knee**

Coronal (A) and sagittal (B) views show minimal periprosthetic osteolysis areas underneath the tibial base plate with no obvious loosening of the components

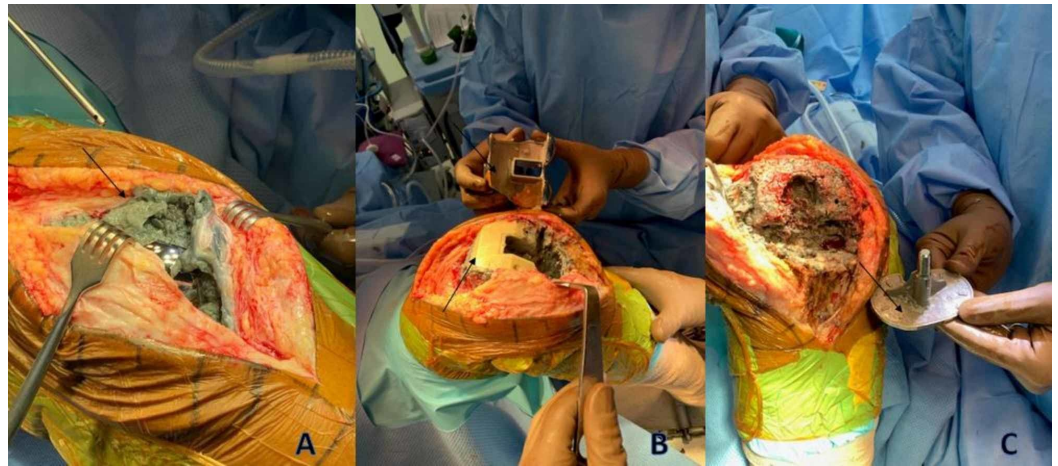
**FIGURE 4: Intraoperative photographs of gross examination of tissue staining of pseudotumor from metal-on-cement disease**

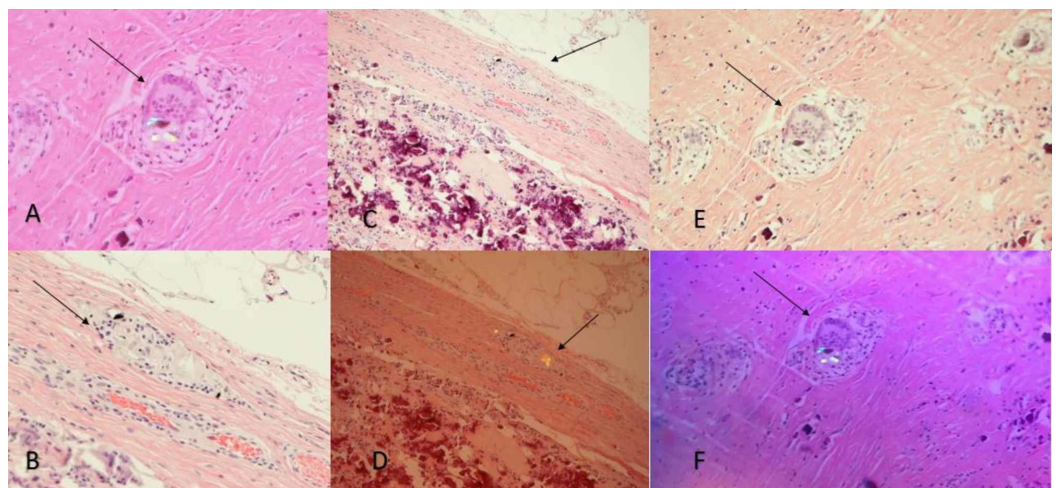
**FIGURE 5: Histopathological slides with photomicrograph showing Type 1 histology of light to dark pigmented foreign body deposits under light microscopy (A, B, C) and under polarized light (D, E, F) in fibroconnective tissue with necrosis consistent with metal particle disease**

Hematoxylin and eosin stain, original magnification x100

After bone surface preparation, tourniquet inflation, implant sizing, and balancing flexion-extension gaps with trial implants, cemented short-stemmed components were implanted in the knee using low-viscosity tobramycin antibiotic-loaded bone cement. A standard polyethylene insert trial was placed until the cement hardened. The patella was left unresurfaced due to fear for patellar fracture. Adequate hemostasis was achieved before the beginning of the wound closure, a drain was not placed, and the wound was closed in layers in a regular fashion. Final cultures, as well as histopathological findings, were negative for infection but positive for adverse local tissue reaction resembling metallosis (Figure 5A-C) in combination with polyethylene particles (Figure 5D-F) and cement (Figure 5E-F) particles.
