Neck fracture of the Exeter stem in 3 patients

A cause for concern?

Aleksi REITO, Antti ESKELINEN, Jorma PAJAMÄKI, and Timo PUOLAKKA

Coxa Hospital for Joint Replacement, Tampere, Finland
Correspondence: aleksi.reito@fimnet.fi
Submitted 2015-06-15. Accepted 2015-08-31.

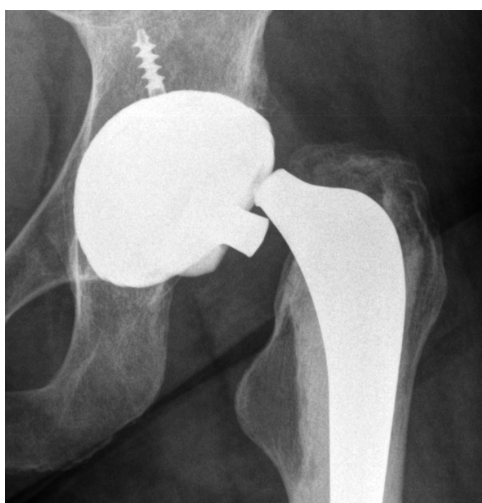
Figure 1. The left hip of patient 1, note the notch in the stem.

Patient 1 (Figure 1)

A 63-year-old woman (height 1.70 m, weight 92 kg, BMI 31) with developmental dysplasia of both hips underwent bilateral hybrid total hip replacement (THR) using the cemented Exeter V40 stem (offset 44 mm, size 3) and uncemented Trident PSL (Stryker) with alumina-on-alumina ceramic bearing (BioloX Forte; Ceramtec, Plochingen, Baden-Württemberg, Germany) at our hospital in 2004. A ceramic femoral head with a diameter of 36 mm and offset of +5 mm was used. Short-term functional outcome was excellent. 5 years and 3 months later, the patient tripped on a flat floor and fell down, and was unable to move her left leg due to severe pain. Plain radiographs revealed a neck fracture in the Exeter stem. She underwent revision surgery, during which both the remnant of the Exeter stem and the uncemented acetabular component were found to be well fixed. A posterior notch distal to the fracture line was seen in the stem, indicating neck-cup impingement. The fractured stem was removed and a new short (125-mm) Exeter Revision stem (offset 44 mm, size 0) was cemented

into the well-retained cemented mantle. The well-fixed cup was retained. However, both the ceramic liner and the femoral head were replaced with new ones that corresponded with the original liner and the head, both in diameter and in offset.

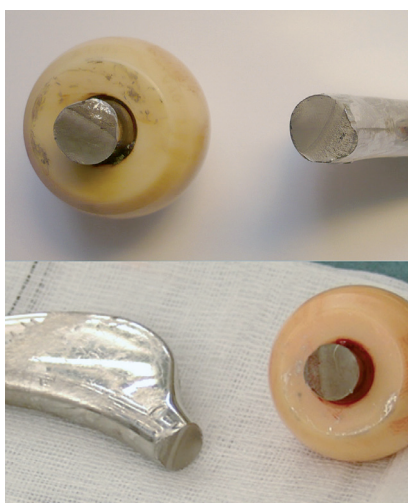
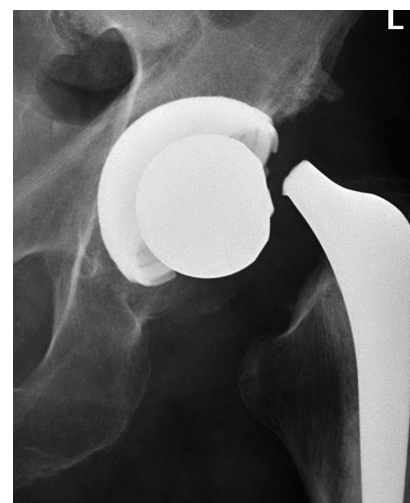
Figure 2. A. The left hip of patient 2.

Patient 2 (Figure 2)

An 87-year-old man (height 1.78 m, weight 84 kg, BMI 27) underwent hybrid THR at our hospital in 2009, due to advanced osteonecrosis of the left femoral head. On the femoral side, a cemented Exeter V40 stem was used (offset 44 mm, size 2). A femoral head made of stainless steel (Orthinox; Stryker) with a diameter of 40 mm and offset of +8 mm was coupled with the Exeter stem. On the acetabular side, a press-fit cup (Trident) with highly crosslinked polyethylene liner (Trident X3 acetabular insert) was used. In August 2013, the patient bent forward to treat an ulcer in his lower limb. He had a feeling of subluxation, and the replaced hip became painful. Plain radiographs revealed a neck fracture of the Exeter stem. He underwent revision surgery, during which both the stem remnant and the cup were found to be well fixed. The fractured stem was removed and a short Exeter revision stem (offset 44

mm, size 0) was cemented into the well-retained cement mantle. The damaged polyethylene liner was exchanged for an identical new one. Similarly, the femoral head was replaced with a new one that was identical to the one used in the primary THR.

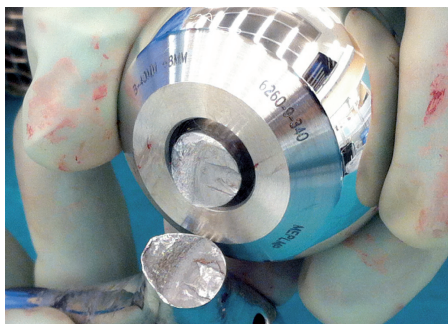
Figure 2. B. The fractured stem of patient 2.

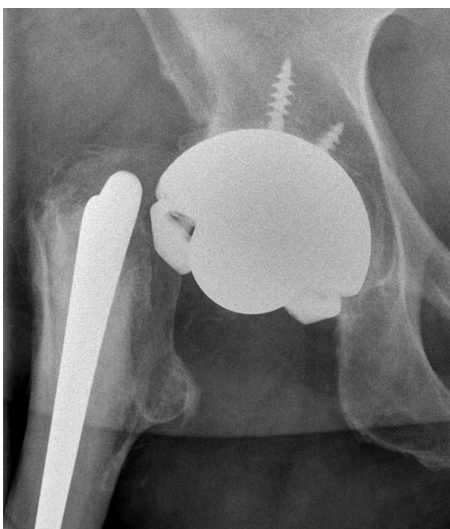
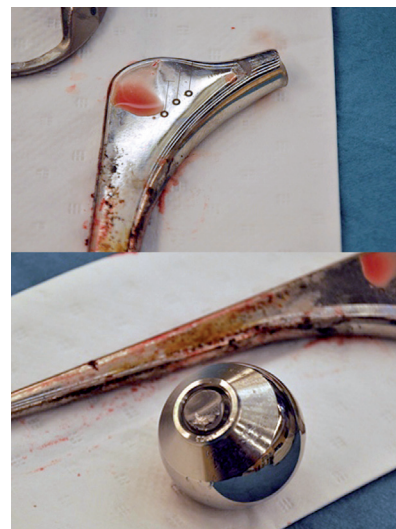
Figure 3. The right hip of patient 3, note the notch in the stem.

Patient 3 (Figure 3)

A 76-year-old man (height 1.76 m, weight 120 kg, BMI 38) underwent primary THR on the right hip at another hospital in 2000. A cemented Exeter stem (V40) and an undisclosed cemented cup were used. Because of recurrent dislocations, the hip was revised in 2003 and the original femoral head was replaced with a 32-mm head made of stainless steel (+10 mm offset). However, after revision surgery the patient still experienced 3 more dislocations, which were treated with closed reduction. After the third dislocation in January 2012, a second reoperation was performed in February 2012. In this second revision, the original Exeter stem was revised to a new standard Exeter V40 stem (offset 44 mm, size 1). A CoCr femoral head with a diameter of 36 mm and an offset of +10 mm (LFIT; Stryker) was used. The cemented cup was also revised to a press-fit trabecular metal cup (Trabecular Metal Revision Shell; Zimmer, Warsaw, IN). A constrained polyethylene liner (Longevity Constrained Liner; Zimmer) was used on the acetabular side. Recovery after the second revision was uneventful. In November 2014, however, the patient had a feeling of subluxation in the revised hip while turning in standing position. This feeling was immediately followed by severe pain in the groin area. Plain radiographs revealed a fracture in the stem neck. The hip was again revised. Both components were found to be well fixed. An anterior notch distal to the fracture line was seen in the stem, indicating neck-cup impingement. The constrained liner was removed and a new constrained liner (Longevity) was cemented inside the trabecular metal shell. The fractured stem was removed and a new Exeter stem (offset 50 mm, size 1) was cemented after the old cement mantle had been thoroughly removed. A stainless steel femoral head with a diameter of 36 mm and an offset of +5 mm was used (Orthinox; Stryker). Recovery after the third revision was uneventful.
