# SCREW MIGRATION IN TOTAL KNEE ARTHROPLASTY: CLINICAL REPORT

Complications from total knee arthroplasty caused by the implanted material are rare, with the exception of polyethylene wear. Descriptions of screw migration into the knee joint cavity are very rare. The authors report intra-articular migration of a polyethylene safety screw in a case of total knee arthroplasty,

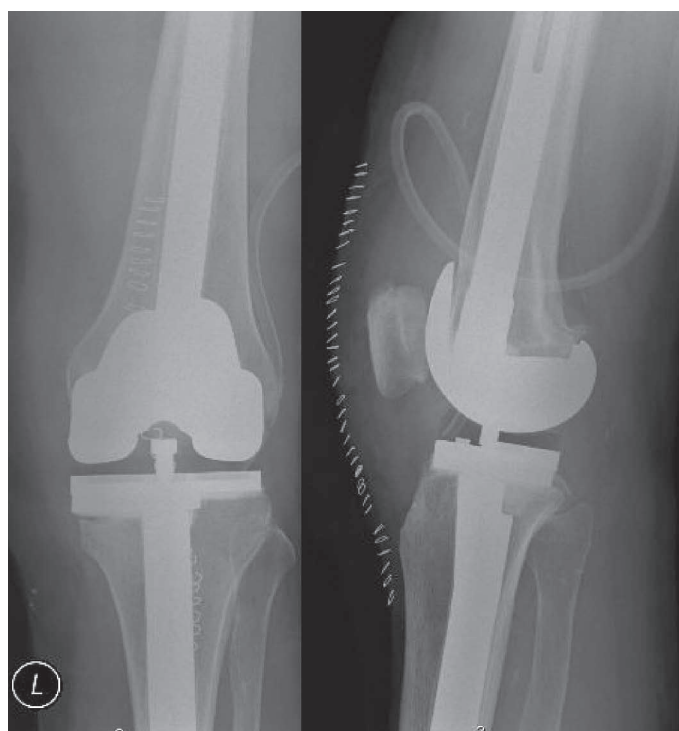
**Figure 4** – Postoperative control

We cannot be sure that this was the best solution, but controls carried out over the subsequent two years showed that the screw was stable. We have not had any other case of migration of a screw as a free body.
