Article

Damage Detection of Concrete-Filled Square Steel Tube (CFSST) Column Joints under Cyclic Loading Using Piezoceramic Transducers

Keywords: concrete-filled square steel tube column (CFSSTC) joints; piezoceramic transducers; smart aggregates; cyclic loading

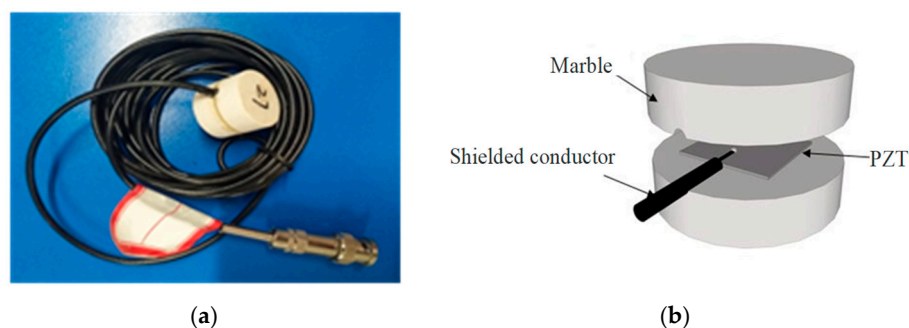
Figure 1. The embeddable piezoceramic smart aggregate. (a) The photo of a piezoceramic smart aggregate; (b) Three-dimensional schematic of a piezoceramic smart aggregate.

Lead zirconate titanate (PZT), as a type of piezoceramic material, has the advantages of good linearity, fast response, low cost, and sensing and actuating capacities [61], and has been widely used to generate and detect stress waves [62–65] for the purpose of structural damage detection [66–69] and health monitoring [70–72]. However, PZT is extremely fragile, and therefore it must be properly protected before deployment in civil structures. Two types of protected PZT transducers are fabricated and used in this paper. The first one is the smart aggregate, shown in Figure 1a, and formed by encapsulating a piezoelectric patch in two marble blocks, as shown in Figure 1b. With this design, the smart aggregate can be easily embedded in a concrete structure. The second type used in this paper is a piezoceramic disk transducer, as shown in Figure 2a, and it is protected by a copper shell, as shown in Figure 2b. With this design, the piezoceramic disk can be easily bonded to the surface of a structure. The detailed parameters of the selected PZT in this research are shown in Table 1.

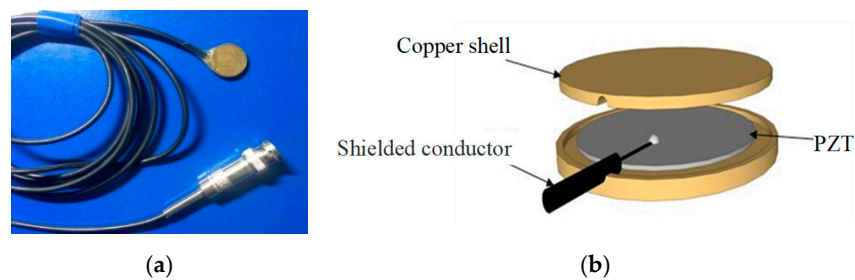
Figure 2. The surface bondable piezoceramic disk sensor. (a) The photo of piezoceramic disk; (b) Three-dimensional schematic of piezoceramic disk.

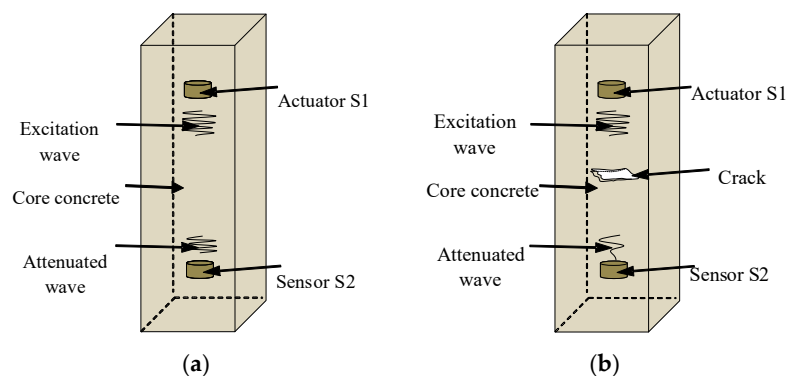
Figure 3. Active sensing approach to damage detection of core concrete using smart aggregates. (a) Core concrete in a healthy state; (b) Core concrete with a crack.

Schematic diagrams of monitoring the concrete core damages and the debonding damages based on piezoceramically-enabled active sensing approaches are presented in Figures 3 and 4, respectively. Upon excitation from a signal from a function generator with amplification, the piezoelectric actuator S1 in the concrete core generates stress waves, which are transmitted to the piezoelectric sensor S2 along the concrete core of the structure. As shown in Figure 3a, when there is no damage in the concrete core, a stronger signal is received by the sensor S2. However, as shown in Figure 3b, with the presence of a crack or cracks, that function as stress relief for the stress waves, a weaker signal is detected by the sensor S2. Meanwhile, the stress waves are also transmitted along the core concrete, the interface between the concrete and steel tube, and the steel tube of the structure, and finally reach the piezoelectric sensor S3, that is bonded on the outer surface of the steel tube. As shown in Figure 4a, when there is no debonding between the concrete and the steel tube, a stronger signal is received by the sensor S3. However, as shown in Figure 4b, with the presence of a debonded area between the concrete and the steel tube, a weaker signal is detected by the sensor S3. As shown in Figures 3 and 4, when the stress wave encounters cracks or debonding damage in its propagation path, the amplitude and energy of the stress wave will be attenuated. The presence of damage and the extent of damage in the specimen can be identified by an analysis of signal amplitude changes from sensors S2 and S3.

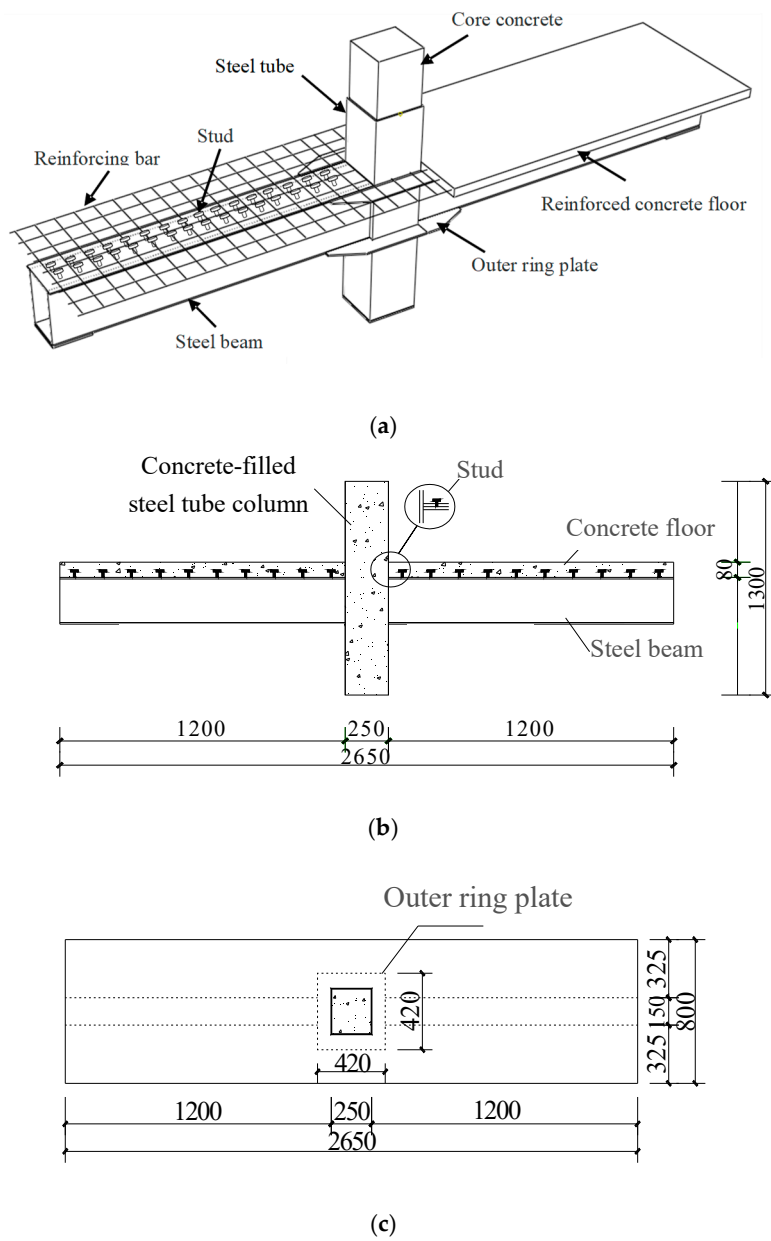
Figure 5. The details of the joint specimen. (a) Joint drawing; (b) The cross section drawing of joint; (c) The vertical view of joint.

Two specimen joints were fabricated, named JD1 and JD2, as shown in Figure 5. A piezoelectric disk sensor was bonded the outer surface of the steel tube to identify the debonding damage of the structure in the experiment. Two SAs were embedded in structure internal to identify the internal damage of the structure. The layouts of the piezoceramic disk sensor and SAs are shown in Figure 6, and the distance between the two embedded SAs is 200 mm. S1 was used as actuator and S2 was used as sensor to monitor the internal damage of the structure. Meanwhile, S1 was used as actuator and S3 was used as sensor to identify the debonding damage of the structure. The schematic of the experimental instrumentation is shown in Figure 7. It is well known that the frequency of the signal is the main factor affecting the propagation distance of the signal in a medium. When the frequency is low, the signal can propagate a long distance in the medium. When the frequency is high, the propagation distance of the signal in the medium is greatly shortened. On the other hand, a stress wave with a higher frequency is more sensitive to smaller cracks. By considering the tradeoff between the propagating distance and sensitivity to small cracks, we choose a sine wave with the frequency of 12.35 KHz and the amplitude of 8 V as the actuator excitation signal. The signals received by sensors are collected by the INV data acquisition and analysis system, and the sampling frequency is 102.4 KHz. The data acquisition length is 5 s.

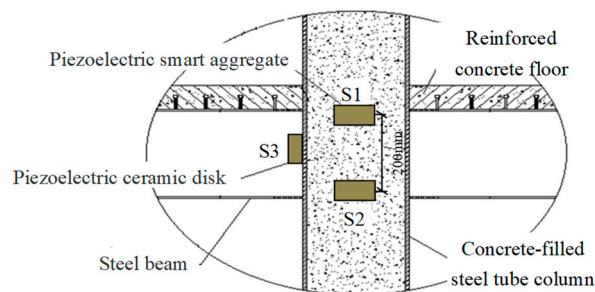
Figure 6. Layout of piezoceramic transducers installed in a joint.

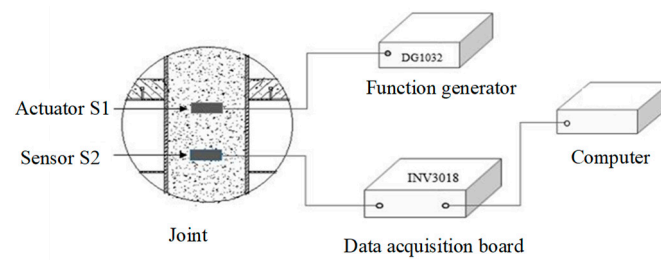
Figure 7. Schematic of the test monitoring system.

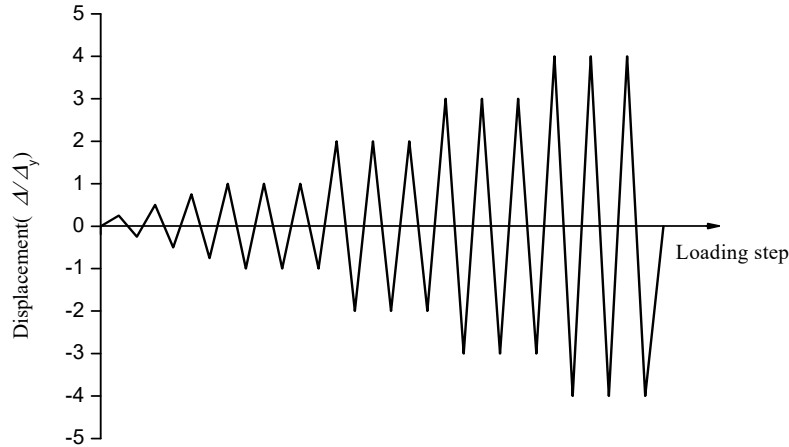
Figure 9. The cyclic loading schedule.

Before the test, the ABAQUS software was used to establish the joint specimen model and to load the model monotonously [73,74]. Through the analysis of the skeleton curve under the monotonic load of the joint, the yield displacement (Δ_y) and the yield load (P_y) of the joint specimens were estimated, which is used as a reference when the test is officially loaded and adjusted according to the actual situation. The displacement control loading method was used in this test. The Δ_y was 8 mm according to the finite element, and the single loading is performed by using 2 mm, 4 mm, 6 mm, etc. In the preloading stage, Δ_y was determined after the specimen has yielded. When the displacement exceeded Δ_y , the control load was applied with a multiple of the displacement, and each loading displacement was repeated three times until the specimens damaged, and then the loading was stopped. The test loading schedule is shown in Figure 9. The amplitude of the specimen can be used as a parameter to represent the signal during the loading process. The damage of the joint specimen will cause the signal to change in amplitude, and the amplitude of the signal will continue to decay following the

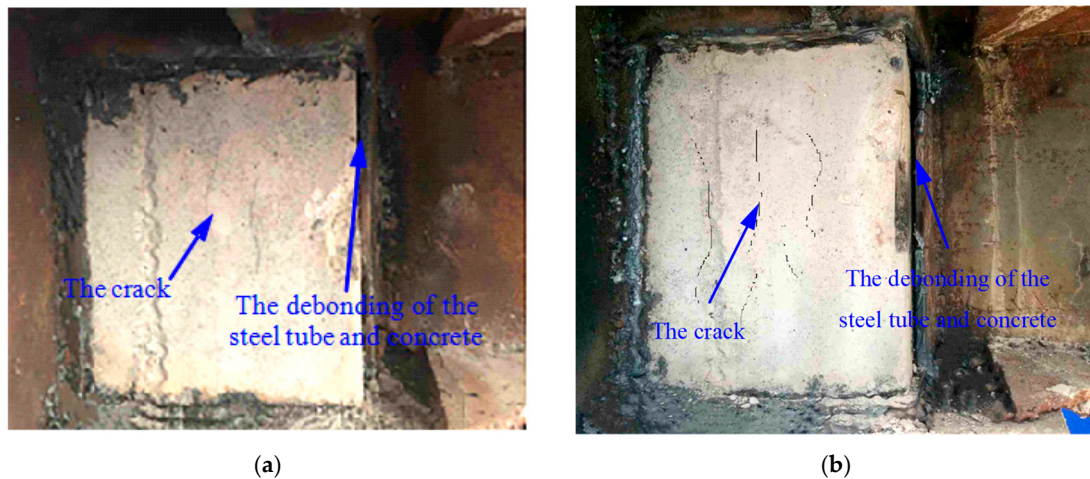
Figure 11. Damages to the joint specimens (cut-away view). (a) Specimen JD-1; (b) Specimen JD-2.

It must be noted that loading should be stopped if one of the following conditions is reached: (1) the weld of the steel beam in the core area of the joint is completely broken or severely buckled at the flange; (2) the lateral loading force of the specimen falls below 85% of the peak loading force. The damage phenomena of the two specimens are basically the same and JD-1 is taken as an example to describe the test phenomena. JD-1 showed the following experimental phenomena: the weld seam at the end of the beam and the external strengthened ring joint basically broke, the web plate closed to the steel tube was cracked, the concrete floor collapsed and the surface crack was basically through, the floor and the ring plate were basically separated. The hysteresis loops and skeleton curves of the two specimens are shown in Figure 10. The steel plates in the monitoring area of the specimens were peeled off after the test. It is found that the concrete inside the specimens is cracked, and the outer steel tube debonds from the inner concrete. Damage photos are shown in Figure 11.

At the end of the test, the outer wall of the steel tube in the core area of the joint specimen was removed to observe the concrete failure and the debonding damage between the core concrete and steel tube. As shown in Figure 11, the interfaces of the two joint specimens are obviously debonded, which is consistent with the result of damage identification by the S1-S3 sensors. The core concrete is basically intact, and there are some slight cracks in JD-1 and JD-2, but the interface integrity is basically maintained, which is consistent with the damage identification result of the sensors and the damage monitor results are in good agreement with the experimental results.

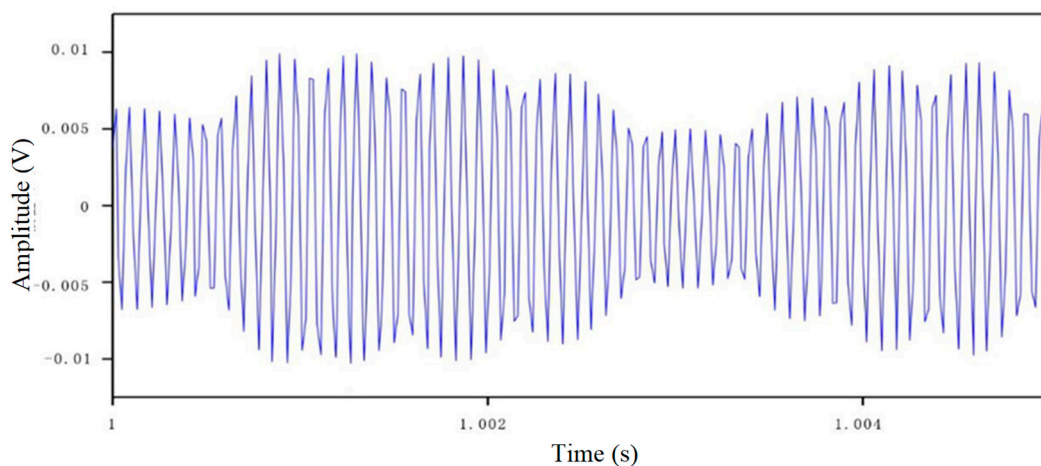
Figure 12. Time domain diagram of sine signals received by a smart aggregate sensor.

Figure 12 shows a time domain signal received by a smart aggregate. Though a piezoceramic sensors may experience drift for long term monitoring, we did not observe any drift in the piezoceramic transducers during all the tests for the following reasons: (1) All the tests were conducted in a relative short time frame; (2) the piezoceramic transducers were operated in the dynamic mode since they are used to generate and to detect high frequency stress waves. Given these reasons, the piezoceramic transducers in this research did not display drift.

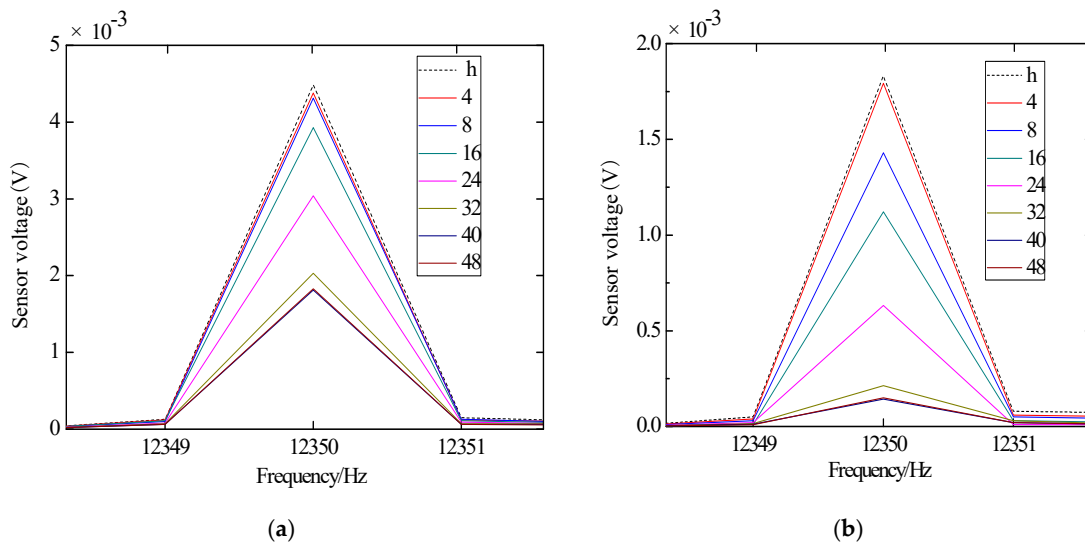
Figure 14. Frequency domain diagram of sine signals received by sensors of specimen JD-2. (a) S1-S2; (b) S1-S3.

It can be concluded that the signal amplitude of the S1-S3 sensor combination is weaker than the S1-S2 one when the specimens are healthy, according to Figures 13 and 14. The reason for this phenomenon is that the stress wave propagation path of sensor S1-S3 traverses two kinds of media (concrete and steel tube) and an interface between them, which leads to an attenuation of the stress waves:

According to Figure 14a, it can be seen that the signal amplitude attenuation is not obvious during the initial stage of displacement loading because of the existence of the reinforced concrete floor and the interaction between the core concrete and steel tube. Subsequently, when the loading displacement is 24 mm, the signal amplitude attenuates greatly. When the loading displacement is 40 mm, the signal amplitude attenuates to the maximum, and the signal attenuation gradually becomes gentle due to the complete cracking of the floor and the damage of the steel beam. According to Figure 14b, it can be seen that the signal begins to gradually decay when the loading displacement is 8 mm. The signal attenuation reaches the maximum when the loading displacement is 40 mm, and the debonding of steel tube and core concrete is obvious. The results of the signal amplitude of the specimen are basically consistent with those of the skeleton and hysteretic curves analysis.

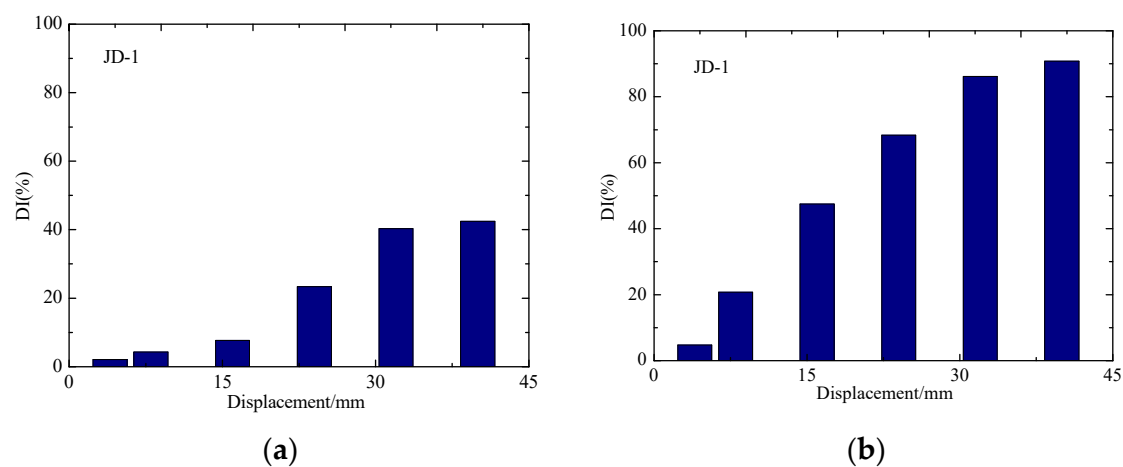
Figure 15. The damage indices of JD-1. (a) S1-S2; (b) S1-S3.

To carry out a more detailed and accurate analysis of the damage of the specimens, the normalized DIs of the signal amplitude of the test specimens are shown in Figures 15 and 16, and the damage evolution of each specimen can be more intuitively seen from these figures. In the entire process, the DI of each sensor shows a gradual increase trend with the loading of displacement. According to Figures 15a and 16a, it can be seen that the DI of concrete in the core area of the two joint is not up to 60%. As the concrete floor gradually drops out of work, the steel bars and beams in the floor bear most of the load and the damage of concrete-filled steel tube columns is smaller. The phenomenon shows that the core concrete of the joint is not damaged in large area. From the Figures 15b and 16b, it can be seen that the debonding damage between concrete and steel tube occurs earlier in the core area, the DI increases linearly with the test loading, and the stress wave signal decreases sharply with the increase of the debonding damage. The DI of S1-S3 reached about 90%, indicating that the debonding damage between the core concrete and steel tube is serious.

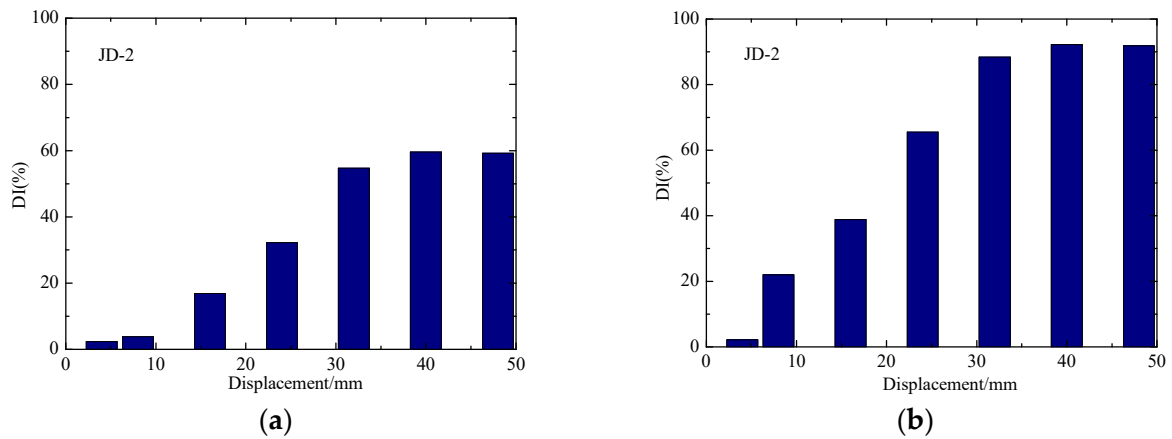
Figure 16. The damage indices of JD-2. (a) S1-S2; (b) S1-S3.

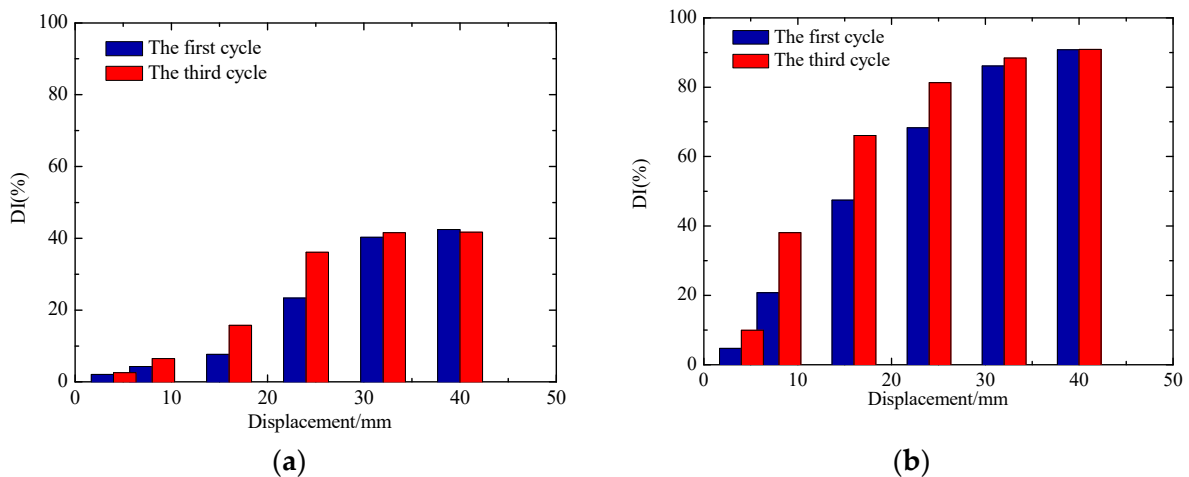
Figure 17. The damage indices of JD-1 in different cycles. (a) S1-S2; (b) S1-S3.

The comparisons of normalized DI for different loading cycles of JD-1 and JD-2 are respectively plotted in Figures 17 and 18, which show that the DI increases gradually with the increase of the number of cycles in the same level. Though the difference between the cycles gradually increases, the overall trend is consistent at the elastic and yielding stage of the joint. In the yielding stage of the specimens, the DIs under different cycles are quite different, the reason is that the deformation of the joints develop with the increase of the load at this stage, and the attenuation of the signal amplitude increases gradually between different cycles. At the failure stage of the specimens, the load on the beam of the joint core zone is gradually weakened, and the attenuation of the signal amplitude tends to be stable between different cycles because of the damage of the steel beam.

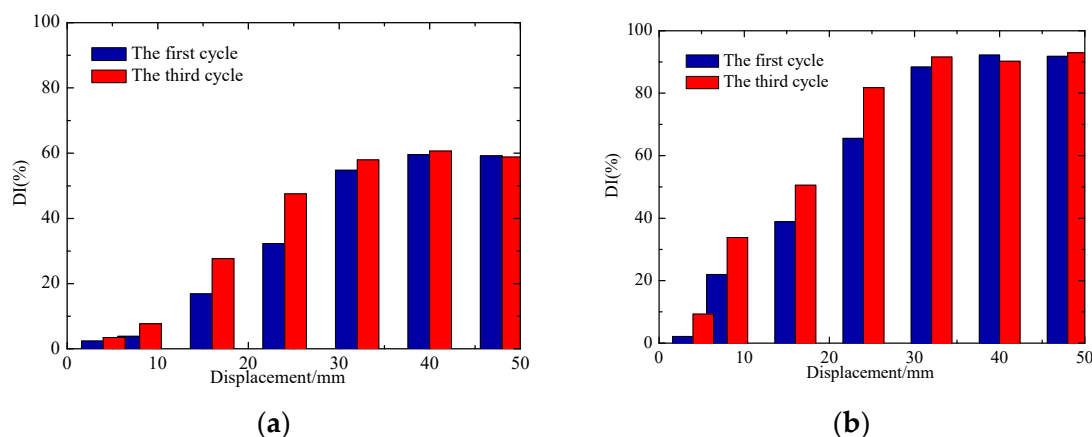
Figure 18. The damage indices of JD-2 in different cycles. (a) S1-S2; (b) S1-S3.
