Non-Contact Diagnostics of the Geometry of a Historic Wooden Building as an Element of Periodic Safety Assessment

Abstract: The article presents a method of non-invasive diagnostics of a historic wooden church, built in the 18th century. Over the hundreds of years of its use, changes in the geometry of the structure have been observed. This article presents the requirements of so-called architectural and geodetic survey and the method of using terrestrial laser scanning to create a three-dimensional solid model of an object. The diagnostic tests performed made it possible to perform analysis based on a so-called point cloud, which is a virtual representation of a real object. In order to determine the basic parameters of the building, the area and volume of all rooms were determined. It was found that the object exhibited deformations that cannot be explained solely as a result of imperfections during climb and normal wear and tear during operation. Therefore, the changes in shape were assessed in detail by means of an assessment of the verticality of the pillars supporting two levels of the church, the verticality of the walls, and the inconsistency of the floors, as well as the

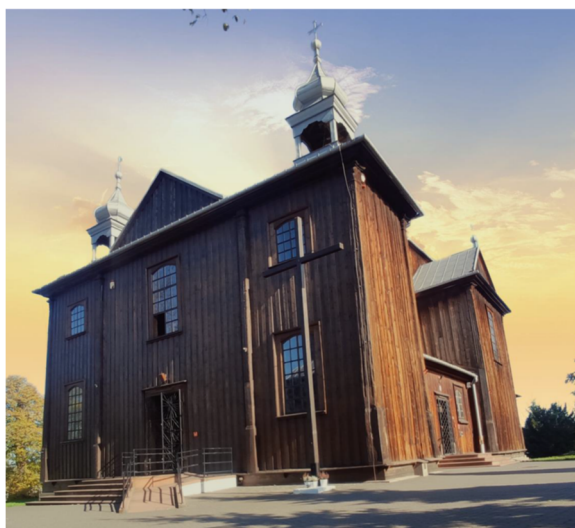
The subject of this article is a historic wooden church dedicated to St. Szczepan (Stephen) (Figure 1), located in Mnichów, a village in the Świętokrzyskie province of Poland. The building is located in a narrow area of Jurassic sea rock (lithologically: calcareous gaizes), which is covered with post-glacial sands, gravel, and clay. The western side of the church is crossed by the border of a third-order natural watershed, which also separates the geological mesoregions of the Nida River trough and the Jędrzejowska plateau. Such a location may be expected to have a negative impact on the stability of the foundation of the building. This architectural object is one of very few original wooden monuments that have been preserved to this day, as wood is a material susceptible to harmful biological and atmospheric factors. It has a dome with two towers in the facade and unique Rococo interiors, which have been maintained in a uniform style.

Figure 1. View of the church of St. Szczepan in Mnichów (source: private archive).

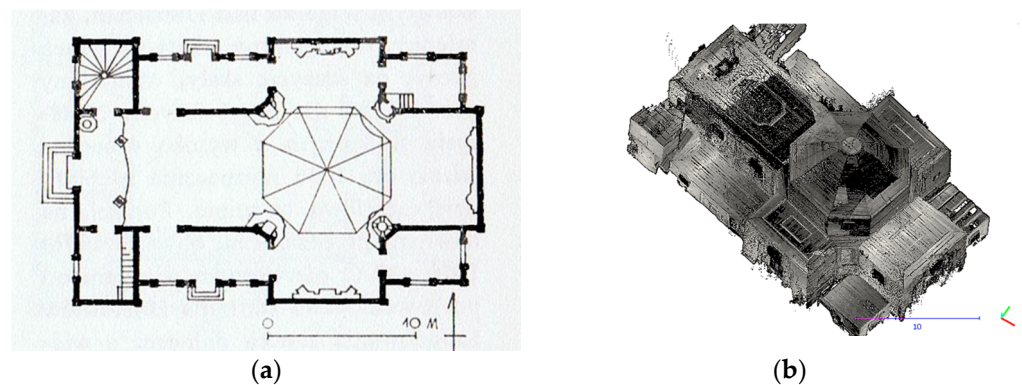
Figure 2. (a) Plan of the church of St. Szczepan in Mnichów (source: <http://www.zabytkowekoscioly.net>, accessed on: 15 October 2021) and (b) the scanned shape of the internal structure with a cross plan.

The construction of the church is very well thought out and architecturally homogeneous. The first entries describing the church can be found in the Inventory fundi instructi [43]. They show that it was built of larch wood, covered with shingles, and had two entrances: a main entrance with pine doors, preceded by a stone staircase, and a smaller side entrance with a double door also made of pine. The floor in the church was made of boards. In the basement of the church there is a brick chapel, the vault of which

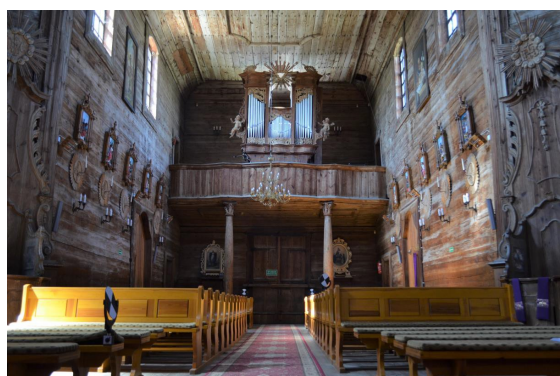
On the western side of the interior there is a music choir (Figure 4). This is supported by slender, tall, wooden carved columns made in the Corinthian style. The organ prospectus placed on the choir is decorated with Rococo ornamentation.

Figure 4. Music choir in the church of St. Szczepan in Mnichów (source: private archive).

One of the elements of the internal structure which exhibits potential deformation is the columns supporting the floor on both floors. In the main nave they support the choir (Figure 4), while in the underground chapel they support the ceiling (Figure 5). To determine the values of deflection from the vertical of the columns, it was necessary to determine their height, as well as the values of the shift of their centres in the horizontal plane. The assessment was based on some extreme sections, for which the geometric centres of each column contour at individual height levels were determined. The cross-sections of the columns were separated from the obtained point cloud, which enabled analyses based on the Cartesian coordinates of these points. The results of the calculations are presented below in the Figure 11.

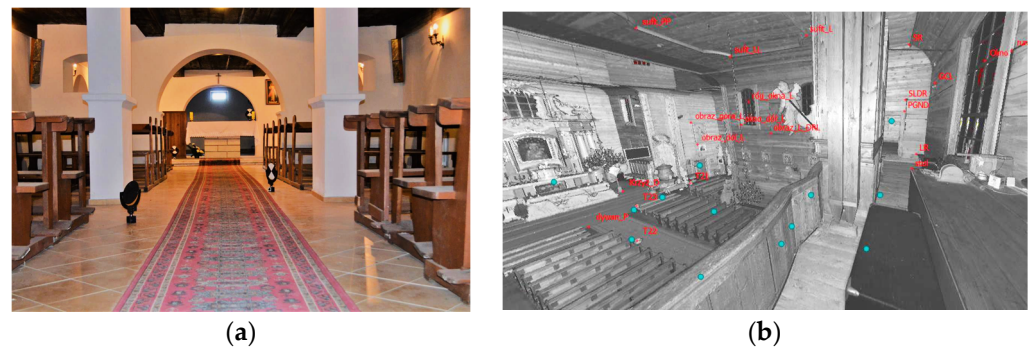
Figure 5. Measurement targets in the underground chapel (a) and the view of the scanning data in the reflectance intensity of the laser beam—one of the scanner positions inside the church (b).

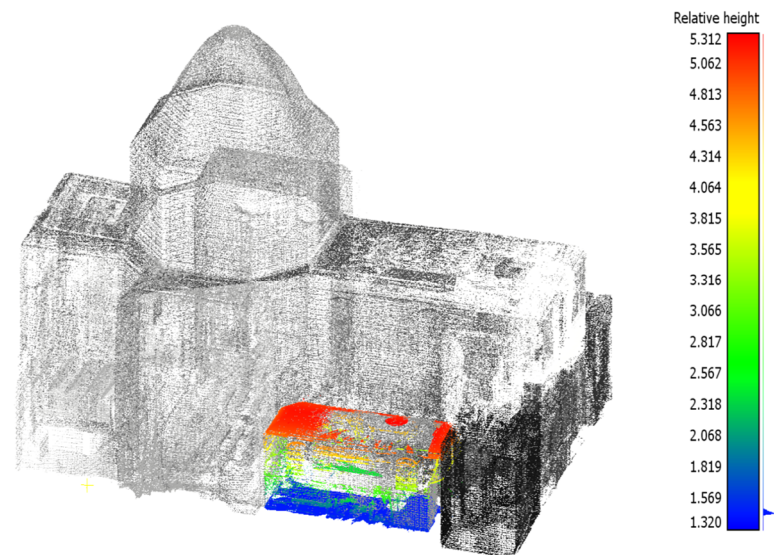
Figure 7. Points used to measure the built-up area, volume, and height of room D (on the right—hypometric legend of relative height of objects (m)).

According to the analysis, the church is 27.75 m high, has a total area of 695.50 m², and is 4150 m³ in volume. Room volumes were determined based on the area determined in AutoCad 2020 and the average height based on the floor and floor identification using CloudCompare. An example of the analysis conducted for room D is shown in Figure 7, and detailed results for individual rooms are presented in Table 1.

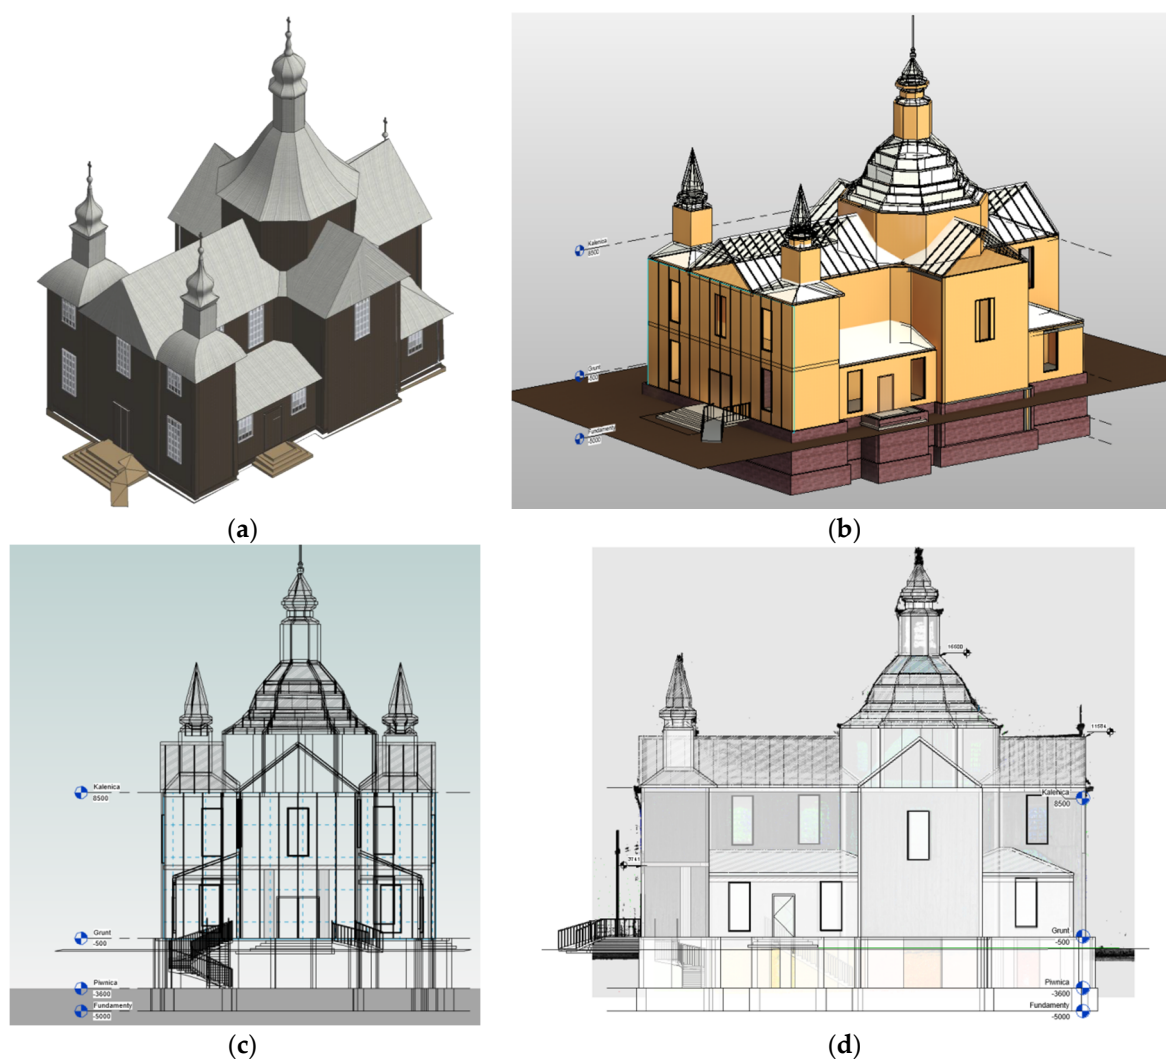
Figure 8. Model of the church St. Szczepan in Mnichów—southwest view ((a)—rendered model and (b)—structural model) and construction projections ((c)—view from the entrance and (d)—view from the south-west).

Based on the work carried out, a virtual replica of the building was created in the form of a 3D model, which is shown in Figure 8. In order to reproduce the colour of the outer walls of the church, RGB colour obtained from simultaneously taken photos was used.

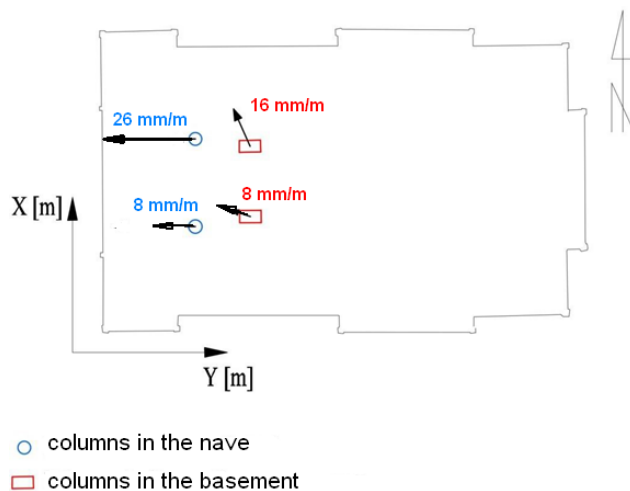
The columns in the underground chapel are again tilted to the north-west. The northern column has a greater inclination, i.e., 16 mm/m. The columns located in the nave of the church lean only to the west. The northern column has a greater inclination, i.e., 26 mm/m. These analyses also indicate that the inclination of the structure at the level of the main nave is predominantly in the western direction, similar to the external walls of the structure. The structure of the church is reinforced by a roof truss, which interacts with elements of the wooden skeleton in a much more active way than in modern concrete and brick constructions. For this reason, checking the shape of the truss, by examination its symmetry, may allow additional inferences to be made regarding the condition of the entire structure. For this purpose, analysis of the levelness of the roof edges (ridge) in the longitudinal and transverse directions and of the roof slope inclination were performed.

Figure 11. Determined vectors of inclination of the column axes from the vertical.

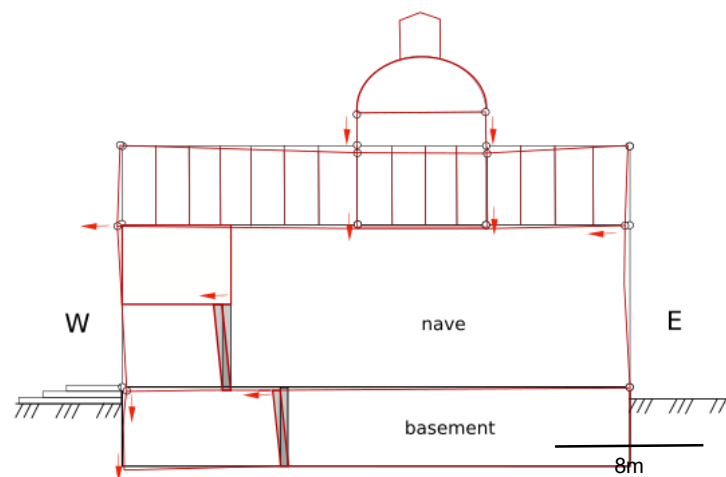
Figure 13. View of identified displacements of church structure.

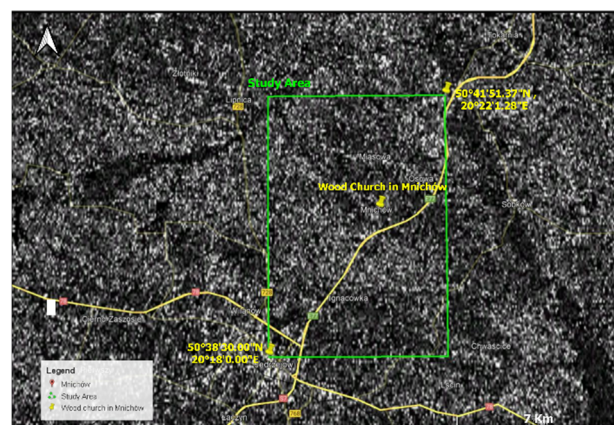
Figure 15. The raw interferogram picture of coherence (value of coherence from 0 to 1). From 0.4 to 1 is good coherence (white colour) and near to 0 is bad (no satellite signal or bad value of signal) and has black colour. The standard filtered coherence value > 0.4 was used in the calculations.

The Sentinel-1A data is processed with the PSInSAR method. The interferograms are first processed by the Sentinel Application Platform (SNAP) software package by European Space Agency (ESA), then the InSAR time series are analysed by the Stanford Method for Persistent Scatterers (StaMPS) software package (Figure 15).

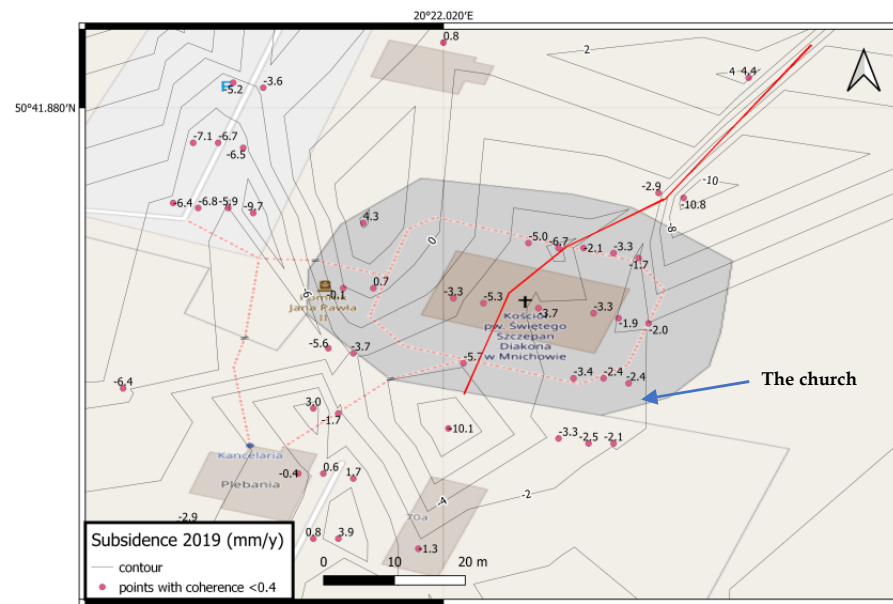
As a result of the development of the PSInSAR technique, the result of annual vertical displacements of the terrain in the area of the analysed church building was obtained, which was visualized in the form of contour lines (isocatabases) generated on the basis of clearly identifiable points of high coherence. The results are shown in Figure 16. The red line also shows the division into two regions, the boundary of which intersects the building, in accordance with the previously presented hypothesis about the watershed (Figure 14).

Figure 16. Annual ground depressions (grey contour lines and red points) near the church observed in the period January–December 2019, corresponding to the date of geodetic measurements. Red line—observed division on two regions crossing the church building.
