Letter to the Editor

Polyaxial pedicle screw dislocation during screw tightening for posterior spinal lumbar stabilization

Ali Akhaddar^{1,2}

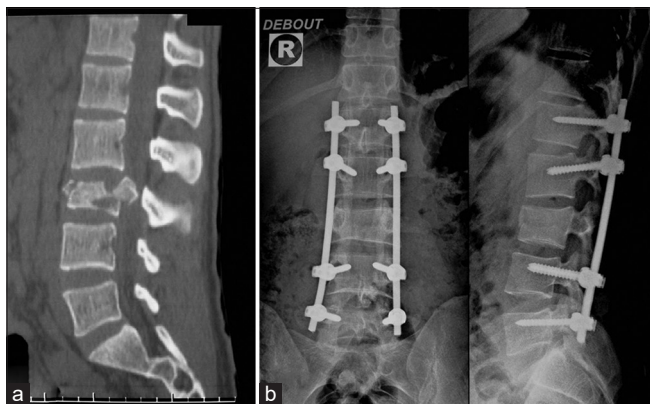
Figure 1: A burst fracture of L3 as seen on sagittal reconstruction computed tomography scan (bone windows) before operation (a). Postoperative lumbar spinal X-rays showing the emplacement of polyaxial pedicle screws (on L1, L2, L4, and L5), decompressive posterior laminectomy (on L3 and L2) with bilateral connecting rod screws (b).

A 21-year-old male, neurologically intact following a motor vehicle accident, had a L3 burst fracture as demonstrated on the emergent spinal computed tomography-scan [Figure 1a]. He underwent a posterior surgical reduction, decompression, and stabilization using PAPS [Figure 1b]. However, during the right L4 PAPS tightening, the head was suddenly detached from the screw shank [Figure 2]. This caused the surgeon to directly injure the lumbar spine with the screwdriver; fortunately, this did not result in any adverse sequelae. The screw was removed and a second spare screw was finally replaced. The operation ended successfully and the postoperative recovery was uneventful. He was discharged on the 10th postoperative day.

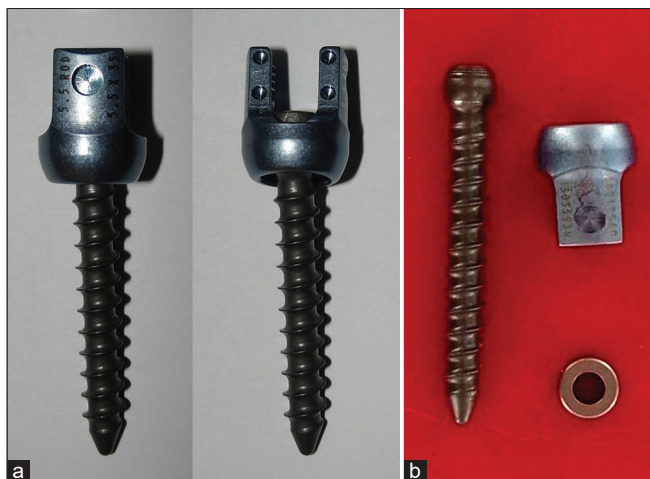
Figure 2: Polyaxial pedicle screws before use. These multiaxial screws have 360° head polar mobility (a). Picture of the dislocated polyaxial screw: The screw head was detached from screw shank (b).

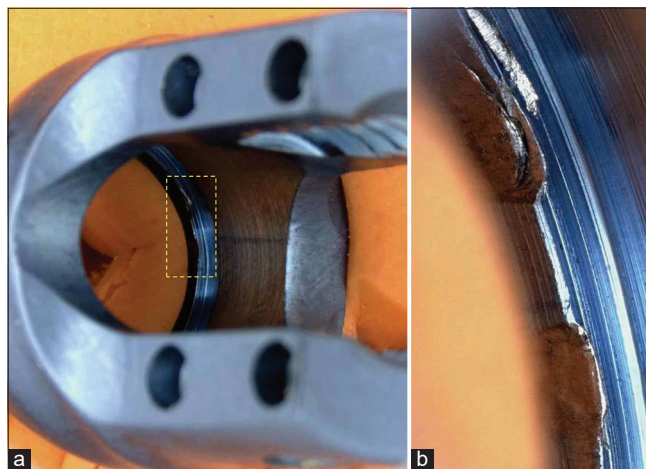
The implant was sent to the manufacturer for their examination; they found “witness marks” and “deformation” noted on the inner diameter surface below the retaining ring pocket of the head; this suggested the ring may not have been fully seated in the ring screw pocket [Figure 3]. The manufacturer’s conclusion was consistent with a manufacturing error, resulting in the foregoing event.

Figure 3: The technical analysis of the manufacturer has found witness marks and deformation noted on the inner diameter surface below retaining ring pocket of the head screw (visual review [a] and microscopic review [b]).

This case emphasizes the importance of proper checking of the integrity of the surgical implant before its use. In addition, industry has to guarantee the quality of their product. Here, this unpredictable incident was recognized immediately without serious consequences for the patient. One similar case was previously reported; however, there was no clear manufacturer defect.^[3]
