Guide wire displacement in robot-assisted spinal pedicle screw implantation

Videosurgery Miniin 2021; 16 (3): 526–535

Aim: Guide wire displacement in spinal pedicle screw implantation was analyzed in order to reduce or avoid the occurrence of this phenomenon and to reduce the complications associated with robot-assisted pedicle screw implantation surgery.

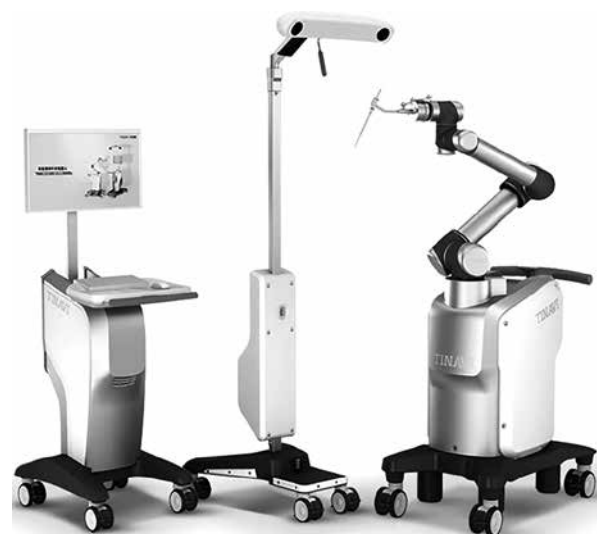
Photo 1. The China TINAVI Medical Co., Ltd. produced the 3rd generation TiRobot system

A retrospective study was conducted with 398 patients (209 men and 189 women, aged 19 to 76 years, with an average age of 49.1 years) who underwent robot-assisted spinal pedicle screw fixation between April 2017 and December 2019. The orthopedic robot was a 3rd generation TiRobot system (Photo 1 was downloaded from <https://cn.tinavi.com/index.php?m=content&c=index&a=lists&catid=13#>) produced by TINAVI Medical Technologies Co., Ltd. There were 8 cases of the cervical vertebrae, 12 cases of the upper thoracic vertebrae, 36 cases of the middle thoracic vertebrae, 134 cases of the lower thoracic vertebrae, 204 cases of the lumbar vertebrae, and 4 cases of the sacrum. Moreover, there were 6 cases of cervical vertebrae fracture, 2 cases of cervical vertebrae degeneration, 337 cases of thoracic vertebrae and lumbar vertebrae fracture, 50 cases of thoracic vertebrae and lumbar vertebrae degeneration, and 3 cases of spinal vertebrae tumor. This study was conducted in accordance with the Declaration of Helsinki. This study was conducted with approval from the Ethics Committee of Yantaishan hospital University. Written informed consent was obtained from all participants.

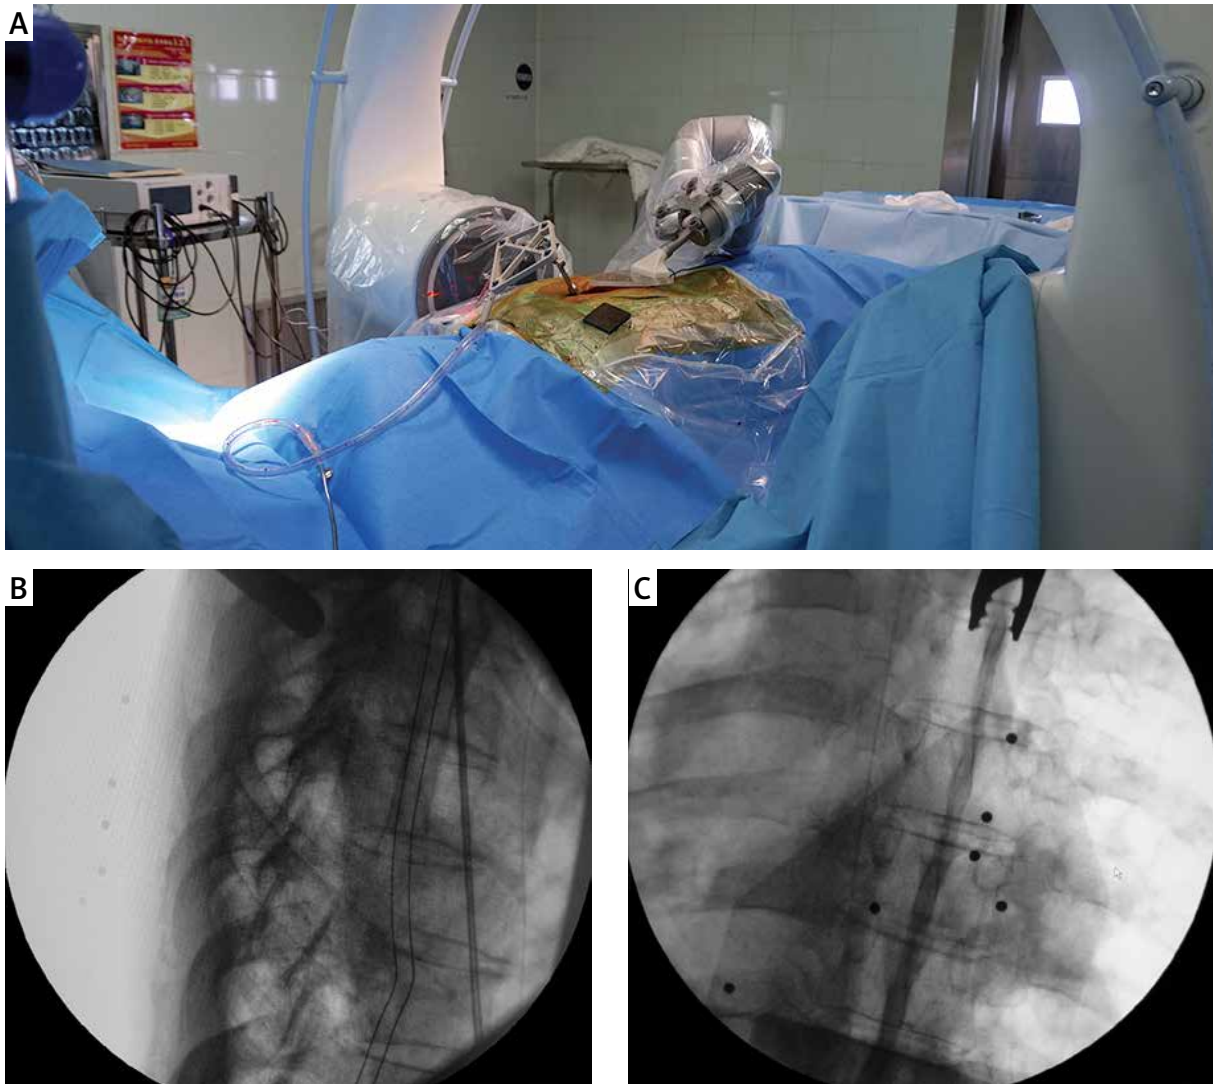
Photo 2. A – During operation a tracer and a positioning scale were installed at the end of the robot and the positioning scale was placed in the operating field. **B, C** – X-rays show a human tracer spinous process clip that was then used to clamp the cranial spinous process of the operation area

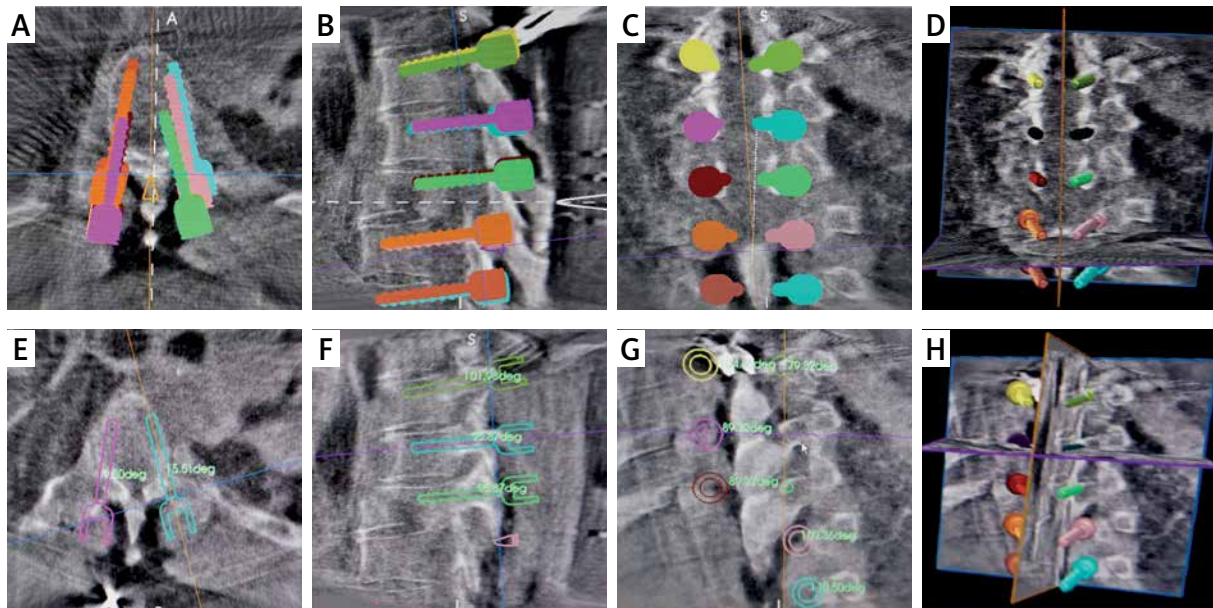
Photo 3. The pedicle screw trajectory was planned on a surgical planning and control console

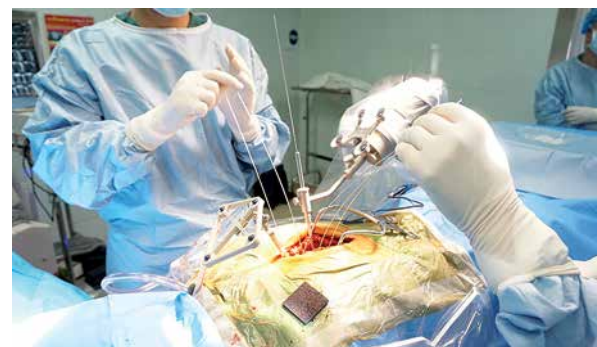
Photo 4. The guide wire was inserted along the direction of the working sleeve

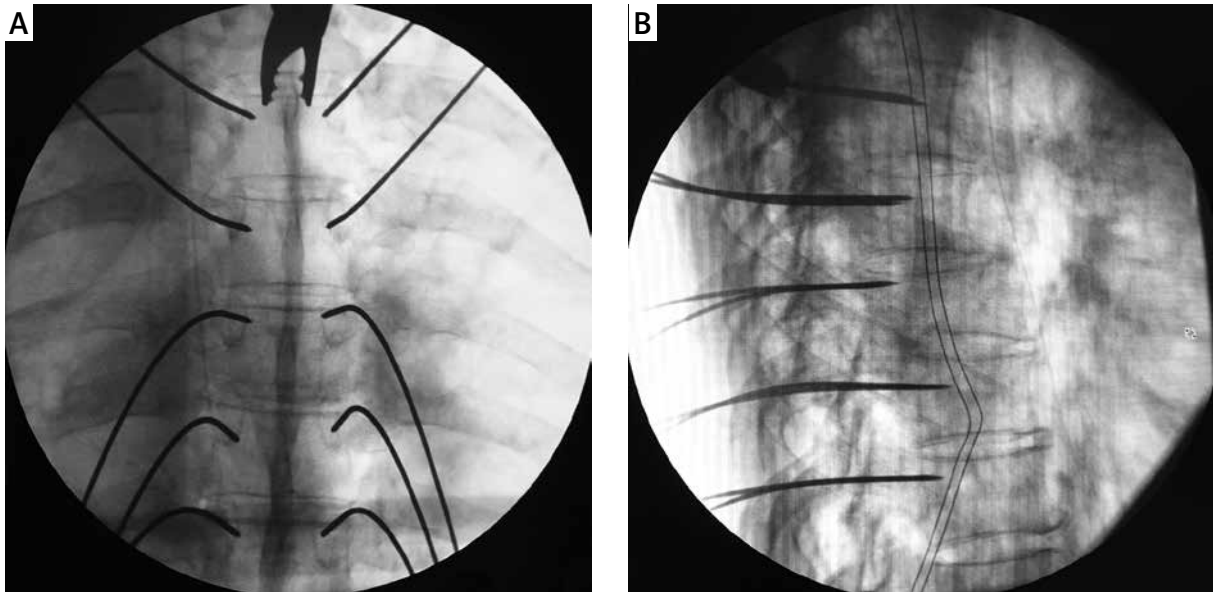
Photo 5. Intraoperative X-rays confirmed if the guide wires were in the pedicle

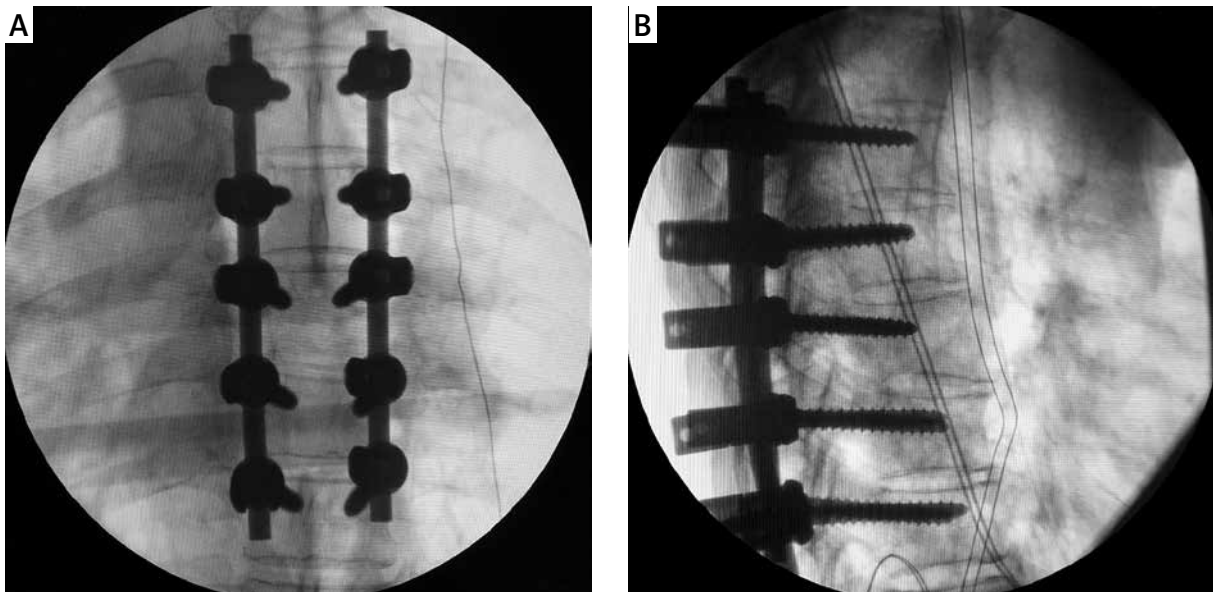
Photo 6. X-rays show the completed the fixation: **A** – AP fluoroscopic imaging, **B** – lateral fluoroscopic imaging

the adjacent vertebral spinous process by a clamp. The clamp connecting the patient tracker to the spinous process should be tightened and then the patient tracker is powered on. The robot is covered with a sterile cover. Then the registration is installed and placed into the operation area so that the registration is within the fluoroscopic field (Photos 2 A–C). An intraoperative computed tomography (CT) (SIEMENS ARCADIS Orbic 3D C-ARM, Germany) scan was performed, and the image was transmitted to the robotic workstation, and the pedicle screw trajectory was planned (Photo 3). This ensured the correct placement direction and specification of the pedicle screws. After the screw guider is installed, the guider is moved to the surgical field. The positioning accuracy will be displayed in the software interface in real time during the movement of the robot arm. The sleeve is placed into the screw guider. The sleeve is brought to the cortical bone surface after the bone surface is exposed. The guide wire was drilled into the vertebrae, then the optimal position was confirmed by fluoroscopy (Photos 4, 5). The cannulated tap was used to prepare the placement path first, then the screw was implanted (Photo 6).

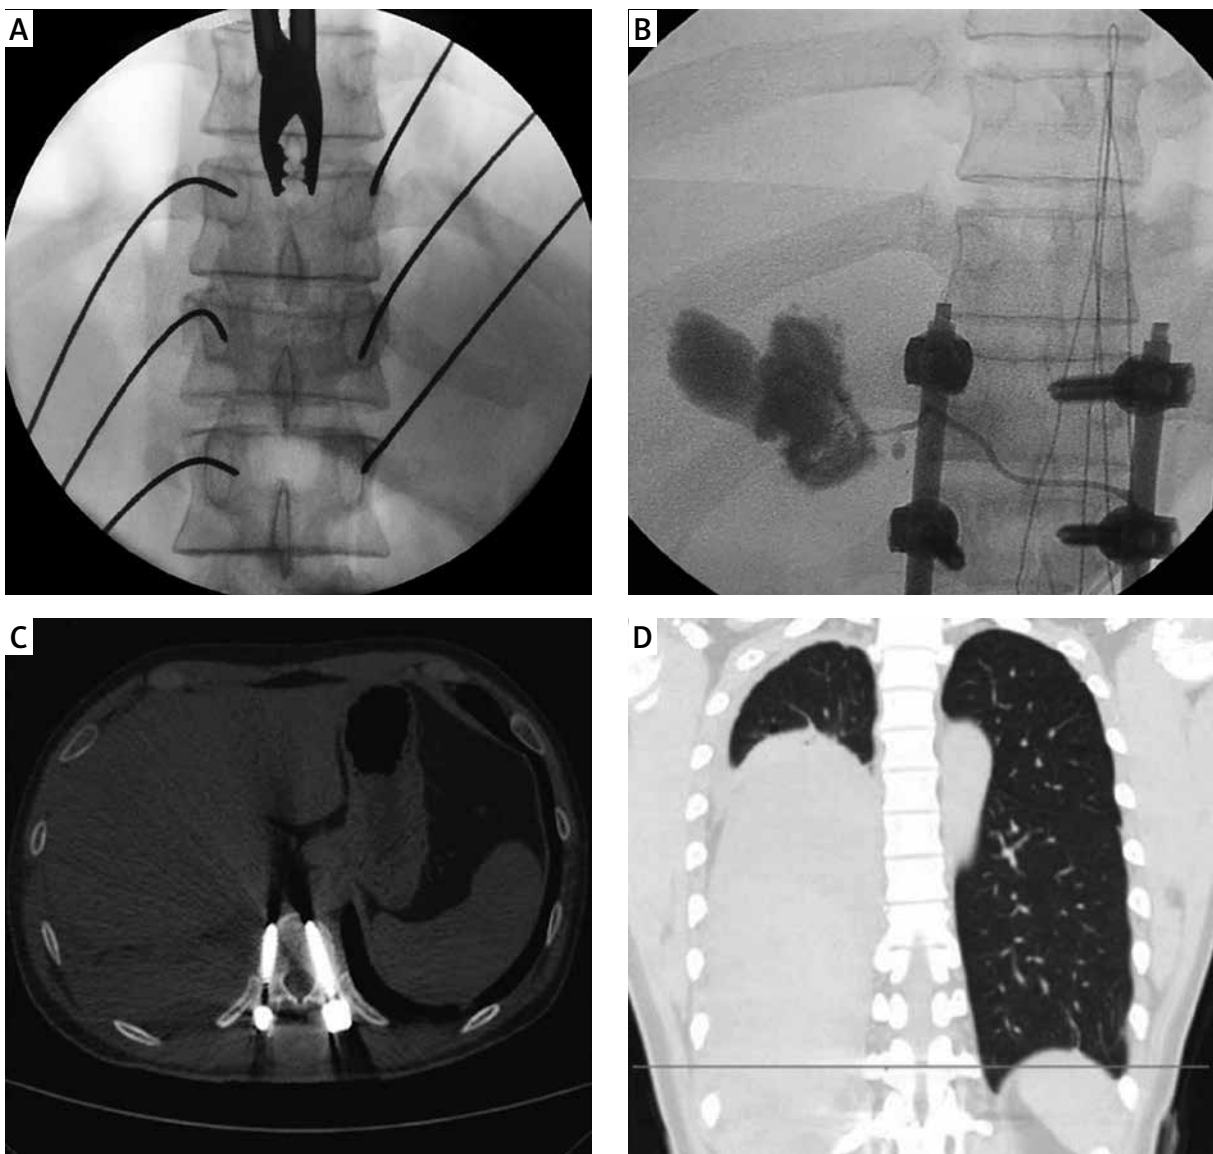
8 times medial to the pedicle. The displacement of the guide wire resulted in 16 surgical bed moves. Surgical operation affects posture: 8 times; the unstable fixation of the spinal process clip: 6 times; the human tracer was far from the operating field: 2 times; the respiratory factor: 28 times. Among them, 1 case of right segmental artery injury of T11 (Photo 7 A, B) resulted in massive pleural effusion on the right side (Photo 7 C). Arterial embolization at the right segmental artery of T11 was conducted under the guidance of intervention. A residual pleural enveloping hematoma was removed by thoracotomy 1 week after the operation. In 1 patient with cervical spondylotic disease, the left guide wires were displaced medially and punctured the walls of the pedicle from C3 to C6 (Photo 8), and the pedicle

Photo 7. **A** – Intraoperative X-rays show that the wires were displaced laterally to the right T11 pedicle. **B** – Angiography shows that the right segment artery of T11 was injured. **C** – Postoperative CT scan shows that there was massive hemorrhage in the right thorax

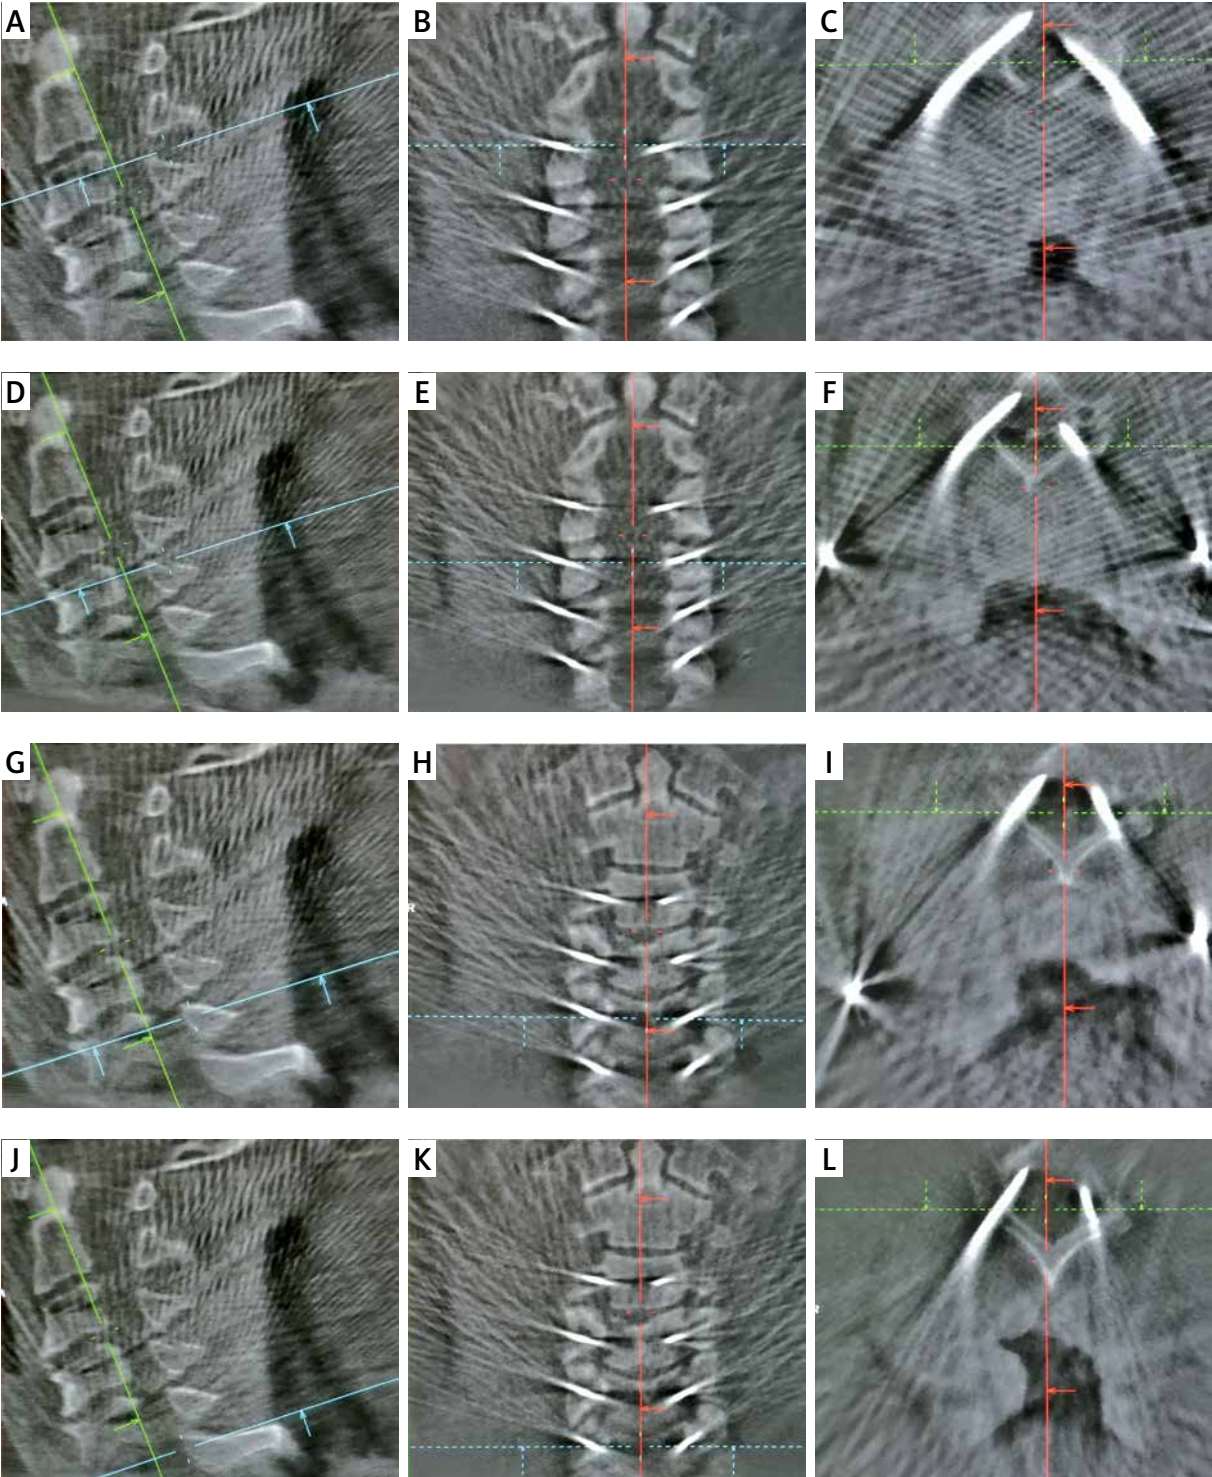
Photo 8. Intraoperative CT scans show that the left guide wires were displaced medially and through the walls of the pedicles from C3 to C6

screw fixation was replaced by lateral mass screw fixation. The postoperative muscle strength of the patient's left upper limb was grade 3 (grade 5 before surgery), and the patient's muscle strength returned to normal after 6 months of conservative treatment. In 1 patient with thoracic vertebral fracture, the guide wire on the left side of T4 was displaced to the upper part of the pedicle, and the guide wire was removed; the pedicle screw was then implanted free-
