CASE REPORT

Aorto-Right Ventricular Fistula and Paravalvular Leak After Transcatheter Aortic Valve Implantation

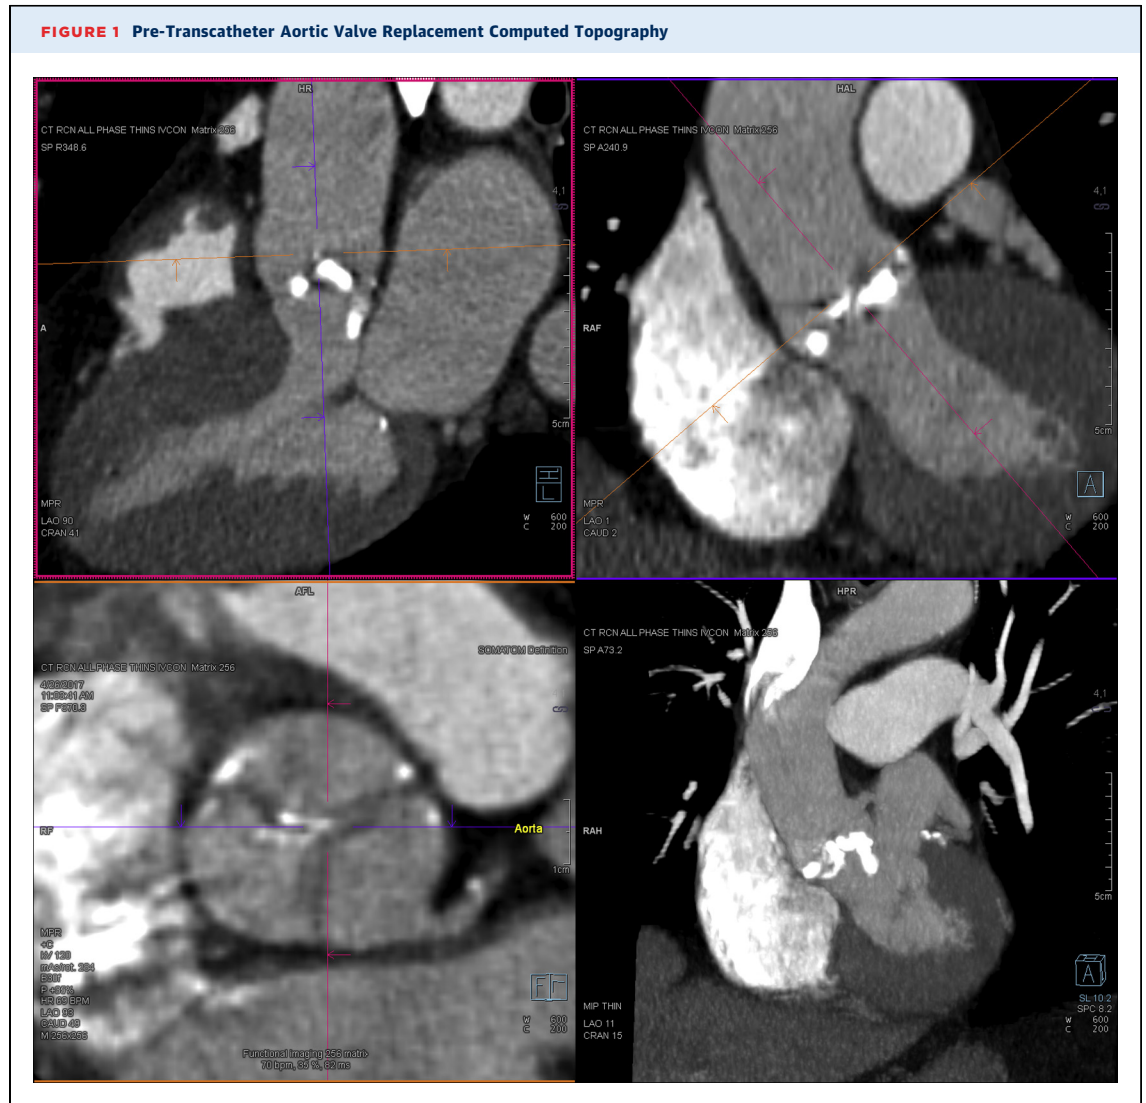
FIGURE 1 Pre-Transcatheter Aortic Valve Replacement Computed Topography

INVESTIGATIONS. Transthoracic echocardiography showed an aortic valve mean gradient of 51 mm Hg, a peak velocity of 4.2 m/s, and an aortic valve area of 0.6 cm². Pre-procedural computed tomography (CT) (**Figure 1**) was performed, and an aortic annulus of 32- × 26-mm with an area of 660 mm² was measured.

aorto-right ventricular fistula and PVL. The fistula was measured and evaluated by cardiac CT (Figure 2). CT data were processed with Mimics Innovation Suite software (Materialise, Leuven, Belgium) to create a 3-dimensional (3D) model incorporating the relevant anatomy and printed (Figure 3) using an Objet 360 printer (Statasys, Eden Prairie, Minnesota). This model was reviewed by the interventional team to aid in planning the procedure.

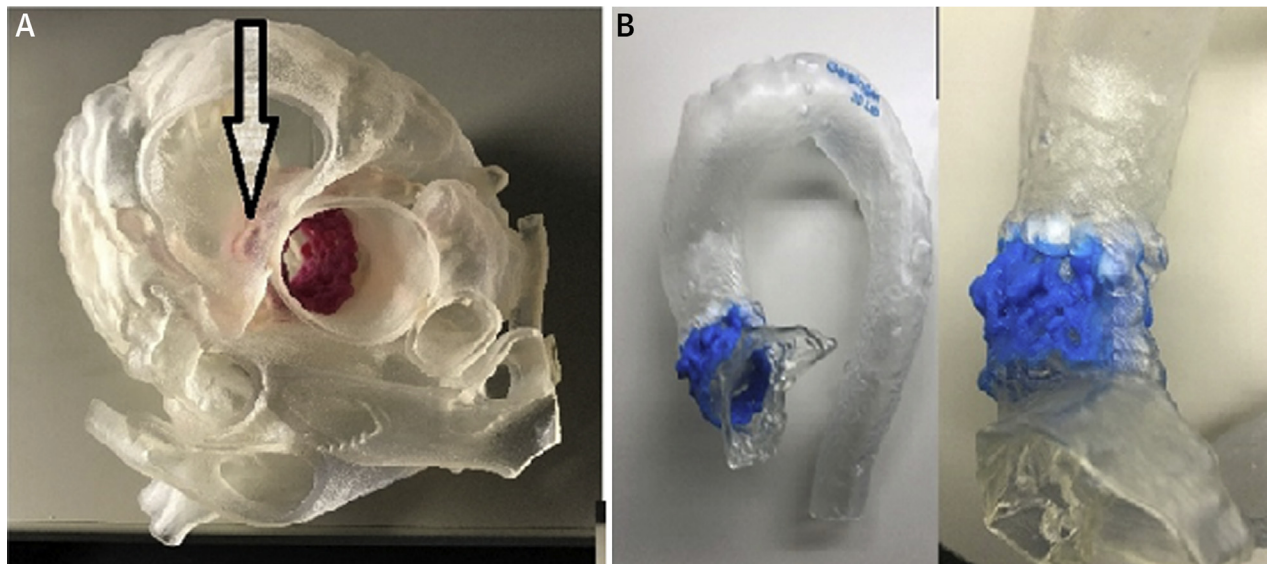
FIGURE 3 3-Dimensional Model of the Patient's Aortic Valve and Ascending Aorta Showing the Prosthetic Valve and the Aorto-Right Ventricular Fistula Location

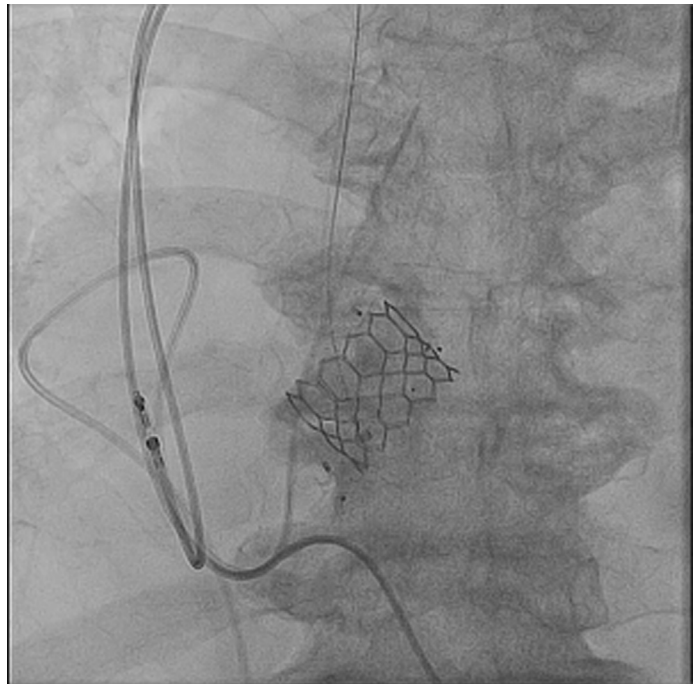
FIGURE 5 Final Fluoroscopic Image After Successful Implantation of Ventricular Septal Defect and 2 Amplatzer Vascular Plugs

back to close his paravalvular leak that had progressed in severity, requiring 2 Amplatzer vascular plugs, 8-mm devices deployed successfully (Figure 5) under transesophageal echocardiogram guidance (Videos 5, 6, 7, 8, and 9). Electrophysiology reevaluated the patient at that time. He had no shocks from his LifeVest. His PPM interrogation showed no recurrence of his ventricular tachycardia, and recommendations were against upgrading his PPM to an automatic implantable cardioverter defibrillator. Use of his LifeVest was discontinued, and he was discharged home on unchanged medical regimen.
