Public toilets with insufficient ventilation present high cross infection risk

M. C. Jeffrey Lee^{1✉} & K. W. Tham²

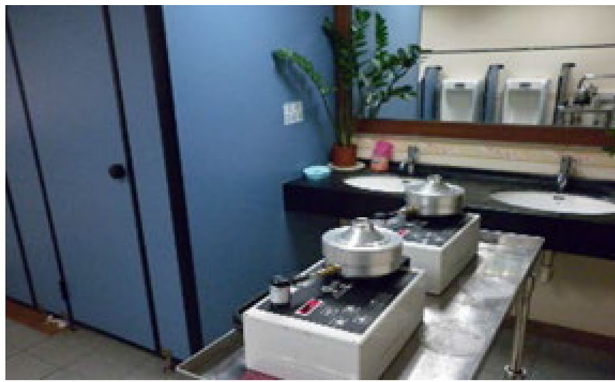
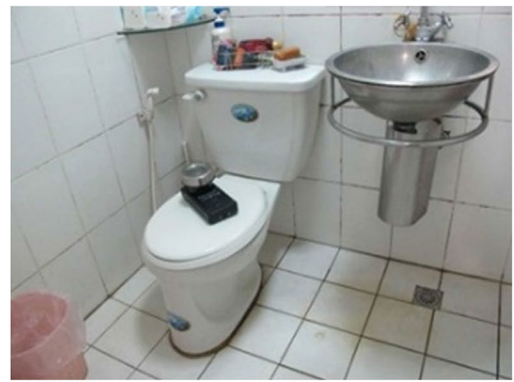
Figure 1. Two types of bioaerosol samplers in the field survey, and the position of the sampling entry for measuring.

Quick Take 30 pump with BioSatge Impactor

MicroBio MB2 Bioaerosol sampler

Two bio-aerosol impactors were used in the field study to sample 100 L of air for each sampling location: either a BioStage Impactor operated with a Quick Take 30 for 4 min at 28.3 L/min or a MicroBio MB2 Bioaerosol sampler operated for 1 min at 100 L/min. The sampling point is separated from the septum (wall) or the corner with a distance of more than 50 cm. The position of the sampling inlet is placed at a height between 120 and 150 cm above the ground, as shown in Fig. 1. After sampling, the culture plate is capped and sealed, transported to the laboratory and incubated at 30 ± 1 °C for 48 ± 2 h, before enumerating the bacterial CFUs.

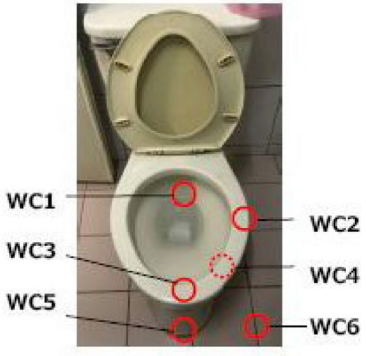
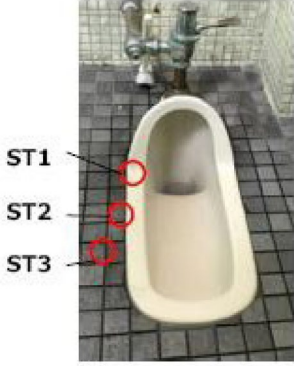
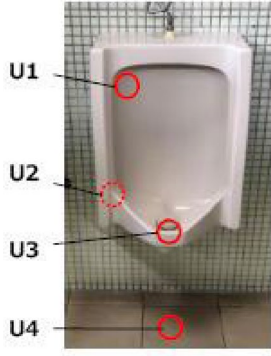
Table 1. The sampling point of bacteria on the toilets.

WC1 Draft section	ST1 On rim(side)	U1 Upper Part
WC2 On rim(side)	ST2 Between ST and F	U2 Rim (inside)
WC3 On rim(front)	ST3 Floor (F)	U3 Rim (front)
WC4 Inside rim		U4 Floor (F)
WC5 Between WC and F		
WC6 Floor (F)

Surface sampling of different types of toilets was conducted, including common toilets (WC), squat toilets (ST), urinal (U) and trash cans (TB)¹⁴. Water outlets tend to have residual water stains due to long-term water flow, as do the area surrounding the wetted surface in the toilet. Hence, this area has been identified as the first sampling point (WC1). The margin around the toilet itself (WC2 and WC3) is the area usually splashed and dripped on so they are also sampling locations. The inner parts of the toilet are not easily cleaned so it may lead to stain accumulation and the growth of bacteria in the long term. This is sampling point WC4. The lining between the floor and the toilet is usually completed using porous materials such as cement mortar, which is frequently ignored during cleaning. Bacteria and fungi often grow here so this is added to the sample as WC5. In general, users flush the toilet without closing the lid so bacteria inside the toilet is easily released into the space, with frequent splashing onto the floor. This area is WC6, as noted in Table 1. The periphery of the squat toilet is prone to stain accumulation and causes bacteria to grow. This spot is assigned as the ST1 sampling point. Where the squat toilet joins the floor is commonly constructed by porous cement mortar so bacteria and fungi grow easily there as well; this is ST2. Flushing of the toilet often results in splashing onto the surrounding floor and is identified as ST3.

The water outlet of the urinal may have some residual fluid due to imbalanced water flow or poor cleaning; so this is another place that bacteria can grow. The outlet is marked as sampling point U1. The inner peripheral surface of the urinal is not easy to clean thoroughly and urine stain can accumulate; this is marked as U2. The protruding part in front of the urinal accumulates urine and can become an area for bacteria growth and virus accumulation if not sufficiently cleaned—this is marked as U3. Furthermore, if users have benign prostatic hyperplasia or undesired urination habits, urine may drip to the floor; this is sampling point U4.

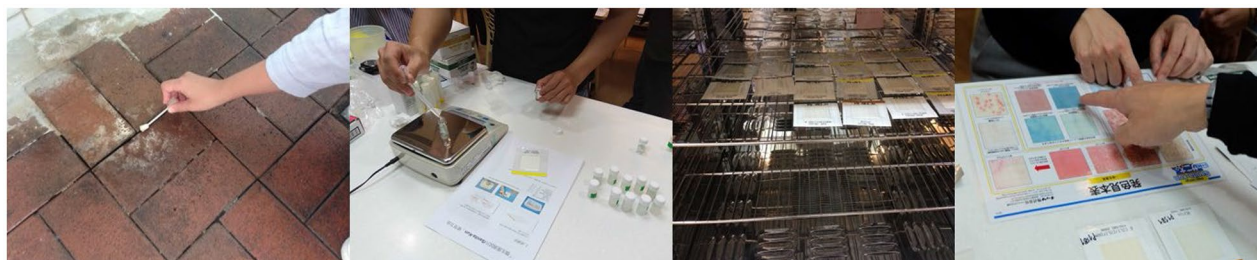
Figure 3. The bacteria culture process and CFUs assessment.

The range of the sample was 2x2cm, then the culture fluid was dripped on the test strips to proceed with the bacteria culture and CFUs assessment

As indicated by Su¹⁵, most of the bacteria found in the toilet are *E. Coli* spp. and *Staphylococcus* spp. To check the locations and quantities of these two bacteria in the toilet, sampling strips are used to retrieve *E. Coli*. (MC-Media Pad “EC”) and MC Media Pad “Aerobic count” was used as a bacteria test. For all sampling locations, culture swabs over a 2 × 2 cm wiping square were performed. The sampling swab was then inserted into the culture medium and the lid closed on the sampling bottle. The bottles of samples were stored at a temperature of under 5 °C and cultured for 12 h. The sampling swab was then taken out of the culture medium and sampling fluid was dripped on the bacteria test strips which were subsequently placed in an oven heated to 35 °C then removed after culturing for 24 h for observation. The strips were then classified based on samples from different sampling toilets and locations, then recorded for bacteria distribution volume based on the bacteria changes on the strips, shown in Fig. 3. The colors shown on the strips are used to evaluate the bacterial contamination (CFUs), as shown at the bottom of Fig. 3.

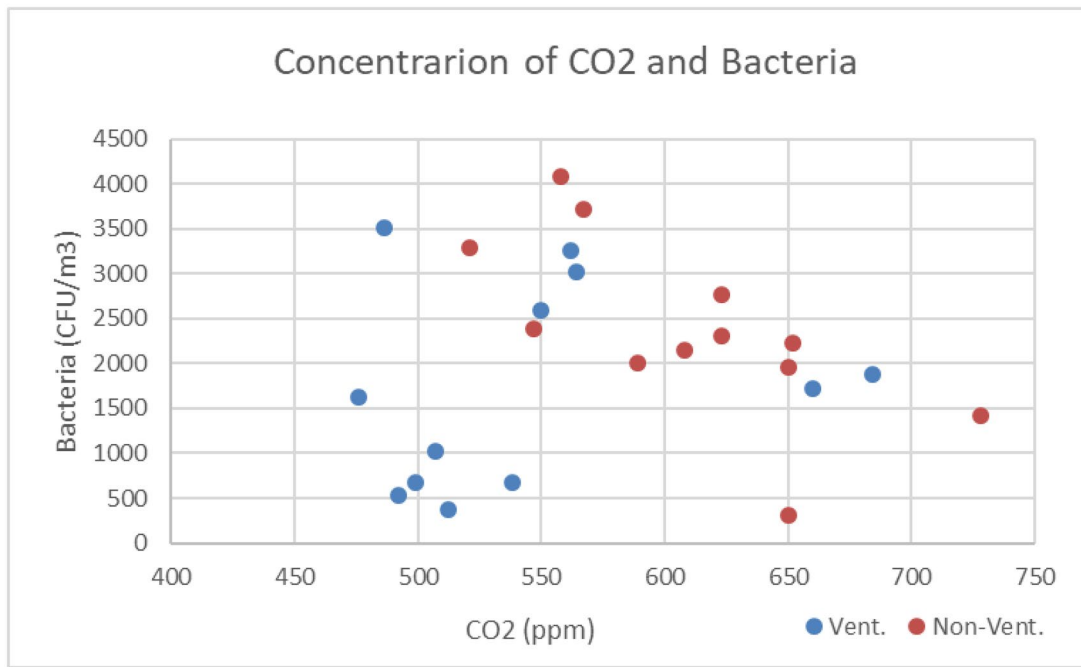
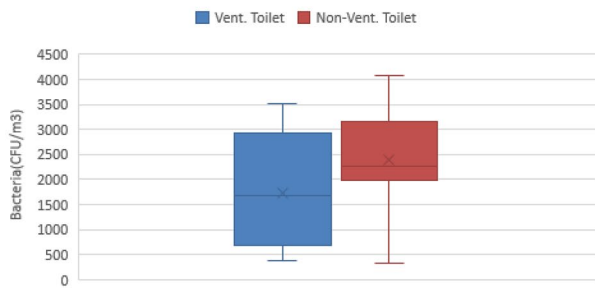
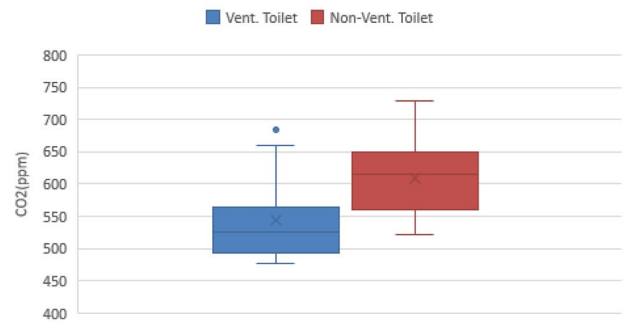
Figure 6. Comparison of the CFUs in ventilation toilet and non-ventilation toilet.

Comparison of the CFUs in vent. and non-vent. toilet

Comparison of the CO2 in vent. and non-vent. toilet

and CO_2 is shown in Fig. 6. Though not statistically significant, there is an observable trend. Both bacterial contamination and CO_2 are higher in non-ventilated toilets compared to their ventilated counterparts. This suggests that non-ventilation-equipped public toilets have higher bacteria concentration and presents a higher risk of cross-infection.
