Incredible position of broken sliding dynamic hip screw implant in the medial of thigh

We report a case with implant failure after nailing of an unstable pertrochanteric fracture with dynamic hip screw. The patient presented with a medial sided thigh pain at 5 years after the surgery. Plain radiographs showed nonunion of the fracture with distant migration of assembled hip screw and side plate to the subcutaneous area of the inner thigh.

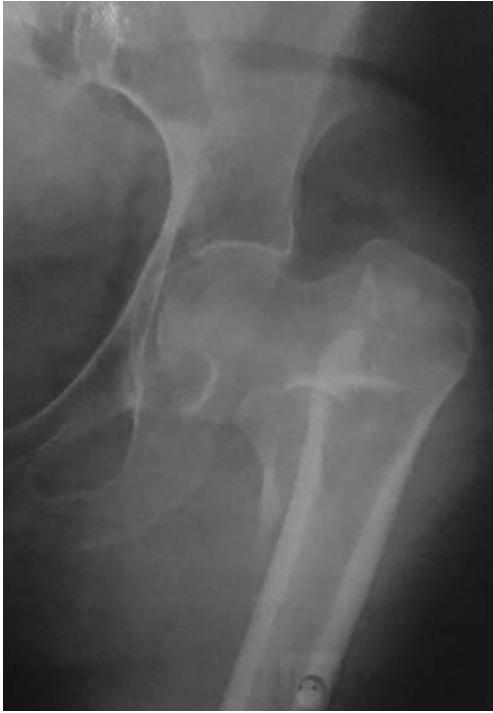
Fig. 1. Pre-op anteroposterior plain radiograph showed unstable pertrochanteric fracture.

An 84-year-old woman came with pain and mass on medial aspect of left thigh. She had undergone reduction and fixation of left pertrochanteric fracture with DHS implant via direct lateral approach about five years before presentation (Figs. 1 and 2). She could walk with a cane without any pain in left hip area. In exam, a strange bulging was palpable in subcutaneous area of medial left

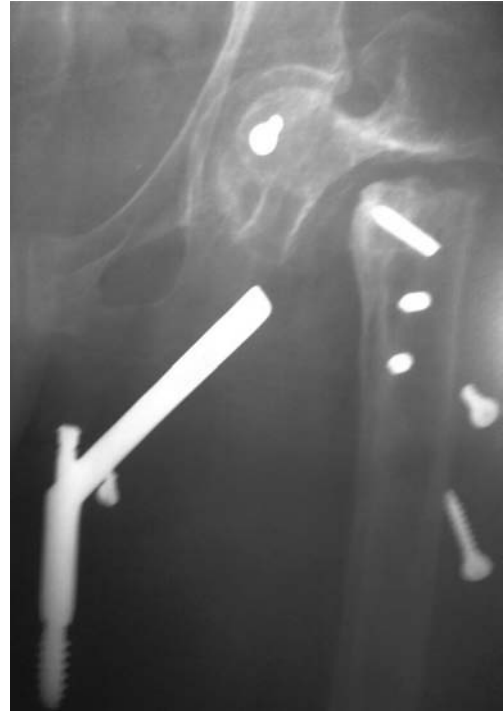
On the plane anteroposterior radiograph, nonunion and deformed pertrochanteric area beside migrated implant in an unbelievable position of medial thigh was obvious (Fig. 3). The broken implant and engaged screws were simply removed through medial thigh incision exactly on the prominent device (Fig. 4). The patient denied any surgery to correct nonunion because of painless walking using a cane.

Fig. 3. Anteroposterior plain radiograph of the patient revealed nonunion and incredible position of broken device in medial of thigh.

of left side. The mechanical stability of DHS to achieve union in this case was inadequate; therefore implant failure was clear from beginning. Another cause of failure in this case would be occult infection which was ruled out by exam and normal laboratory data.

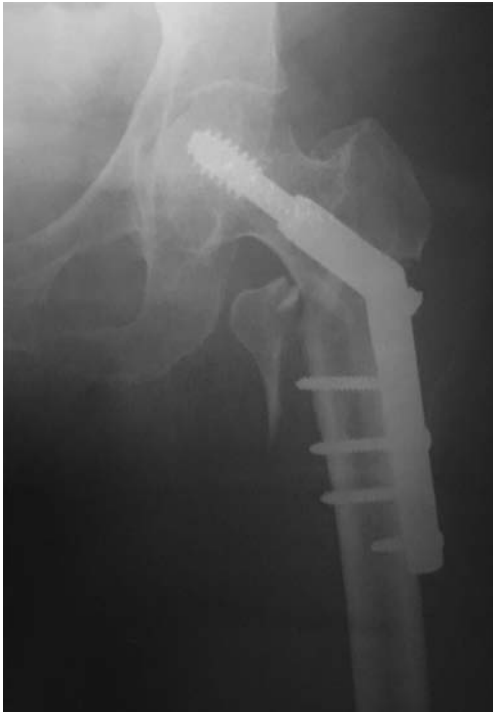
Fig. 2. Post-op anteroposterior plain radiograph displayed reduction and fixation with DHS implant.

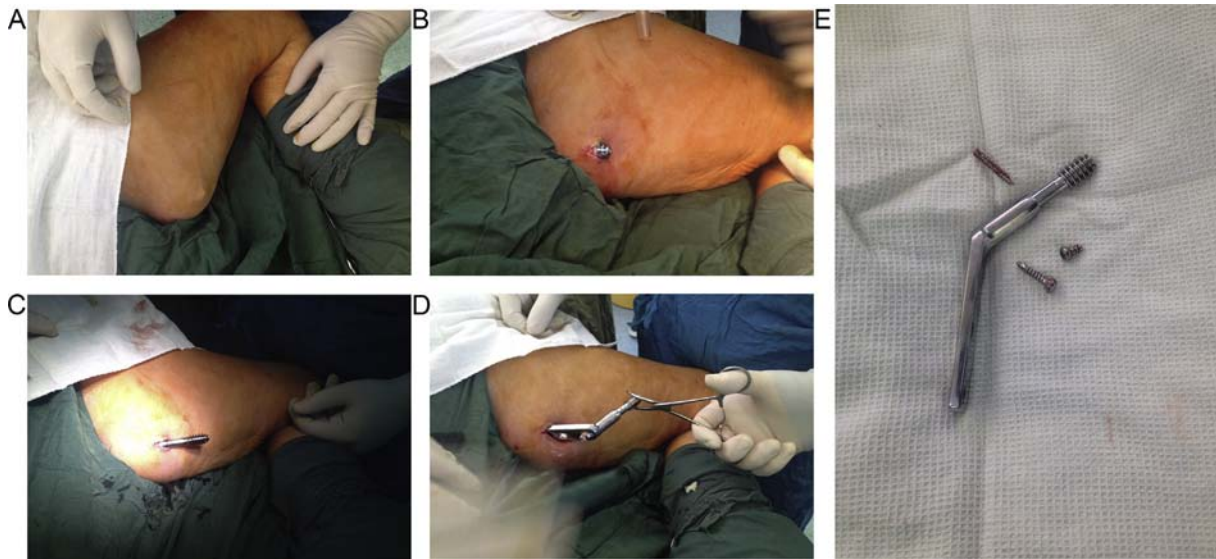
Fig. 4. Sequences of implant removal during surgery (A to E).
