Septic Metallosis after Unicompartmental Knee Replacement: A Case Report and Literature Review

Introduction: Metallosis following prosthetic hip and knee replacement is a well-known complication. However, unicompartmental knee arthroplasty (UKA) metallosis is rare. In this paper, we report a case of septic metallosis after unicompartmental knee replacement and we review the literature for the available treatment options.

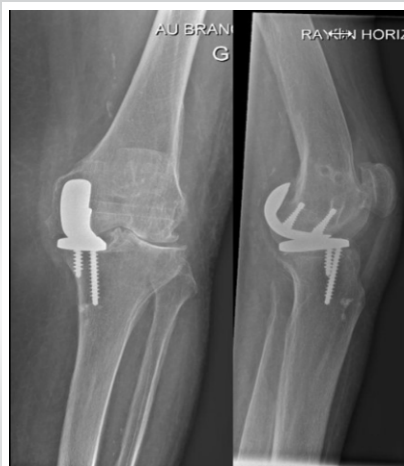
Figure 2: (a and b) Left knee anteroposterior and lateral radiograph.

An 83-year-old female patient with multiple medical comorbidities presented to the emergency department for severe left knee pain and decrease range of motion. She is known to have a unicompartmental prosthesis implanted in her left knee 20 years ago with good functional and clinical follow-up. On physical examination, she had a swollen and erythematous knee, in addition to diffuse tenderness and remarkable pain throughout her arc of motion. 3 months before presentation, she had infectious endocarditis on her native aortic valve and spondylodiscitis. AP chest X-ray showed enlarged cardiac silhouette due to pericardial effusion (Fig. 1) and the germ that was isolated by cultures that time was methicillin-resistant *Staphylococcus aureus* (MRSA). She was treated with intravenous and oral antibiotics for 3 months duration. AP and lateral left knee radiographs showed osteolysis of the medial femoral condyle without prosthetic loosening (Fig. 2).

It is well known that osteolysis is also a consequence of PE wear, where PE debris will be phagocytosed by macrophages, and in their turn, macrophages will secrete some cytokines such as TNF alpha, IL1, and IL6 which have bone resorptive effects [24, 25, 26, 27, 28]. This is clear in our case, where we can see most of the medial femoral condyle being osteolysed.

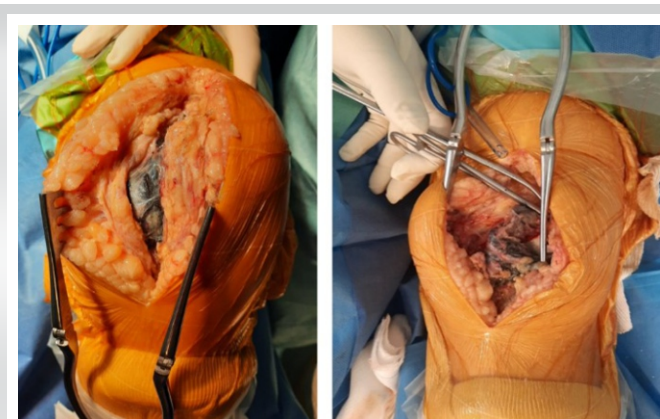
the left medial knee compartment all around the prosthesis. Aspiration of the knee joint yielded the growth of MRSA. Based on the clinical and paraclinical information, a diagnosis of periprosthetic joint infection was confirmed, and a decision to do a two-stage revision arthroplasty was taken. Utilizing the same old incision and through a medial parapatellar approach, surgical exploration showed diffuse infiltration of the synovial tissue throughout the knee with metallic debris (Fig. 3).

Figure 3: (a and b) Per operative photograph showing local soft tissues Metals debris infiltration.

Extensive synovectomy was done, and multiple specimens were sent for bacteriological and pathological analysis (Fig. 4). Medial unicompartmental knee prosthesis was removed and replaced by a cement spacer

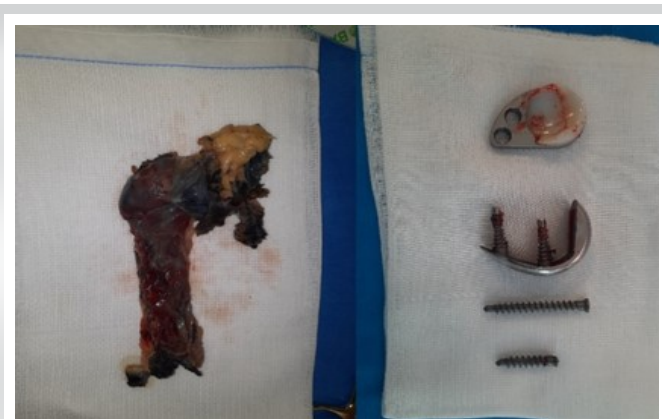
(Fig. 4). The patient was then hospitalized for IV antibiotics, and 6 weeks later, a second stage revision to implant a total knee prosthesis was done after confirming that the knee joint is clean of any infection. Left knee anteroposterior and lateral radiograph post-second stage revision are shown in Fig. 5.

Figure 4: (a and b) Per operative photograph showing the removed Metallosis Polyethylene wear.

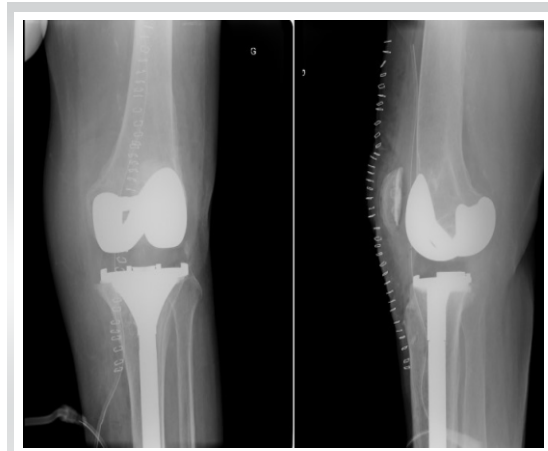
Figure 5: (a and b) Left knee anteroposterior and lateral radiograph post-second stage revision.

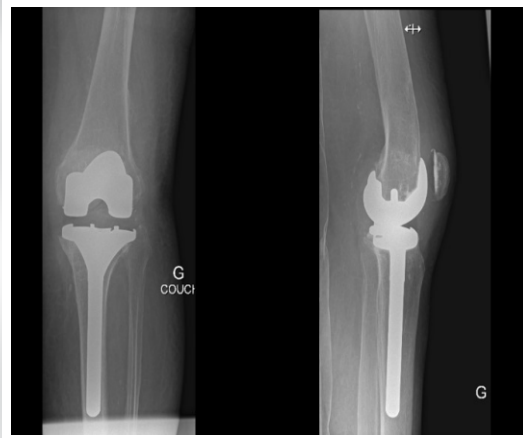
At 1-year post-operatively, she patient was free of symptoms with good functional and clinical outcome (Range of motion: 0–120°). Left knee anteroposterior and lateral radiograph at 1-year follow up are shown in Fig. 6.

Figure 6: (a and b) Left knee anteroposterior and lateral radiograph at 1-year follow up.
