Case Report

Superior bearing dislocation in a unicompartamental total knee prosthesis

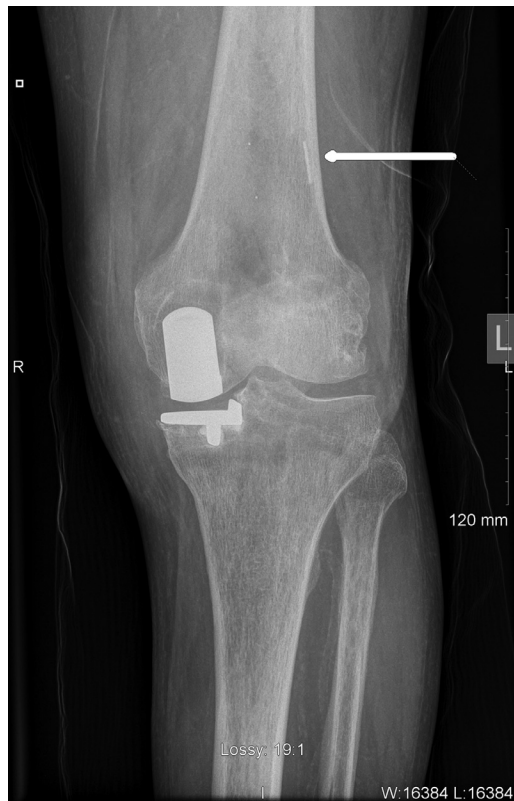
Fig. 1 – AP radiograph (nonweight bearing) showing displacement of meniscal spacer device (arrow)

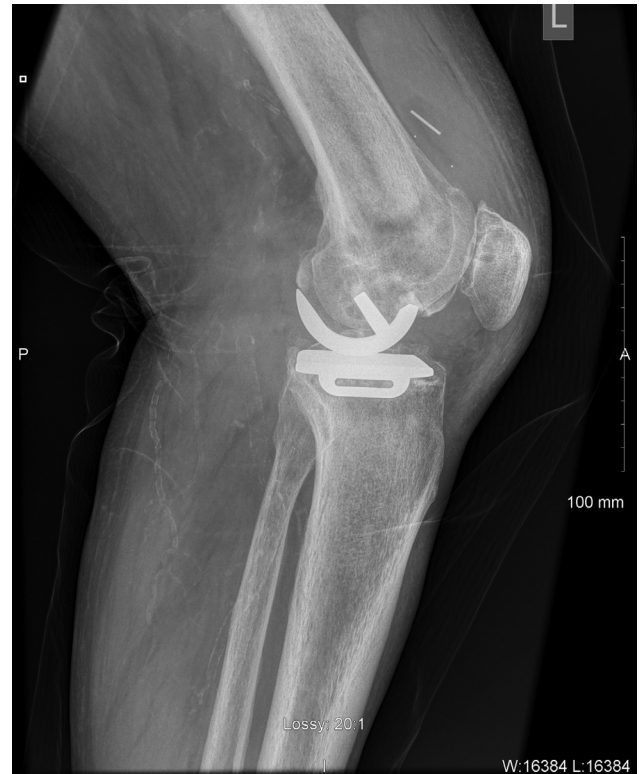
Fig. 2 – Lateral radiograph showing displacement of the meniscal bearing into the suprapatellar recess (nonweight bearing)

A lateral radiograph of the left knee (Fig. 2) demonstrated a new displacement of the medial femoral condyle spacer component of the unicompartmental replacement. The polyethylene meniscal spacer had dislocated superiorly and was visualized in the suprapatellar recess on the lateral radiograph. These findings are less conspicuous on the AP view (Fig. 1) and could easily be overlooked on this view. Radiographs of the left knee performed 5 months prior to this demonstrated satisfactory appearance of the unicompartmental replacement

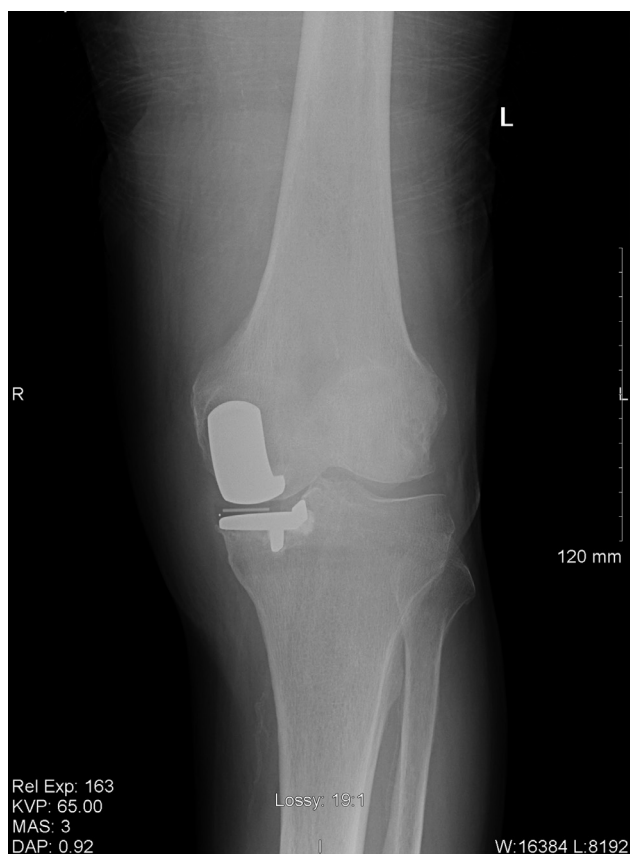
without evidence of prosthetic failure or malalignment (Figs. 3 and 4).

Fig. 3 – Postoperative AP radiograph of OUKR (pretrauma) showing correct location of meniscal spacer device (nonweight bearing)

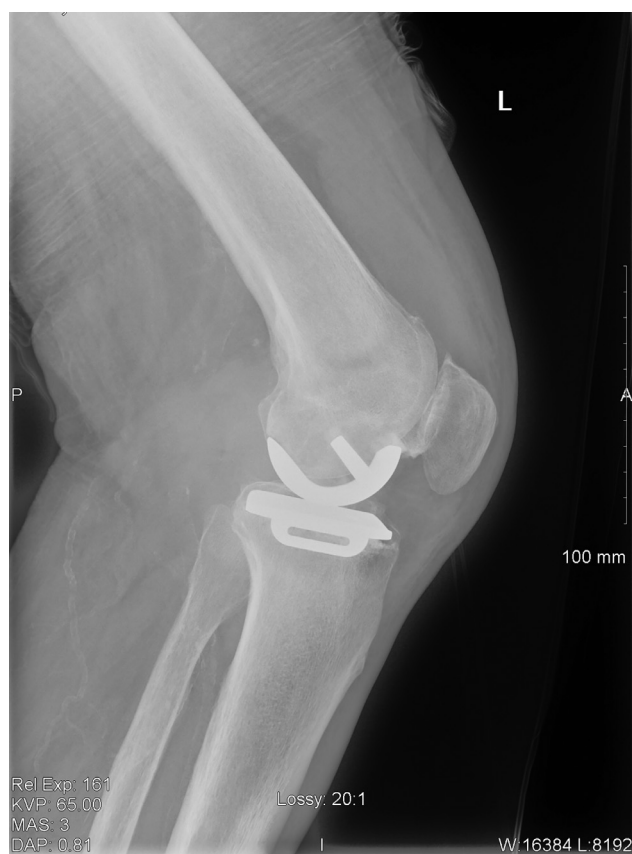
Fig. 4 – Postoperative lateral radiograph (nonweight bearing) of OUKR (pretrauma)

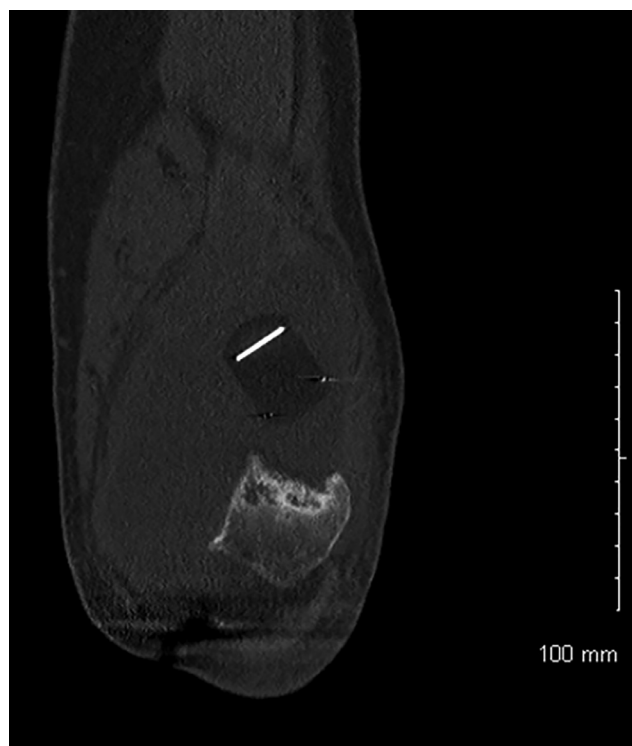
A CT of the knee was performed to assess for a concurrent complication with no periprosthetic fracture identified (Figs. 5 and 6).

Fig. 5 – Coronal CT demonstrating migration of the polyethylene meniscal spacer device into the suprapatellar recess

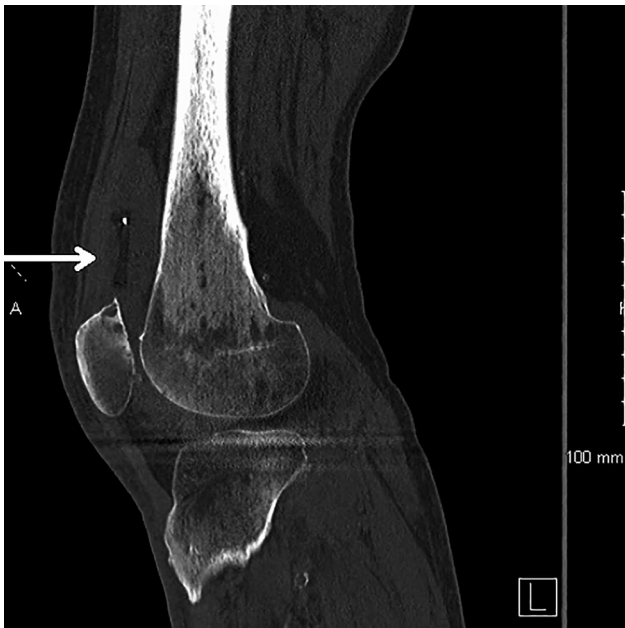
Fig. 6 – Sagittal CT demonstrating migration of the polyethylene meniscal spacer device into the suprapatellar recess (arrow)

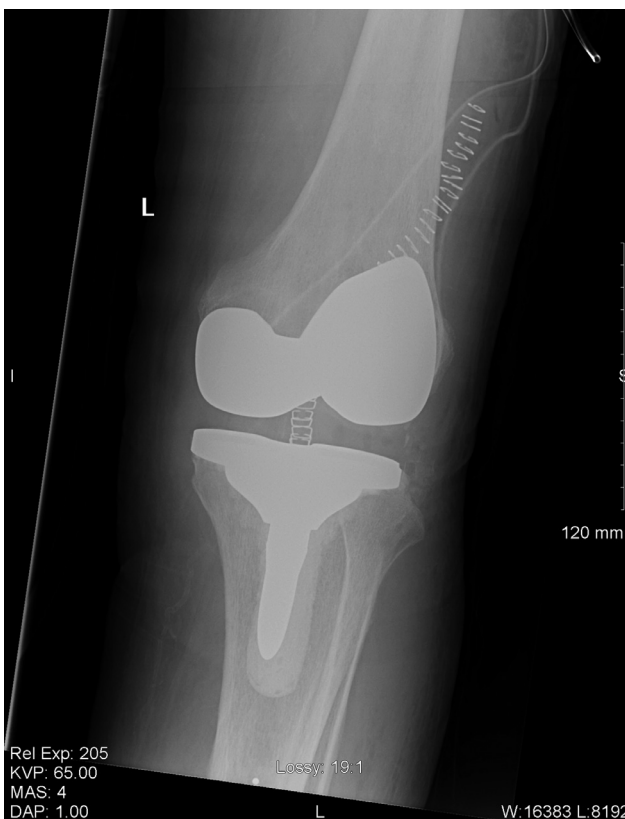
Fig. 7 – Postoperative AP radiograph showing satisfactory alignment post total knee replacement (nonweight bearing)

The patient underwent successful emergent revision of the OUKP with a TKR performed. Conversion to TKR was chosen over simple revision of OUKP due to the traumatic nature of the injury and in order to prevent recurrence of this complication. Postoperative radiographs showed satisfactory alignment of the new prosthesis (Figs. 7 and 8). The patient had an uncomplicated postoperative course regaining excellent overall function in the knee.

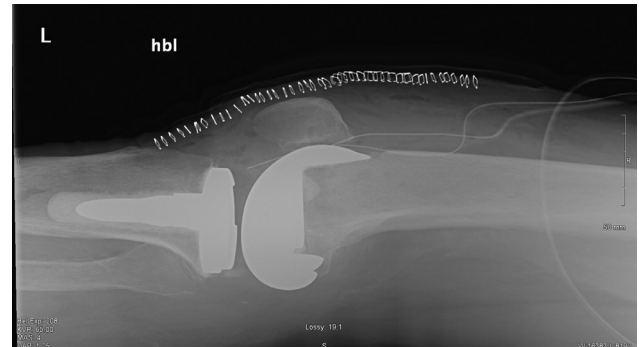
Fig. 8 – Postoperative lateral radiograph post total knee replacement (nonweight bearing)
