Case Reports in Women's Health

Migration of a contraceptive subcutaneous device into the pulmonary artery. Report of a case☆'☆☆'★

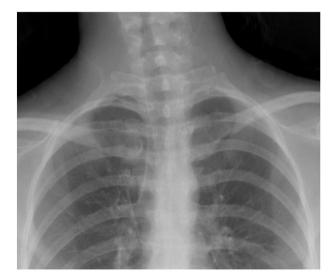
Figs. 1-2. CXR showing a linear opaque structure in pulmonary hemi-right field.

At last, a chest radiograph was performed looking for a possible migration. It showed a linear opaque structure in the pulmonary hemi-right field, whose size and shape were compatible with the Nexplanon (Figs. 1-2). A contrast-enhanced thoracic CT scan confirmed the migration and specified its location in the upper right lobar artery, extending into the apical segmental artery, with

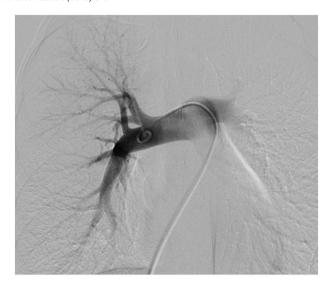
Fig. 4. Interventional technique: capture with a loop snare.

The implant was removed by percutaneous interventional technique through a right femoral vein access. The device was captured with a loop snare after mobilization without complication (Figs. 4–5).
